**WARRANTY
BULLETIN**

WB18-25

DATE:	July 2018	SECTION :	23 ACCESSORIES
EXPIRATION:	July 2020		
SUBJECT :	MONITOR PUSH BUTTON GUARD INSTALLATION

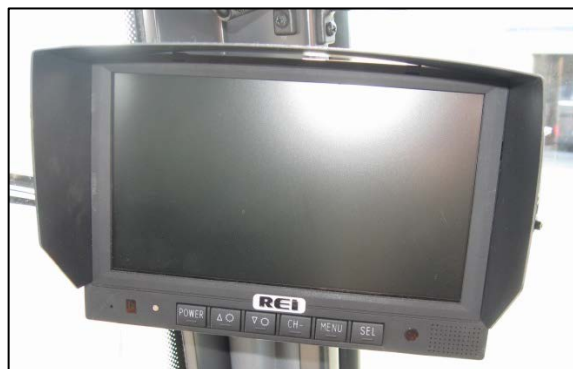
Figure 3

4. New Monitor is installed in the same location using the same mounting hardware (Figure 3). A new harness is connected to the monitor.

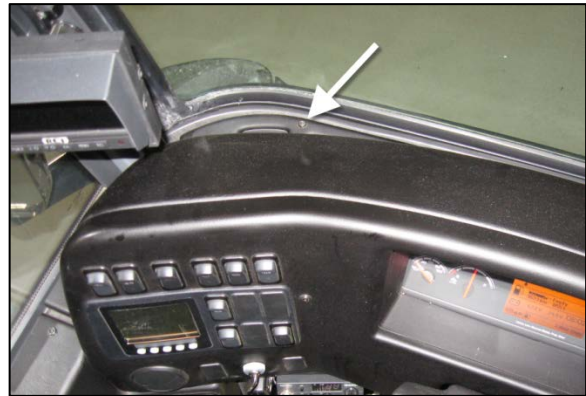
Figure 5

6. Remove dashboard domed cover (Figure 5).

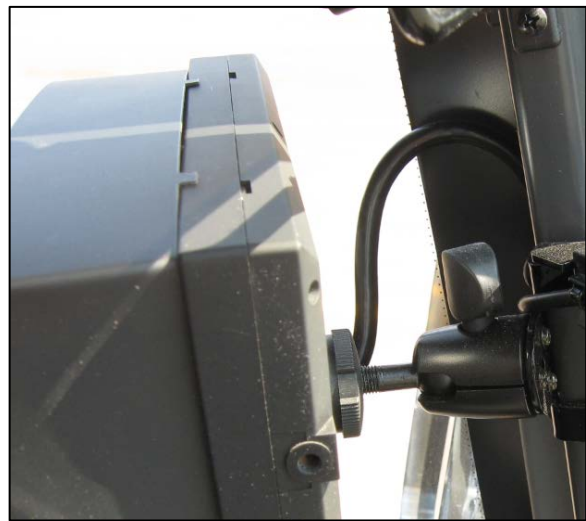
Figure 6

7. Remove old monitor. Keep hardware.
8. Remove cable connected to monitor.
9. Identify mating connectors in the dashboard to locate them easily.
10. Connect new harness 409327 to the connectors in dash.
11. Route harness up to the monitor.
12. Install and connect new monitor reusing reserved hardware.
13. Test monitor operation.
14. Reinstall cable cover.

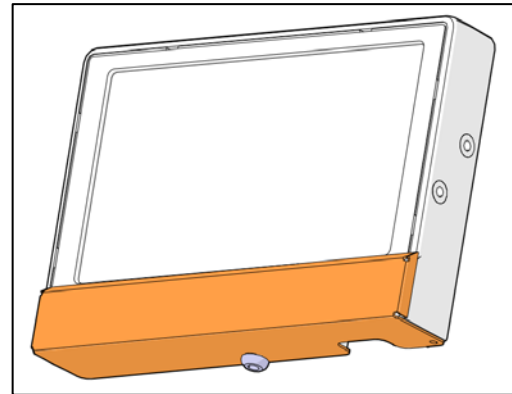
Figure 8

- 16. Tighten the screw (Figure 8).
- 17. Bulletin is complete for this option.
