# MAINTENANCE INFORMATION

MI20-86

DATE: 11 September 2020 SECTION: 06 ELECTRICAL
SUBJECT: DRL CONNECTION VERIFICATION

AFFEIGATION	
Model	
Volvo 9700	
Model Year : 2020	
VIN: From 3CET2V927L5198317 up to 3CET2W424L5201932.

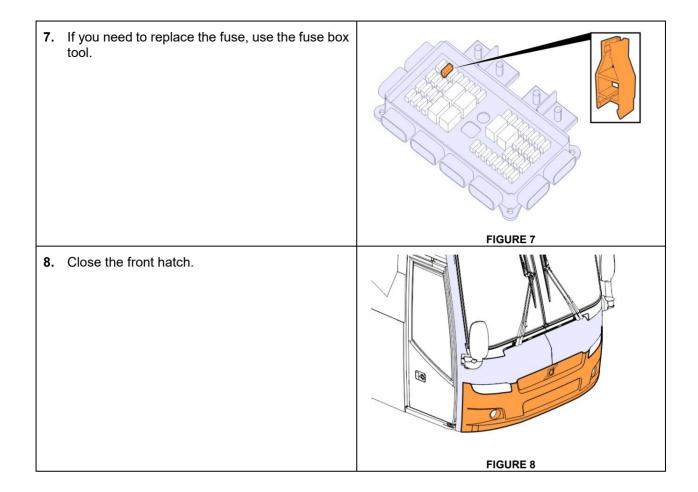
FIGURE 6

4. Verify the harness fixation on the reinforcement of co-pilot side. NOTE Ensure the 6 fixations are well made. FIGURE 4 5. Verify the harness fixation on the reinforcement of driver side. NOTE Ensure the 6 fixations are well made. FIGURE 5 **6.** Verify that the fuse (F2) is not blown. NOTE If the fuse is blown, replace it with a new one.
