**INDUSTRY SAFETY
REMINDER**

**DANGERS OF
DOUBLE CLAMP
BANDED SPRING
BRAKES**

By MGM Brakes

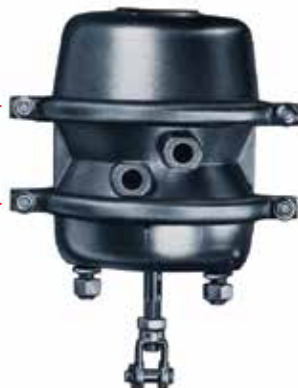
**Spring Side
Clamp Band**

**Service Side
Clamp Band**

DO NOT ATTEMPT TO REMOVE OR LOOSEN THE SPRING PARKING SIDE CLAMP BAND ON A DOUBLE CLAMP BANDED SPRING BRAKE ACTUATOR UNDER ANY CIRCUMSTANCE.

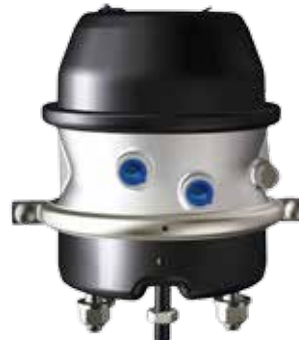
**Spring Side
No Clamp Band**

**Service Side
Clamp Band**

BE SURE TO PROPERLY "CAGE" THE SPRING IN THE SPRING PARKING SIDE ON ALL DOUBLE DIAPHRAGM SPRING BRAKE ACTUATORS - EVEN "TAMPER RESISTANT" MODELS - BEFORE ATTEMPTING ANY SERVICE ON THEM.
