PREVOST

WARRANTY BULLETIN

WB17-16A

DATE :	February 2018	SECTION :	06 ELECTRICAL
EXPIRATION:	February 2020		
SUBJECT :	C15 & C58 CONNECTOR BYPASS

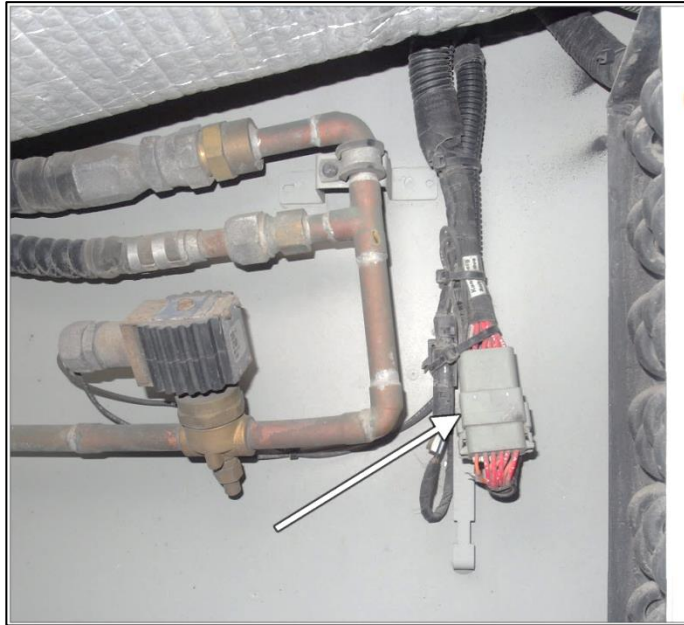
Figure 20: C58

B2. Harness is located along the top of the right (front) wall of the condenser compartment. (Figure 19,Figure 20)

B5. Inspect C58 connector for heat damage. Replace connector and pins if required
