**SAFETY
RECALL**

SR19-04A

DATE :	June 2019	SECTION :	14 STEERING
SUBJECT:	DRAG LINK REPLACEMENT

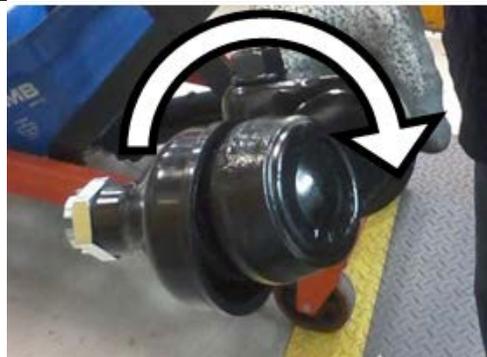
FIGURE 4

7. Screw the drag link elbow ball joint (knuckle side) fully in drag link tube.

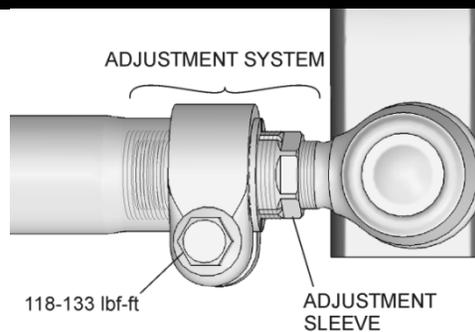
FIGURE 8

11. On the drag link front end you will find an adjustment sleeve which has internal and external left and right threads.

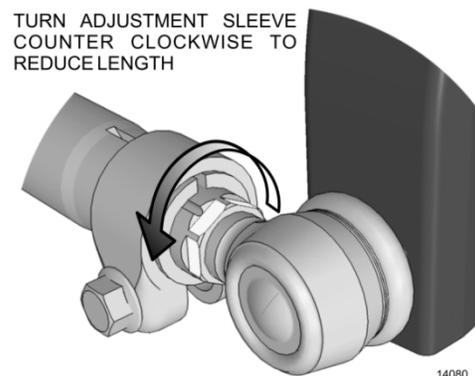
FIGURE 9

12. Fine adjustment of the drag link length if required should be performed exclusively by turning the adjustment sleeve while preventing the tube and joint from rotating.

The only part rotating should be the sleeve

- To extend, turn the sleeve clockwise.
- To retract, turn counter clockwise.

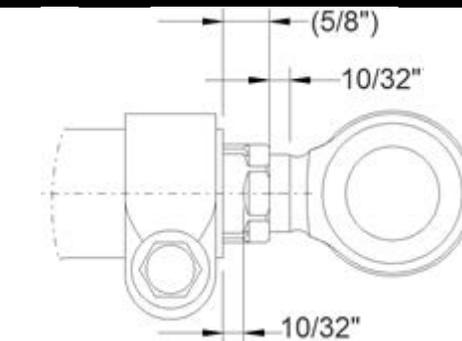
FIGURE 11

13. Adjust sleeve to the values of FIGURE 11.
14. Once the proper length adjustment is done, tighten the front end ball joint clamp. To prevent interference between the ball joint clamp bolts with other components of the steering system, the clamp bolt must be positioned horizontally as shown in FIGURE 12. **Tighten the clamp nut to 118-133 lbf-ft.**
15. Apply a torque seal mark

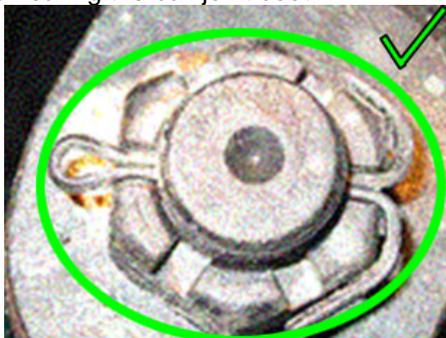
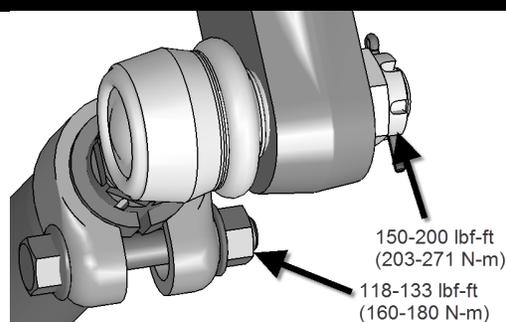
FIGURE 13

16. Install the drag link.
17. Ball joint castellated nut on both ends should be tightened to **150-200 lbf-ft.**
18. Install cotter pin p/n 502104 and bend to lock bolt in place (see example in image below).
19. Apply a small amount of anti-seize compound on all exposed threads for corrosion protection. Be sure to avoid smearing the ball joint boot.
