PREVOST

SAFETY RECALL

SR25-13

DATE:	June 2025	SECTION: 16 SUSPENSION
SUBJECT:	RETORQUE IFS LOWER CONTROL ARM BOLTS

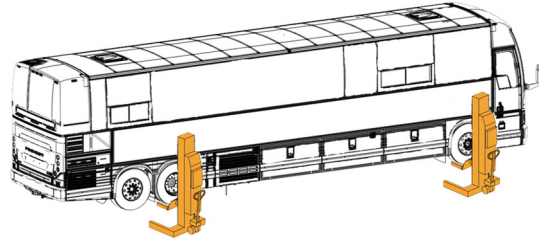
2. Locate the four bolts securing the lower control arms of the front suspension to the backbone.

3. Torque each bolt to **387 lb-ft**.
4. Apply red torque seal mark.
