PREVOST

WARRANTY BULLETIN

WB19-11 A

DATE :	June 2019	SECTION :	06 ELECTRICAL
EXPIRATION:	June 2021		
SUBJECT :	ISM IMPROVEMENT (VEHICLE PROGRAM UPDATE)

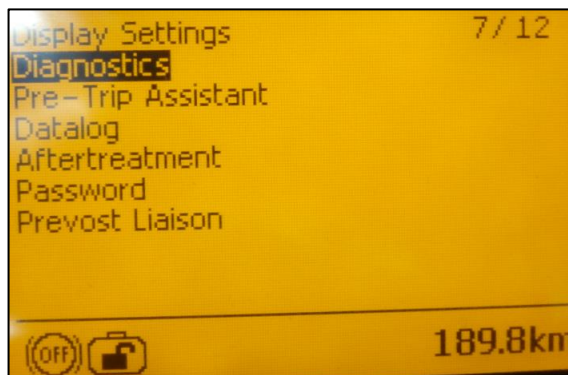
Figure 1

1. Check the vehicle program revision number with the Driver Information Display (DID) in the dash.
2. Select the Diagnostics menu.

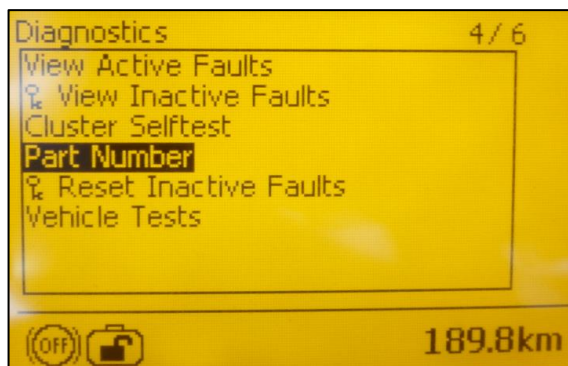
Figure 2

3. Select Part Number menu.

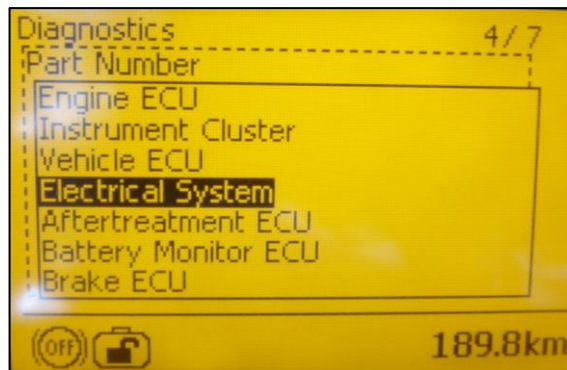
Figure 3

- Select Electrical System menu.

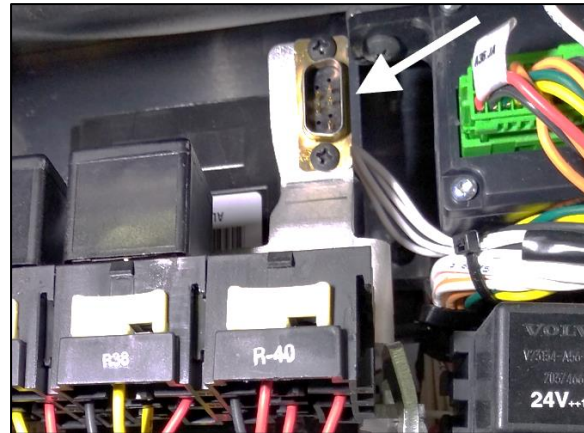
Figure 6

20. Remove the cap and keep in a safe place.
21. Connect the computer on the vehicle into the RS232 port.
22. Open the computer management application on your computer.
23. Right click on "My Computer" on the desk and click on Manage menu.

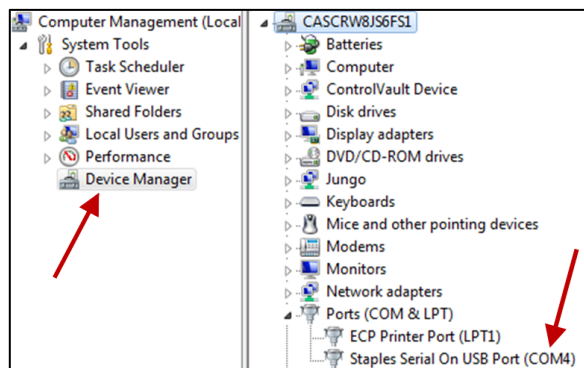
Figure 7

24. Click on "Device manager".
25. Expand the ports list.
26. Check the COM port number and note the number.

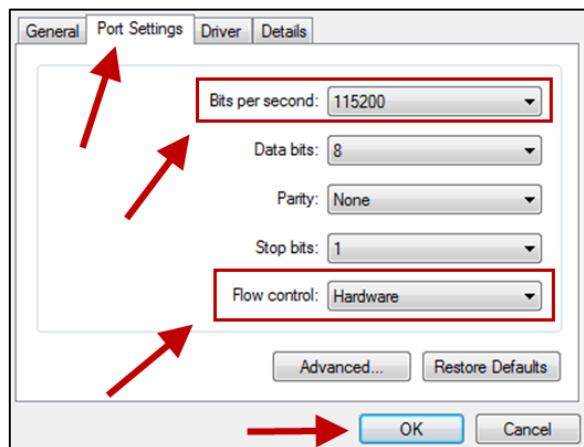
Figure 8

27. Double click on "COM" element to open the properties dialog box.
28. Click on "Port Setting" tab.
29. Select 115200 for the Bits per second.
30. Select Hardware for the Row control.
31. Click "OK".

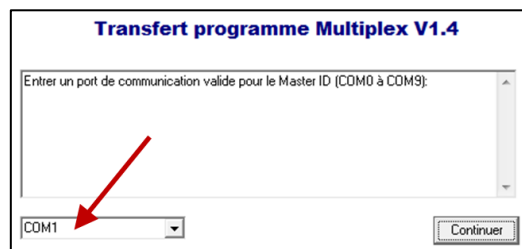
Figure 9

34. Launch the vehicle program (double click on the file name or right click on the file name and select Open).
35. Select the port number noted before.
36. Click "Continue" button.

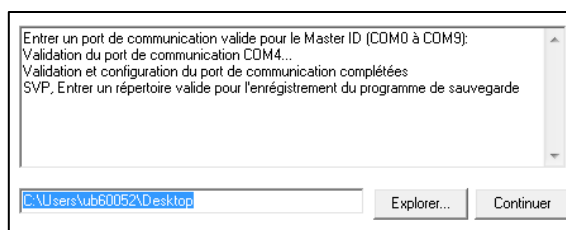
Figure 10

37. Select the destination of the backup file that will be generated with the update processing.
38. Click on "Continue" button.

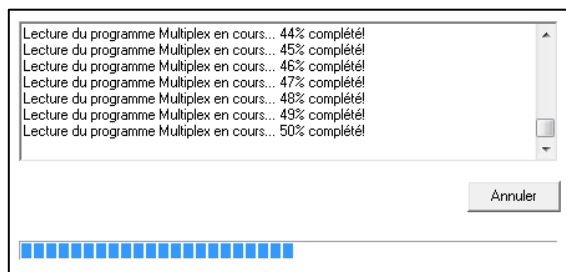
Figure 11

39. Program processes.

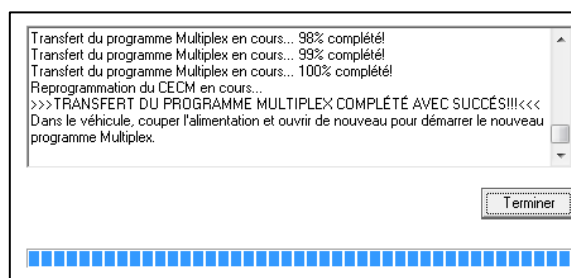
Figure 12

40. Wait until you get the message "TRANSFER COMPLETED".
41. Click "Finish" button.
