SAFETY RECALL

SR23-82

02-01-2023

BAD GPS CONNECTION AT THE VECU CONTROL UNIT
9700 (B13R)

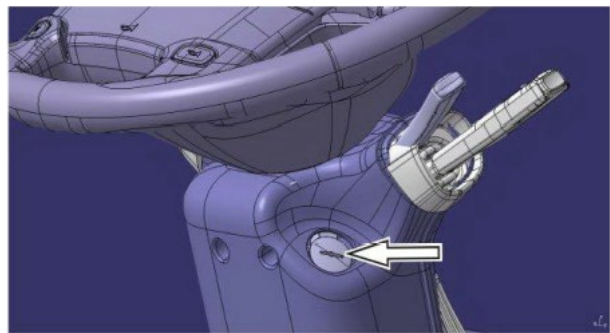
1. Turn OFF the vehicle
 - Turn OFF the vehicle electrical system, by turning the ignition switch to the OFF position.

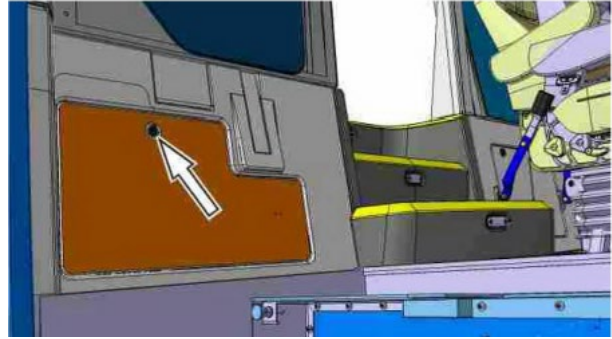
2. Open the body electrical center compartment.

- Open the vehicle electrical center compartment located at the left side of the entrance door steps.

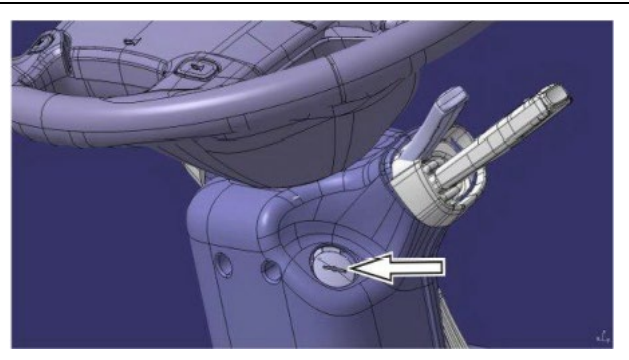
5. Turn ON the vehicle.

- Turn ON the vehicle electrical system, by turning the ignition switch to the ON position.

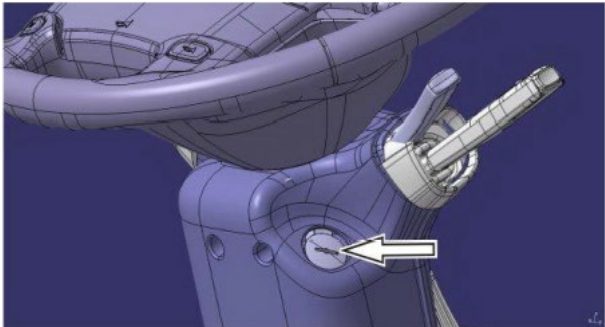
<p>7. Check proper operation.</p> <ul style="list-style-type: none">• Check proper operation of the vehicle throttle and the engine starting.	
<p>8. Turn OFF the vehicle.</p> <ul style="list-style-type: none">• Turn OFF the vehicle electrical system, by turning the ignition switch to the OFF position.

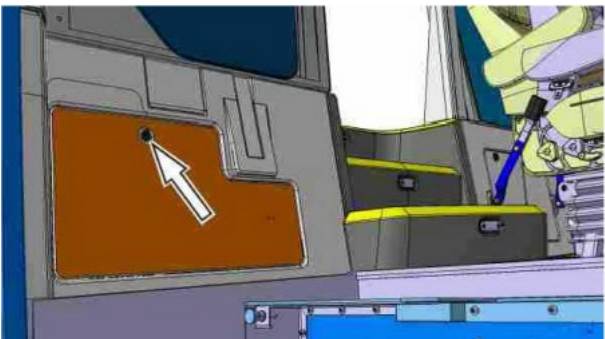
<p>9. Close the body electrical center compartment.</p> <ul style="list-style-type: none">• Close the vehicle electrical center compartment located at the left side of the entrance door steps.
