SAFETY RECALL

SR24-05

DATE :	January 2024	SECTION :	06 ELECTRICAL
SUBJECT:	RETIGHTEN FUSE-HOLDER NUTS F199

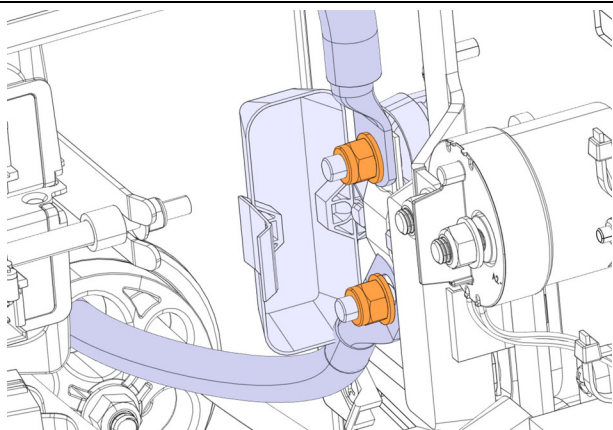
On vehicles affected by this recall, retighten fuse-holder nuts F199.

6. Open the fuse holder.

7. Loosen nuts before retightening.
8. Retighten nuts inside the fuse holder to a torque of **100lb-in**.
9. Applied torque seal on nuts.
