PREVOST

**MAINTENANCE
 INFORMATION**

Mi12-04C

DATE : MARCH 2012	SECTION : 04 - Exhaust
SUBJECT : WIRING - ACM GROUND AND SUPPLY, DPF TEMP SENSORS, VECU SUPPLY

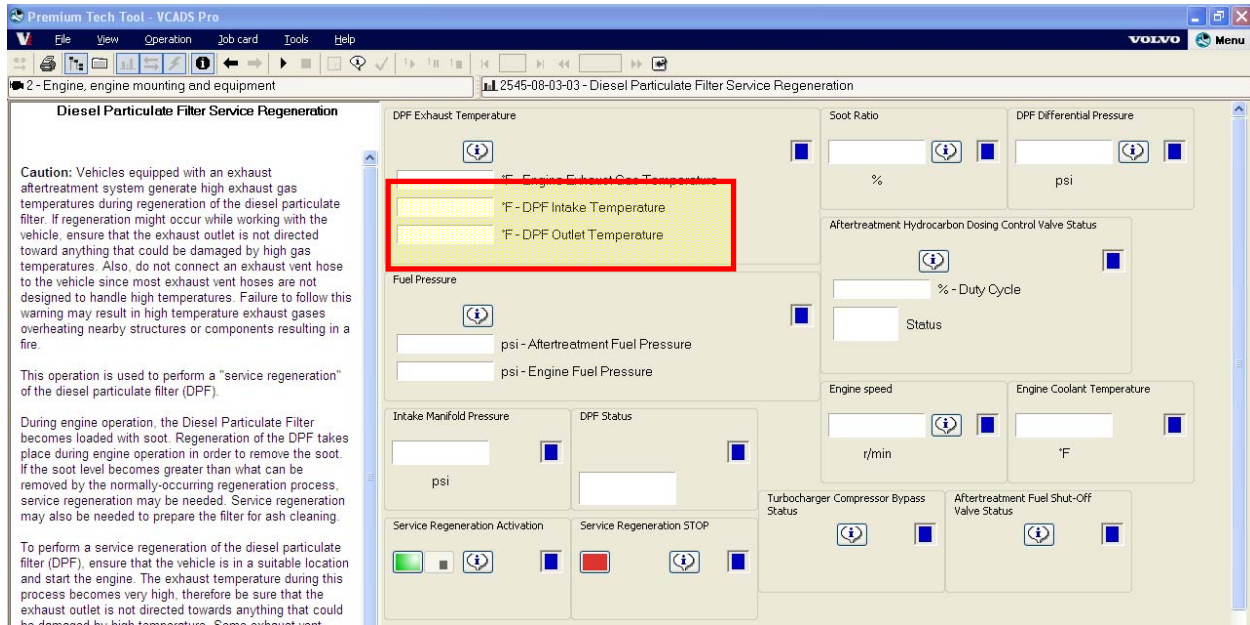
Monitor all 3 temperature sensors to confirm all 3 sensors are reading correctly.

Next will be to go to the DPF Service Regeneration page 2545-08-03-03 and start a Park Regeneration.

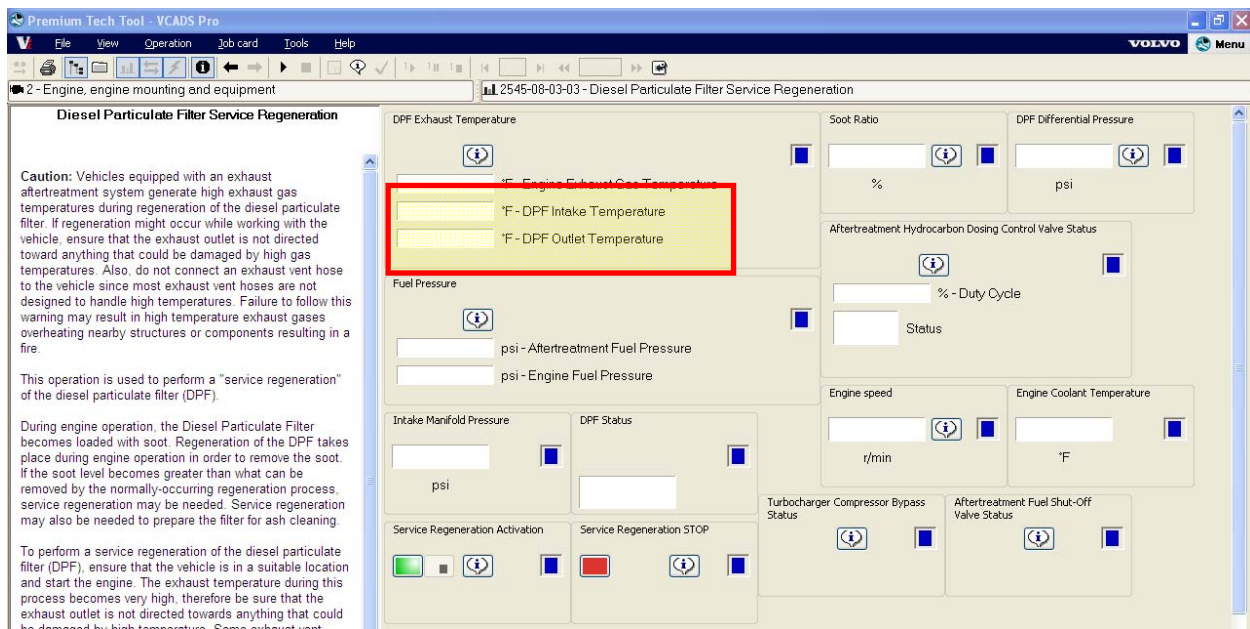
Monitor all 3 temperature sensors to confirm all 3 sensors are reading correctly.

Next will be to go to the DPF Service Regeneration page 2545-08-03-03 and start a Park Regeneration.
