**SAFETY
RECALL**

SR13-73

DATE :	DECEMBER-2013	SECTION :	06 - Electrical
SUBJECT:	P-Clamp on Bosch T1 alternators

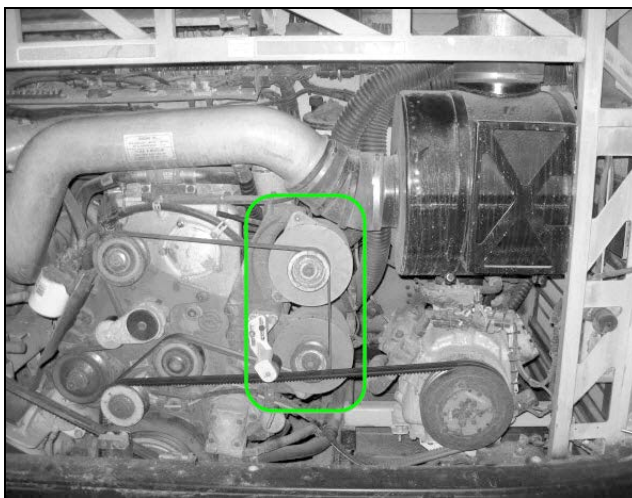
Fig.1 Bosch T1 alternators

1. Open the engine compartment doors and locate the two alternators (Fig.1).

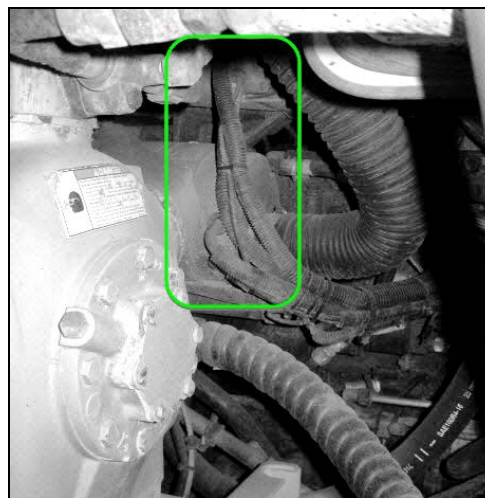
Fig.2 Access from rear curb side door

NOTE: It may be easier to access the alternators from the rear curb side door (Fig.2).
