PREVOST

**WARRANTY
BULLETIN**

Wb09-23

DATE: JANUARY 2010	SECTION: 23 - Accessories
EXPIRATION: JANUARY 2012	
SUBJECT: PREHEATER EXHAUST PIPE HOLDING CLAMP

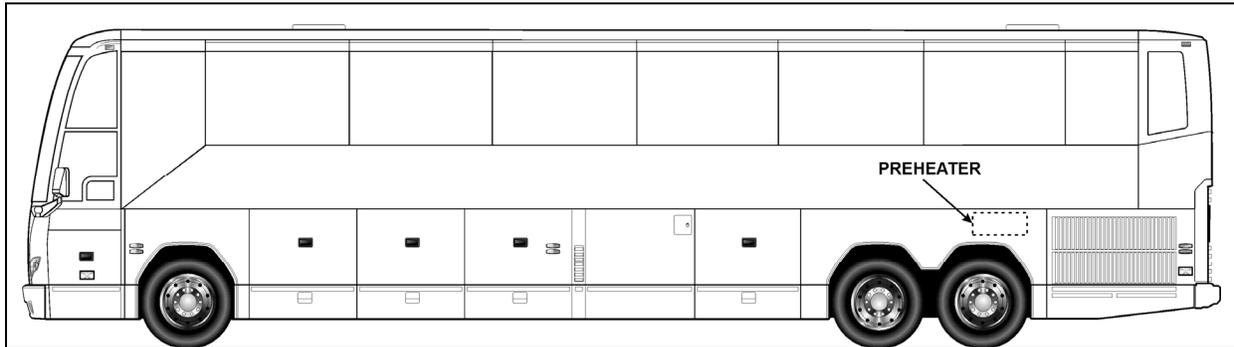
On the vehicles affected by this bulletin and equipped with a preheater, there is a possibility that the clamp holding the preheater exhaust pipe be not properly positioned.

Make sure that holding clamp is located above splash guard panel and not beneath.

1. Check if the clamp holding the preheater exhaust pipe is located above or beneath the splash guard panel. This splash guard panel is located above the tag axle L.H. side wheel.
2. In the case where the clamp is located under the panel, it must be removed and repositioned.

1. Dismount rear L.H. side fender.
2. Remove the clamp located beneath the splash guard panel and relocate it above the panel.
3. Reinstall rear L.H. side fender.
