# PREVOST

## WARRANTY BULLETIN

WB12-35

DATE : NOVEMBER 2012	SECTION :	22 - HVAC
EXPIRATION: NOVEMBER 2014		
SUBJECT : PRE-HEAT EXHAUST TUBE CLEARANCE

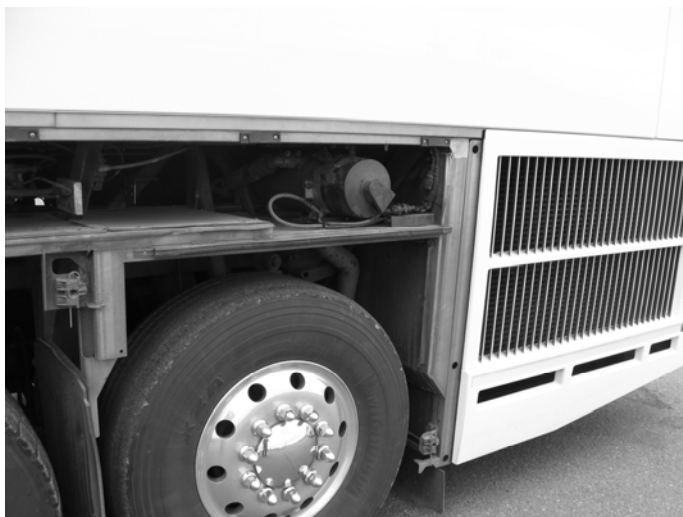
1. Remove the street side rear fender

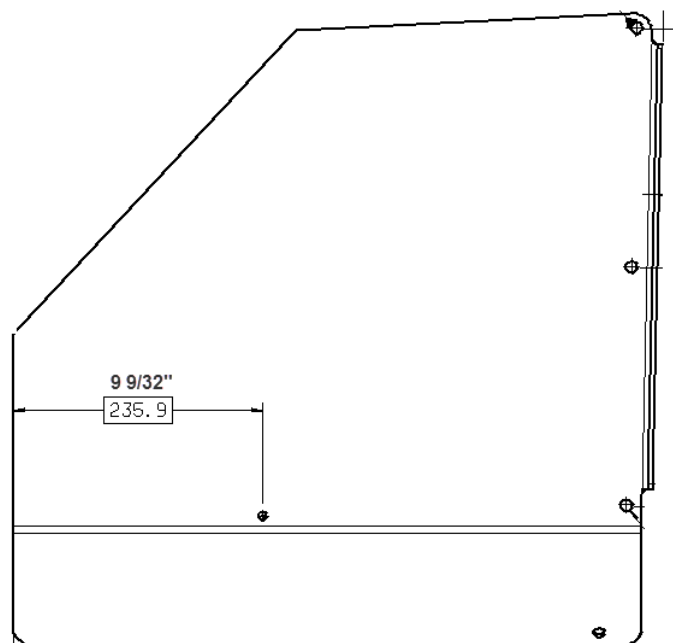
On the vehicles affected by this bulletin, the pre-heater exhaust tube may have been installed too close to the tag axle tire. Inspect tube position and make sure it has proper clearance with the tire. If not, move it away from the tire.

6. Remove the screws and move exhaust tube away from tire.

7. To help position the mounting bracket, there is a mark that indicates the proper mounting hole position on the plastic panel.

8. Secure at new position. Re-use mounting hardware.
