WB24-09

BULLETIN

SUBJECT :
 FLECTRONIC MIRROR LENS CLEANING

CT: ELECTRONIC MIRROR LENS CLEANING SYSTEM INSPECTION

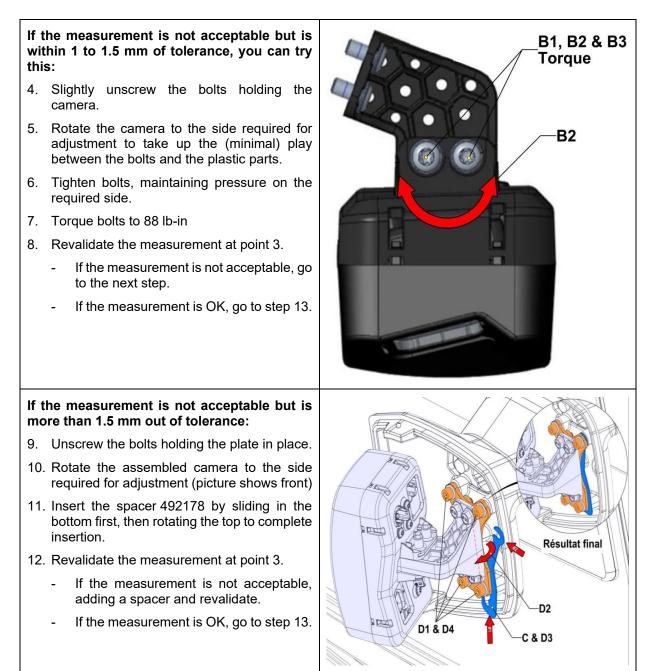
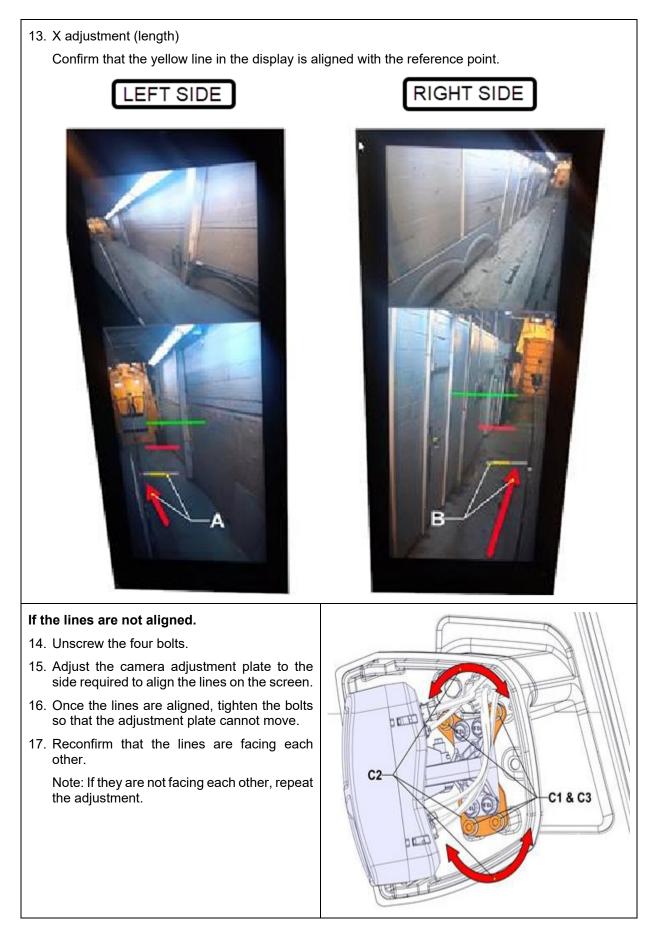
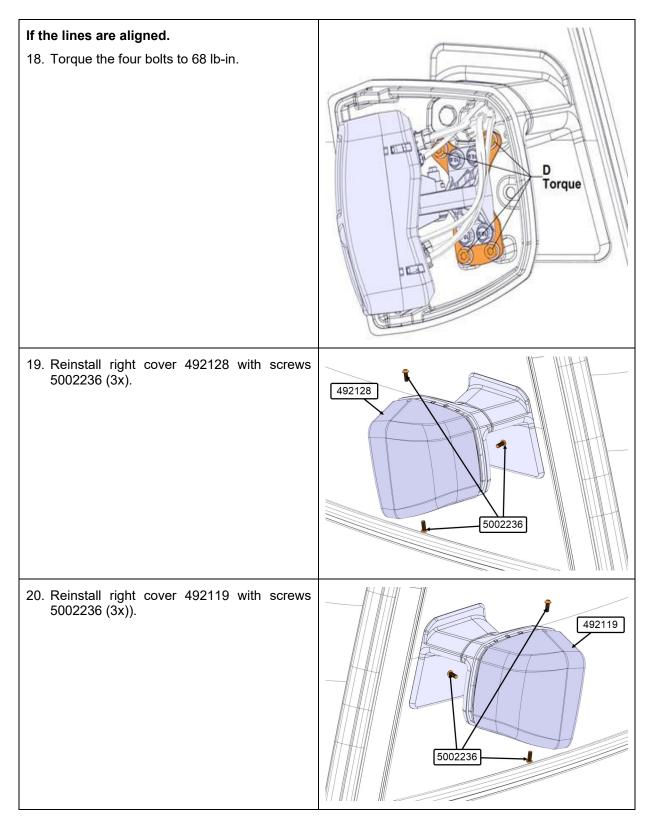
On the vehicles affected by this bulletin, the electronic mirror lens air-cleaning system may not work.

REPLACEMENT	OF RIGHT CAMERA
1.	Remove right cover 492128 and screws 5002236 (3x).	
2.	Disconnect the harness 0610486 from camera 901814.	A142 A223W.A GG GG C C C C C C C C C C C C C
3.	Disconnect air hoses 140495 (2x) from the camera.

11. Reinstall the pin 502006 on the base 492114.	
 12. Reinstall the camera assembly on the base 492114 with the screw 5001912 (1x) and the lock washer 5001161 (1x). 13. Torque to 14 lb-ft. 	
14. Connect air hoses 140495 (2x) to the camera.	
15. Plug the harness 0610486 to the camera 901814.	A142 A223W.A A223W.B A140
