## MAINTENANCE INFORMATION

Mi98-36

DATE : August 1998	SECTION : 22
SUBJECT : Improvement of the Condenser Fan Circuit

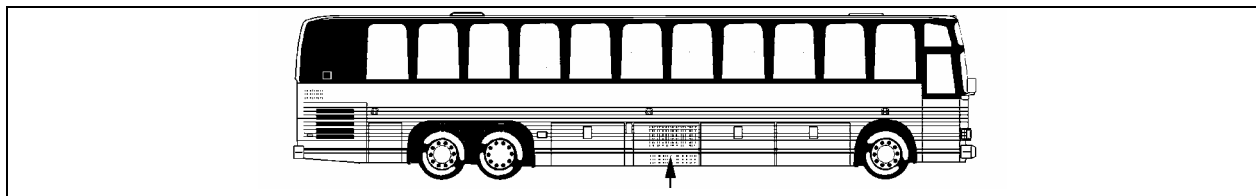
**Figure 1:** Condenser compartment door typical location.

1. Open the condenser compartment door (see figure 1). Locate the white junction box of the A/C. Remove the box lid;
