**PREVOST**

**WARRANTY  
BULLETIN**

Wb06-05A

<b>DATE : JUNE 2006</b>	<b>SECTION : 23 - Accessories</b>
<b>EXPIRATION: JUNE 2008</b>	
<b>SUBJECT : INSPECTION OF A PIVOT ON THE WINDSHIELD WIPERS MECHANISM</b>

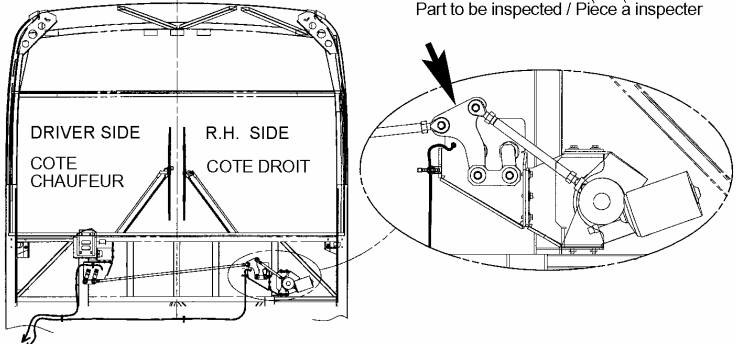
On the above mentioned vehicles, it is necessary to inspect the pivots mounting plate on the wipers mechanism. Prevost Car has determined that some of these parts may be defective due to a weak or missing weld bead on one pivot. If this part is defective, a failure of the wipers mechanism may occur while in use, making the wipers totally inoperative.

<p>2. Locate the pivots mounting plate on the wipers mechanism (see figure at right).</p>

Inspect the part as described in PART A of this bulletin. If the part is defective, replace it as described in PART B.
