PREVOST

WARRANTY BULLETIN

WB15-48A

SUBJECT: BITZER – ADDITION OF A REINFORCEMENT

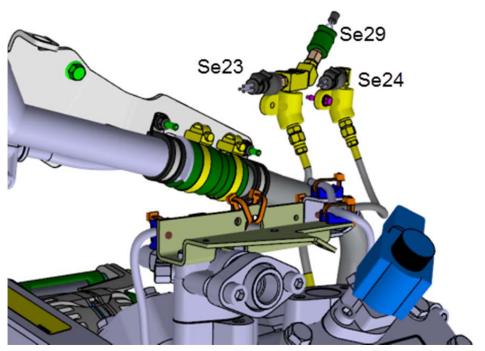
ATTACH THE EXCESS LENGTH OF CABLE ALONG MAIN STRAND OF HARNESS AS SHOWN- NYLON TIES LOCATION SHOWN BY ARROWS
