DESCRIPTION

For the vehicles **on which a notification** for SP18-35 **exists**, perform the following checklist and operations. It has been determined that these vehicles had the code (DTC) P20EE activated.

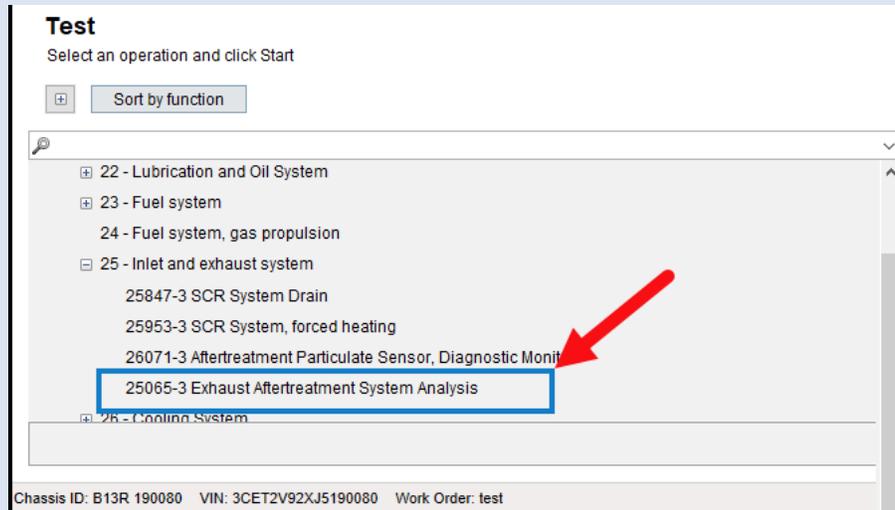
9 Perform the Exhaust aftertreatment system analysis (operation 25065-3)

Take a screen capture of the Test result (image below) and save for submittal.
