**MAINTENANCE
INFORMATION**

MI18-28

DATE :	September 2018	SECTION : 18 BODY
SUBJECT :	Compressor Door Adjustment on X3 Vehicles

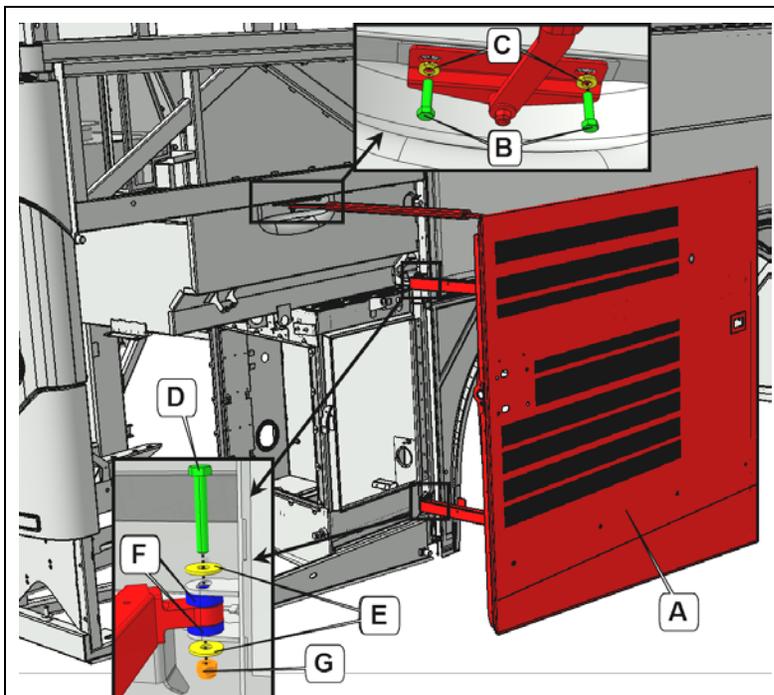
FIGURE 2: HINGES

- A – ENGINE R.H. SIDE ACCESS DOOR
- B - BOLT
- C - BELLEVILLE WASHER
- D - BOLT
- E - WASHER
- F –SPACER
- G - NUT
