PREVOST

SAFETY RECALL

Sr09-10

DATE : JUNE 2009	SECTION : 14-STEERING
SUBJECT : INSPECTION AND REPLACEMENT OF DRAG LINK SPHERICAL PLAIN BEARING ROD END

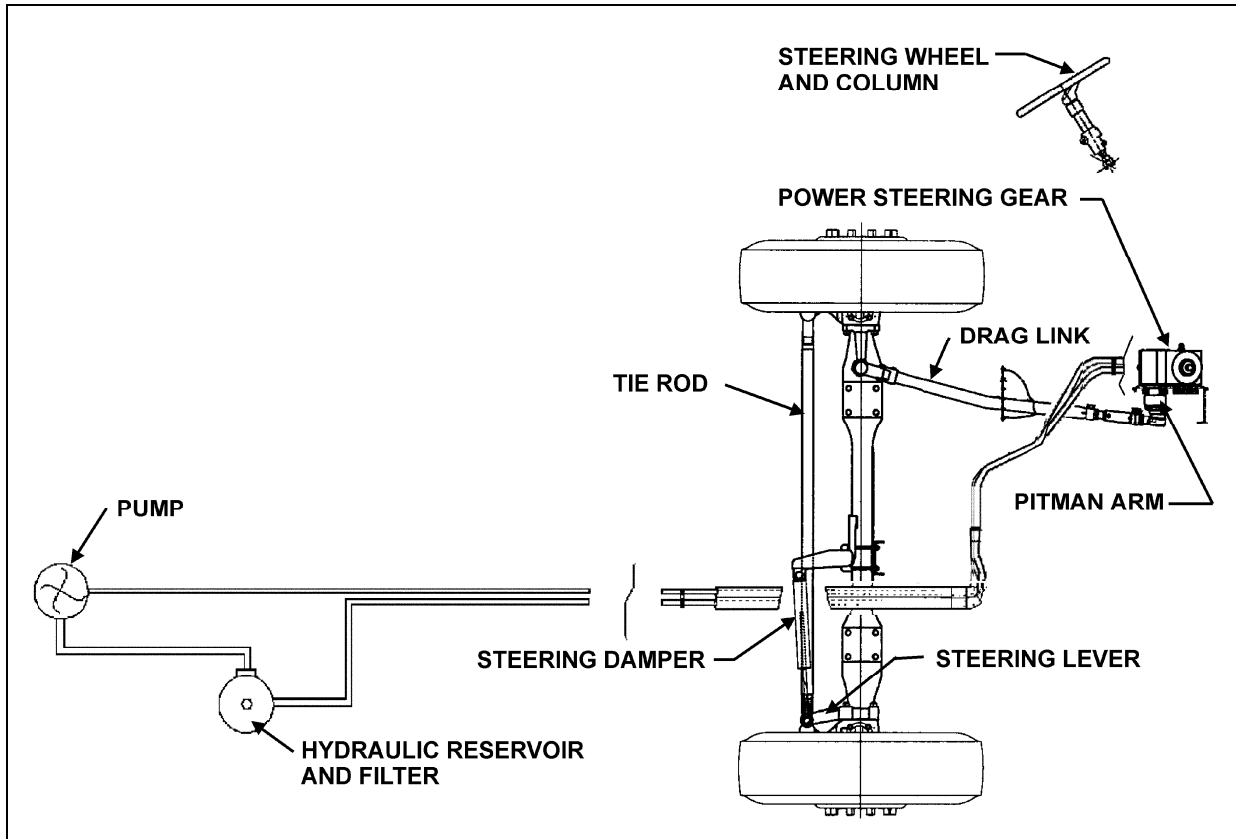
FIGURE 1

On items affected by this recall, material that may not meet Dana requirements for installation on the steering linkage of I-beam axle equipped vehicles have been purchased by you via Prevost Parts. Drag link end opening being off-centered, this can reduce the wall thickness below tolerances.

In certain heavy loading conditions this defective part could break, resulting in a loss of steering control which could result in a crash. Inspect inventory parts and parts already installed if applicable. If measurement is outside tolerances, part must be replaced and returned for reimbursement.

4. If measurement is outside tolerances, part 610991 must be replaced.
