PREVOST

**SAFETY
RECALL**

SR13-03E

DATE : MARCH 2013	SECTION : 23-ACCESSORIES
SUBJECT : AUTOMATIC FIRE DETECTION AND SUPPRESSION SYSTEM – LINEAR THERMAL DETECTOR REPLACEMENT

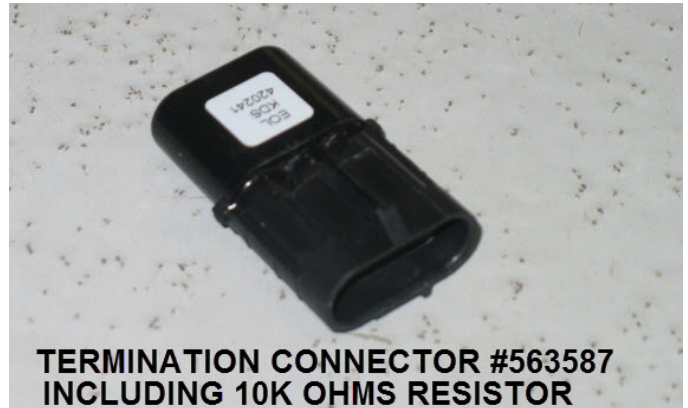
STEP 3-T

**TERMINATION CONNECTOR #563587
INCLUDING 10K OHMS RESISTOR**

Secure the LTD end connector as shown. Unplug the connector housing fitted with green rubber plugs and replace with the termination connector found on the previously installed LTD. This termination connector includes a 10k Ohms resistor required to close the circuit.
