**SAFETY  
RECALL**

**SR14-26A**

DATE :	JUNE 2014	SECTION :	18 - Body
SUBJECT:	SEAT BELT INSPECTION AND REPLACEMENT: AMAYA FLIP-UP SEAT

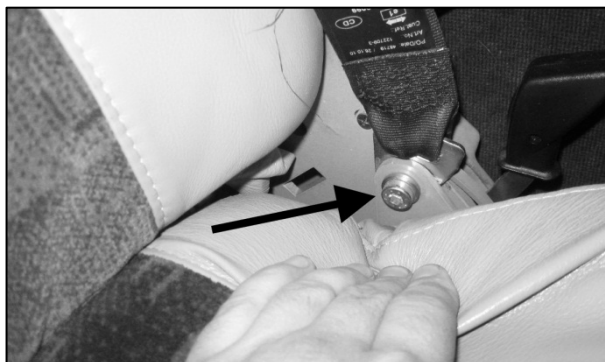
Figure 4 seat pivot and belt anchor (Road side)

Two bolts, left and right. Remove wall side seat belt anchor (fig 4)

1. Remove seat cushion assembly bolts located at pivot location.

12. Re-install cushion assembly.(Fig 4)

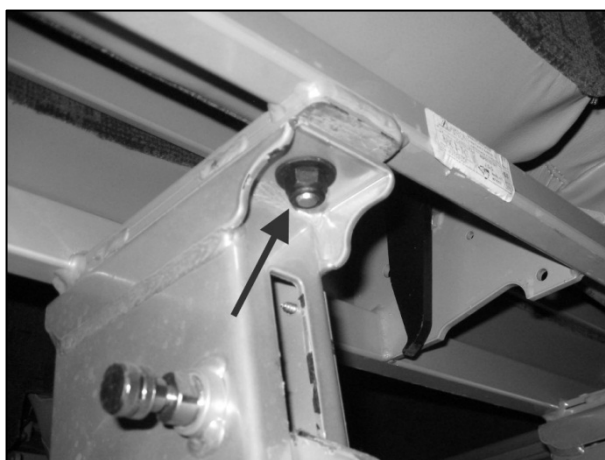
Figure 6 Front nuts.

Front nuts are readily accessible.(Fig 6)

Leave pedestals in locked position and remove seat from pedestals.

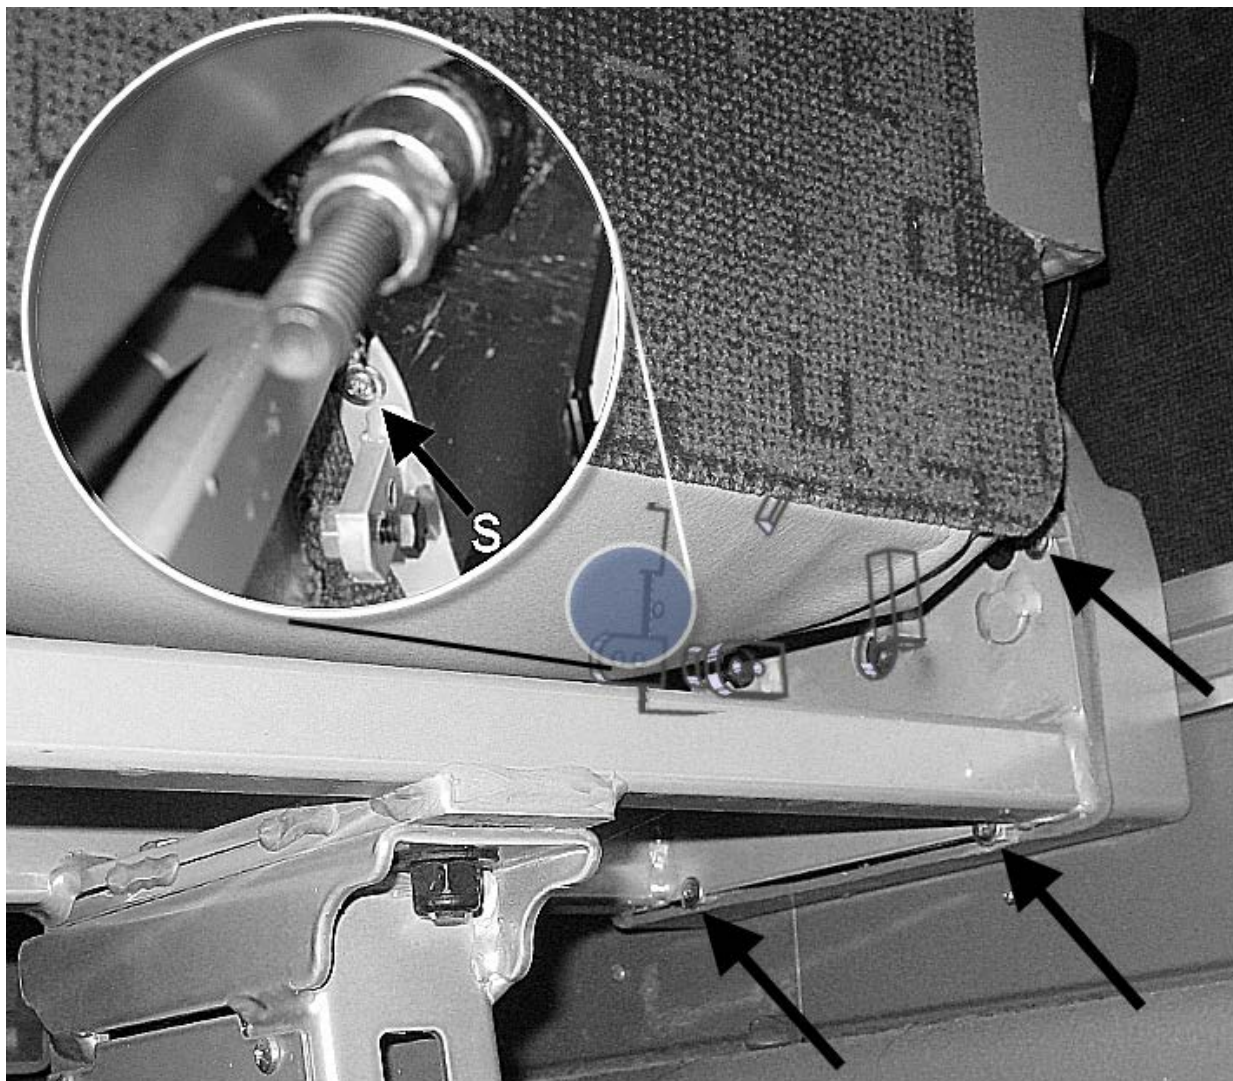
Figure 9: Blind screw "S" location

6. Rear screw "S" is in a blind location. You will find it near the upper rear cross tube of the seat frame above the adjustable flip cushion stopper.

5. Remove the screws retaining the plastic cover, (Fig 8, Fig 9)  
(4 places, from the inside)  
Long screwdriver tips may be required for the rear screws. Keep hardware.
