PREVOST

WARRANTY BULLETIN

WB14-06G

| SUBJECT : | "BITZER" LARGE A/C SYSTEM IMPROVEMENT | | |

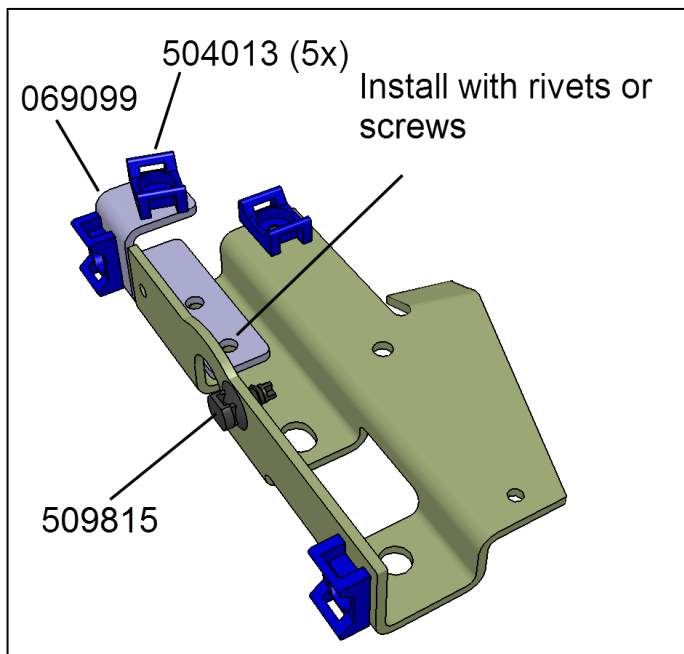
Figure 12

Addition of this support is recommended for all brackets, new and existing to route the unloader cable properly and avoid a sharp edge. You may install the bracket with screws or rivets.

If using screws, drill 7/32" holes using bracket 069099 as template. (Fig 12)

If using rivets, drill with a #10 (0.1935") drill.

Install with a pneumatic riveter if available using two #504379 rivets. Otherwise use two 5001241 screws and nut 5001180.

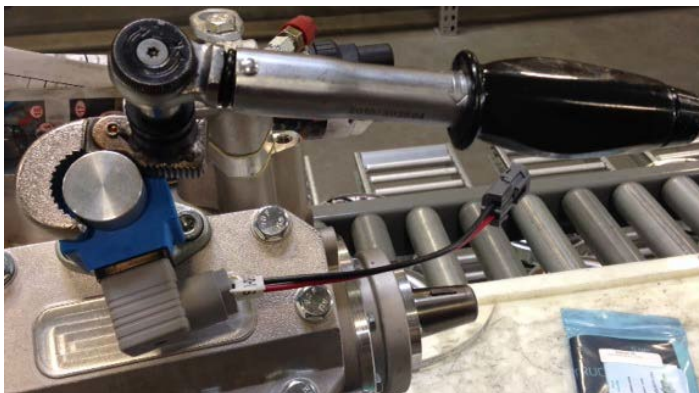
Clamp and Torque Wrench

Due to a number of claims relating to unloader caps coming loose, BITZER US, Inc. has developed a procedure for reliably securing the unloader cap to the unloader coil and stem assembly.

- a. Check torque wrench is set for **3Nm**
 - b. Hold the coil in desired position
 - c. Tighten the cap with the wrench **set at 90° to the clamp assembly** –see Figure 1 below.
