WARRANTY BULLETIN

WB15-19H

BITZER A/C COMPRESSOR VIBRATION – ADDITION OF A REINFORCEMENT BRACKET TO THE MOUNTING

Rev H: THIS WARRANTY BULLETIN SUPERSEDES PREVIOUS VERSIONS

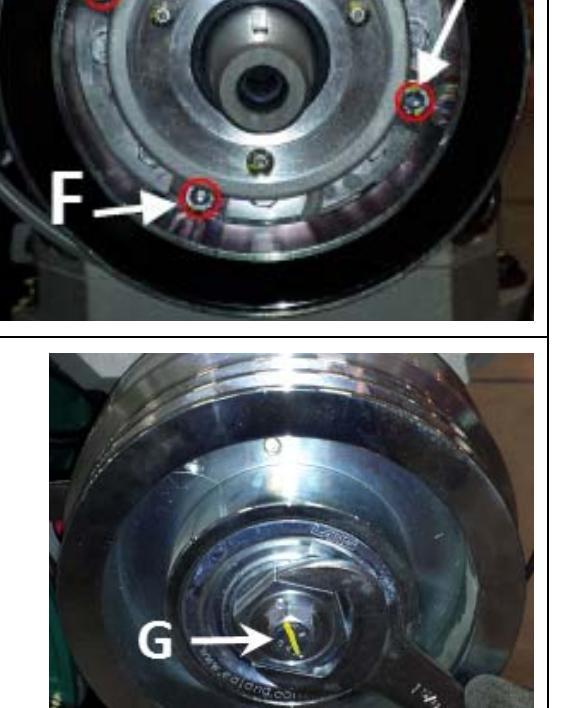
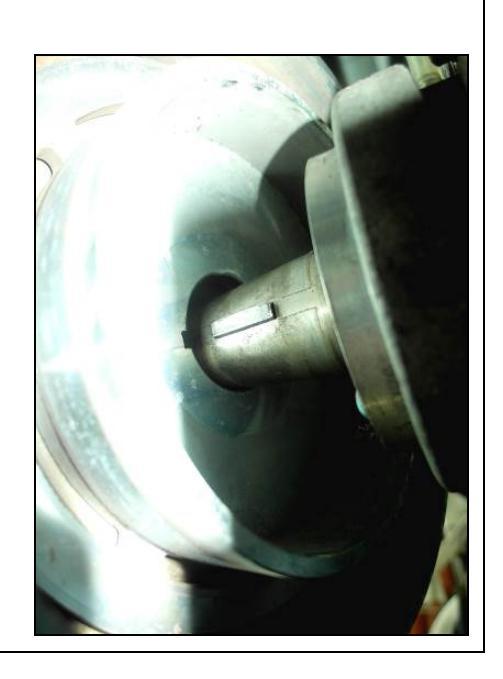
22. Turn rotor by hand and pay attention to the free run and the generation of noises. In case of grinding or similar noises, dismount the clutch and check installation.

Rotor mounting screw (**G**): **60 lbf-ft** (81 N-m) Use blue Loctite 243.
