PREVOST

SAFETY RECALL

SR23-14

DATE :	May 2023	SECTION :	06 ELECTRICAL
SUBJECT:	Power Cable Missing Grommet

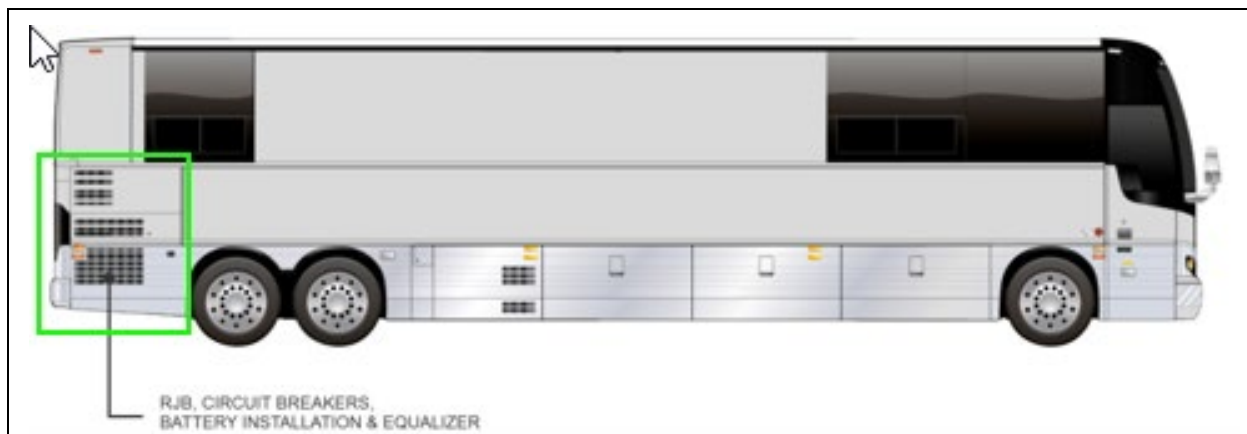
1. Locate the missing grommet location in the rear electrical compartment.
 - Open the vehicle curb side engine door.
 - Open the rear electrical compartment (next to the batteries).
 - In the compartment, the missing grommet must be installed in the cable pass through hole located at the top right corner of the compartment (hidden behind the battery equalizer).

2. Cut all the cable ties holding the power cables passing through the hole.
3. Make sure that the cables insulation is not damaged.
 - If damage is noticed, replace the cable(s) before installing the grommet (do not repair power cable(s)).
