**PREVOST**

**SAFETY  
RECALL**

**SR23-02**

| SUBJECT: | ENGINE REAR STOP BUTTON | | |

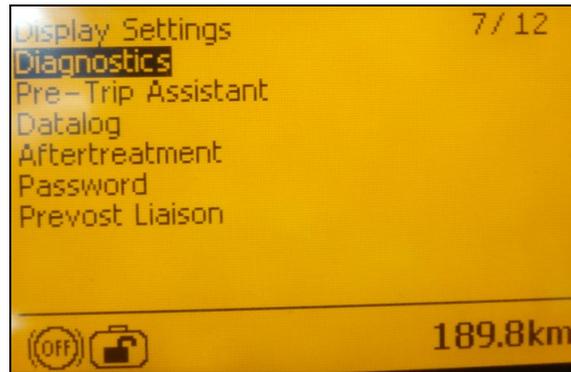
Figure 1

1. Check the vehicle program revision number with the Driver Information Display (DID) in the dash.
2. Select the Diagnostics menu.

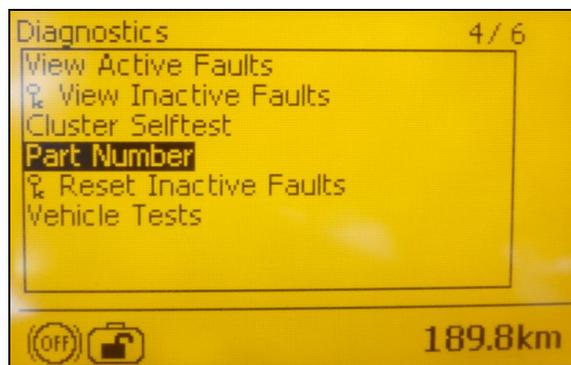
Figure 2

3. Select Part Number menu.

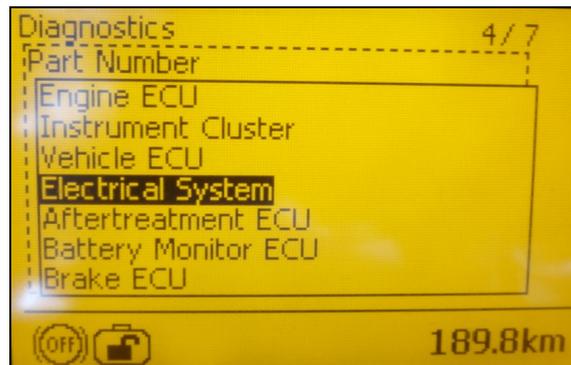
Figure 3

4. Select Electrical System menu.

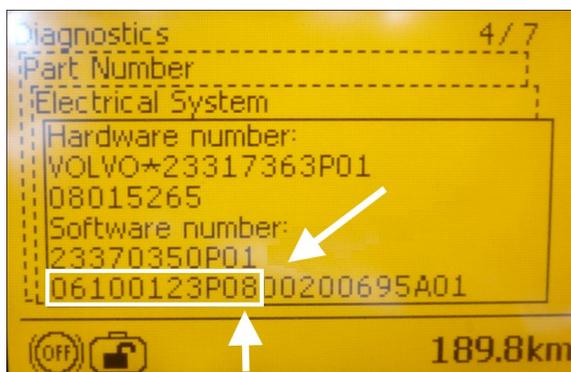
Figure 4

5. The DID shows the software number (program number) and the actual revision number just after the "P" letter for the vehicle (rev 8 in the example).
6. Note the program number and the revision number.

*The vehicle program number begins with "06"*

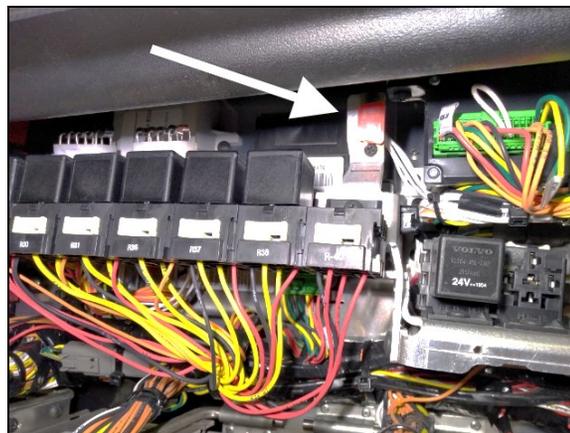
Figure 5

1. Connect the 110 power line on the vehicle.
2. Turn the ignition to "ON" position.
3. Activate the Hazard flashers.
4. Locate the RS232 serial port into the front service compartment at the right top corner.

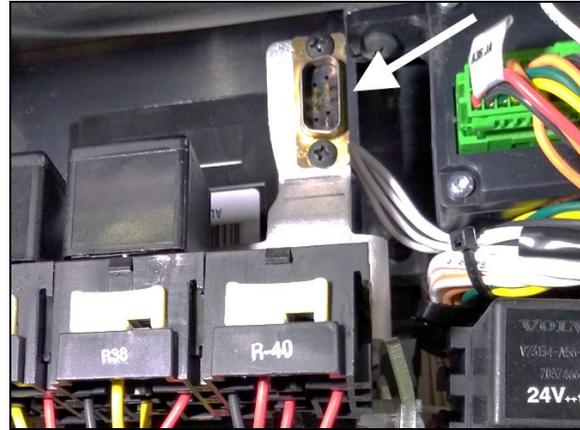
Figure 6

5. Remove the cap and keep in a safe place.
6. Connect the computer on the vehicle into the RS232 port.
7. Open the computer management application on your computer.
8. Right click on "My Computer" on the desk and click on Manage menu.

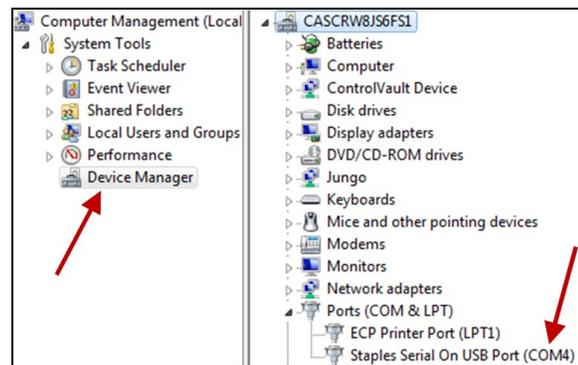
Figure 7

9. Click on 'Device manager'.
10. Expand the ports list.
11. Check the COM port number and note the number.

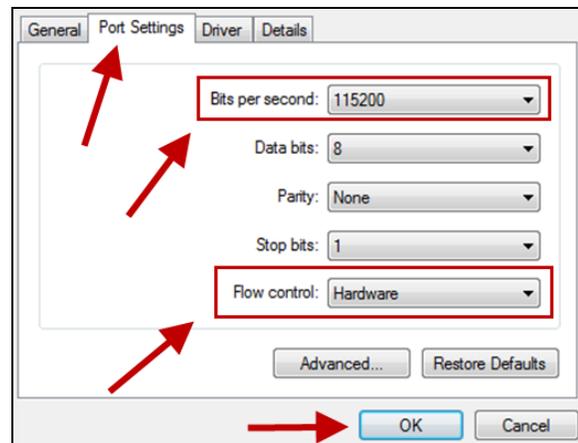
Figure 8

12. Double click on "COM" element to open the properties dialog box.
13. Click on "Port Setting" tab.
14. Select 115200 for the Bits per second.
15. Select Hardware for the Row control.
16. Click "OK".

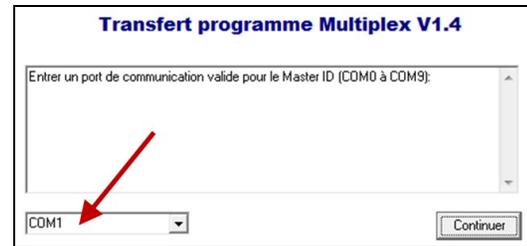
Figure 9

19. Launch the vehicle program (double click on the file name or right click on the file name and select Open).
20. Select the port number noted before.
21. Click "Continue" button.
22. Select the destination of the backup file that will be generated with the update processing.
23. Click on "Continue" button.

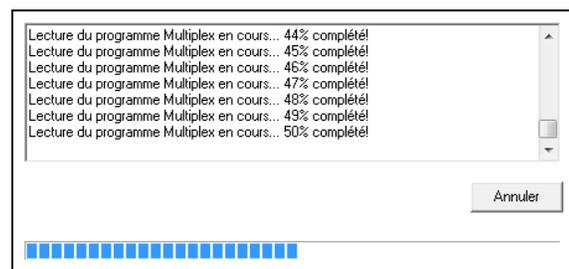
Figure 11

24. Program processes.

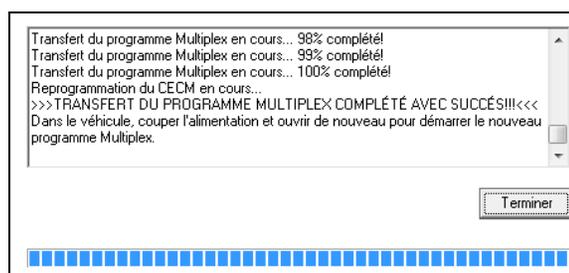
Figure 12

25. Wait until you get the message "TRANSFER COMPLETED".
26. Click "Finish" button.

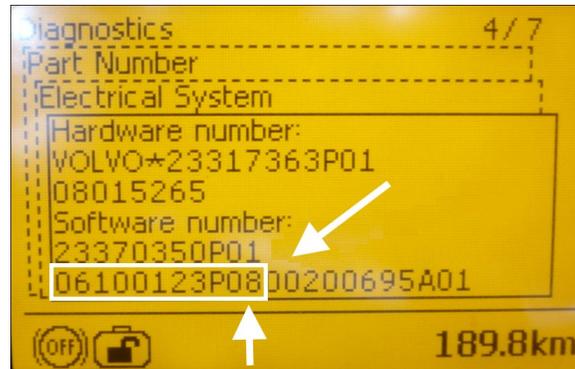
Figure 13

27. Disconnect the computer.
28. From the rear electrical compartment, trip circuit breaker CB6 and reset after 5 seconds.
29. The system needs some time to complete the update. Wait until the head lights shut down or until you have access to information on the DID.
30. Check in the DID the Software number (program number) and compare again with the table 1.

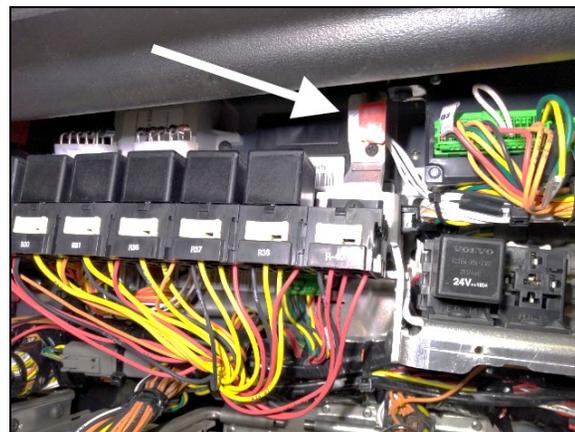
Figure 14

31. Reinstall the RS232 serial port cap.
32. Start the vehicle and validate that the rear stop button will stop the running vehicle once pressed.
33. Bulletin is complete.
