**SAFETY
RECALL**

SR24-04

DATE :	February 2024	SECTION :	06 ELECTRICAL
SUBJECT:	Exterior Lights Control Logic

MULTIPLEX SOFTWARE UPDATE PROCEDURE FOR PREVOST SERVICE CENTER

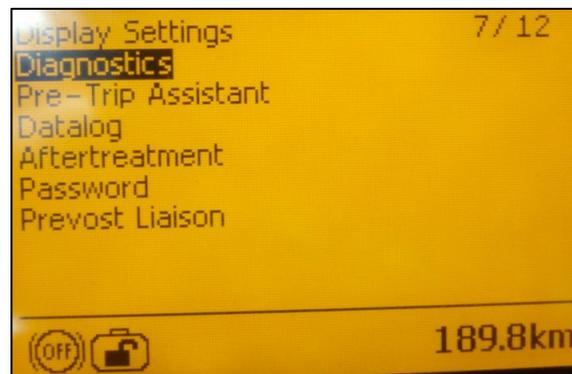
Figure 1

1. Check the vehicle program revision number with the Driver Information Display (DID) in the dash.
2. Select the Diagnostics menu.

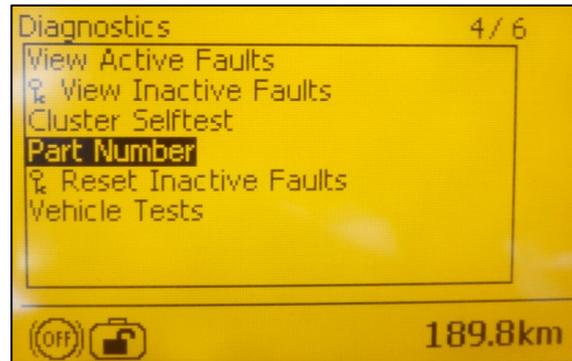
Figure 2

3. Select Part Number menu.

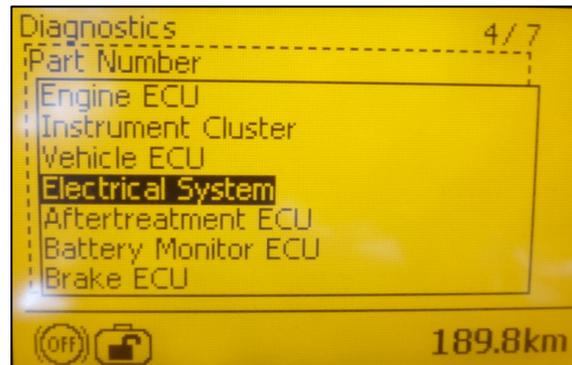
Figure 3

4. Select Electrical System menu.

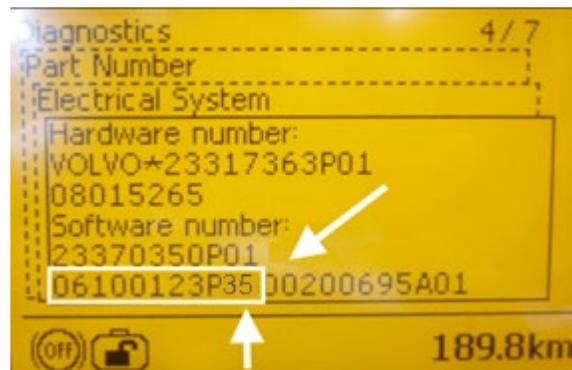
Figure 4

5. The DID shows the software number (program number) and the actual revision number just after the "P" letter for the vehicle.
6. Note the program number and the revision number.

NOTE
The vehicle program number start with "06"

7. Table 1 shows the minimum revision number needed, according to the program number.
8. Compare the vehicle program number and revision number shown in the DID with the corresponding numbers in Table 1.
9. If the vehicle has the program revision number shown in Table 1 or a higher number, the bulletin is complete.
10. If you need your vehicle program to be upgraded, move next section of the bulletin.

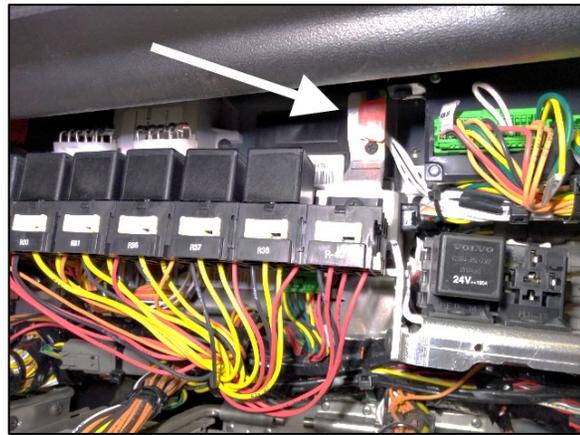
Figure 5

13. Connect the vehicle to a battery charger.
14. Turn the ignition to "ON" position.
15. Activate the Hazard flashers.
16. Locate the RS232 serial port into the front service compartment.

17. Remove the cap and keep in a safe place.
18. Connect the computer on the vehicle into the RS232 port.
19. Open the computer management application on your computer.
20. Right click on "My Computer" on the desk and click on Manage menu.

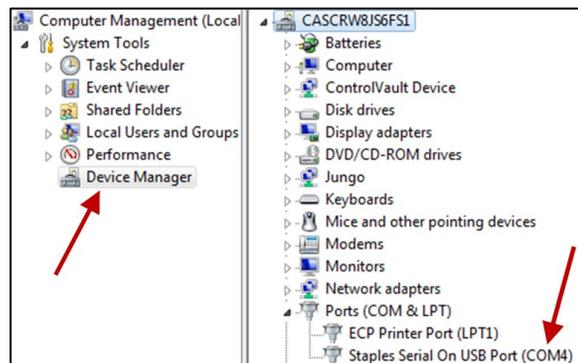
Figure 7

21. Click on 'Device manager'.
22. Expand the ports list.
23. Check the COM port number and note the number.

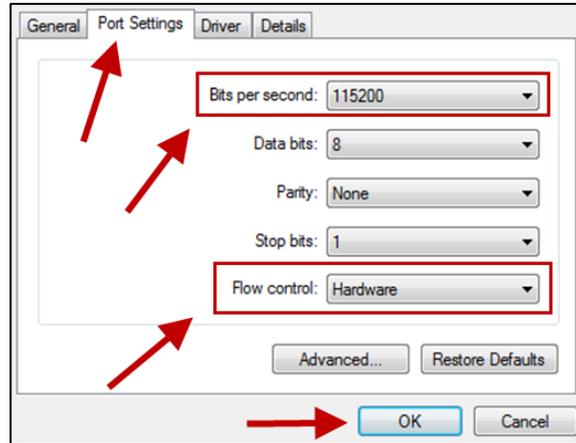
Figure 8

24. Double click on "COM" element to open the properties dialog box.
25. Click on "Port Setting" tab.
26. Select 115200 for the Bits per second.
27. Select Hardware for the Row control.
28. Click "OK".

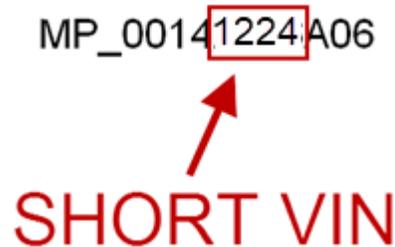
29. Make sure you have the vehicle program update, supplied by the Prevost service center, on your computer.
30. Rename the file and remove the last digits ".txt". Keep only the extension ".exe"

NOTE
The name of the file that you received should match with the VIN of the vehicle you are about to update. It should look like this example: MP_00141224A06.exe.txt. The four numbers before the last letter are the last 4 numbers of the VIN (short VIN).

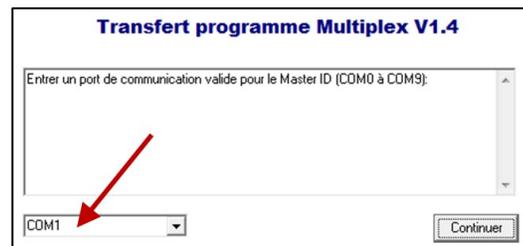
Figure 9

31. Launch the vehicle program (double click on the file name or right click on the file name and select Open).
32. Select the port number noted before.
33. Click "Continue" button.

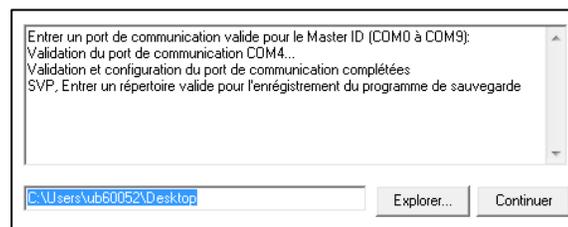
Figure 10

34. Select the destination of the backup file that will be generated with the update processing.
35. Click on "Continue" button.

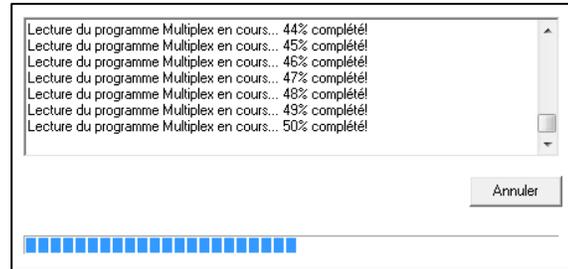
Figure 11

36. Program processes.

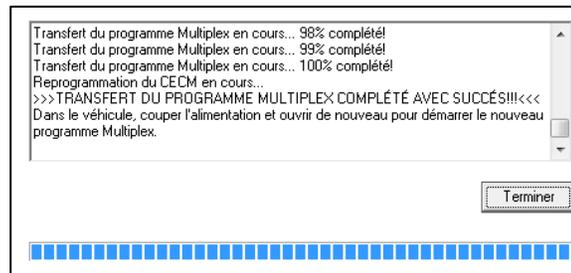
Figure 12

37. Wait until you get the message "TRANSFER COMPLETED".

38. Click "Finish" button.

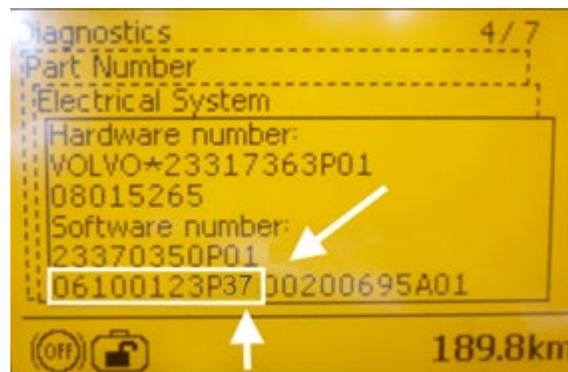
Figure 13

42. Check in the DID the Software number (program number) and compare again with the table 1.

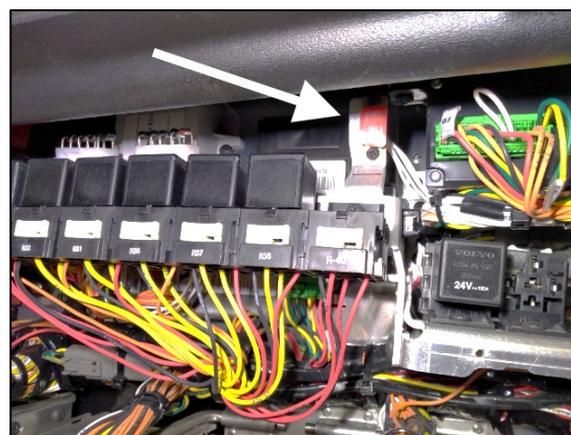
Figure 14

43. Reinstall the RS232 serial port cap.
