REVISION B: THIS WARRANTY BULLETIN SUPERSEDES PREVIOUS VERSION.

EMS & ACM SOFTWARE UPDATE
9700 (B13R)

Software updates with enhancements are available for the EMS and aftertreatment control module (ACM) for the vehicles affected by the bulletin.

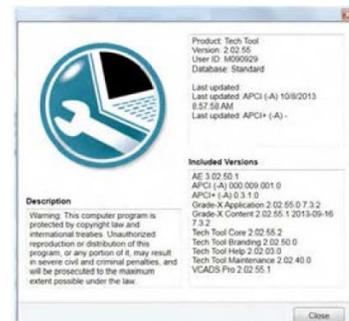
Check Premium Tech Tool version by clicking on Help tab and then click on "About TechTool".

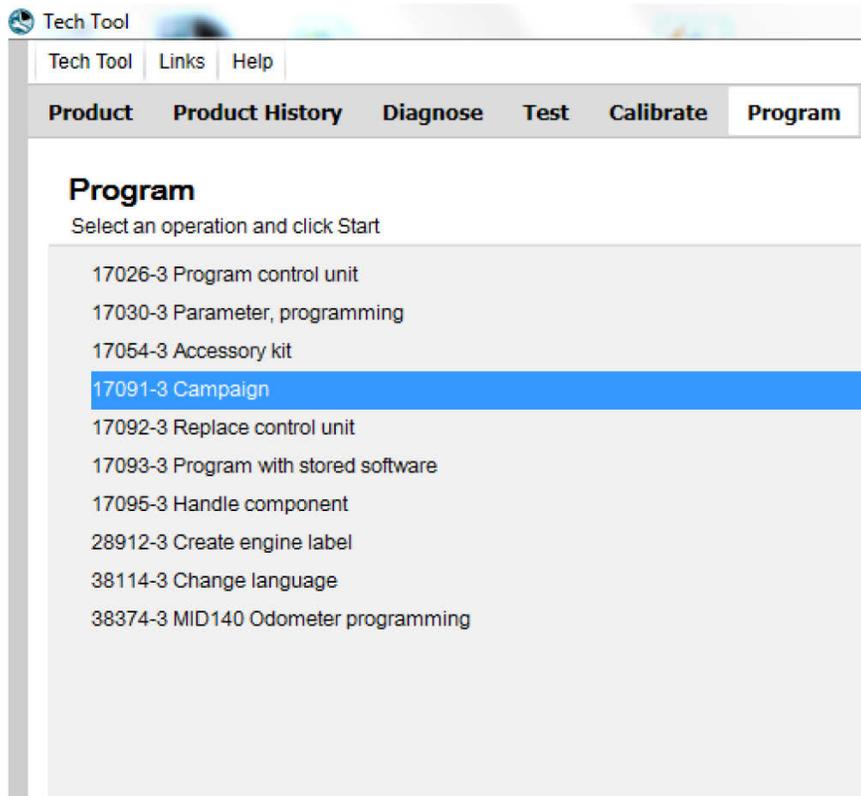
1. Secure the vehicle for service by parking it on a flat level surface, applying the parking brake, chocking the rear wheels, and placing the transmission in neutral.
2. Connect Premium Tech Tool (PTT) to the vehicle diagnostics connector using the 16 pin OBD cable 88890304 and Communication Interface 88890300. Connect the PC to a functional LAN or modem connection and a 120 Volt AC source.
3. Turn the ignition switch "ON".
4. Log in to PTT and Identify Vehicle is displayed.
5. Once the vehicle has been identified, enter the Work Order Number information, then click Start Work
6. From the Main Menu select Program and then Program Control Unit 1700-08-03-39. Then click Start.

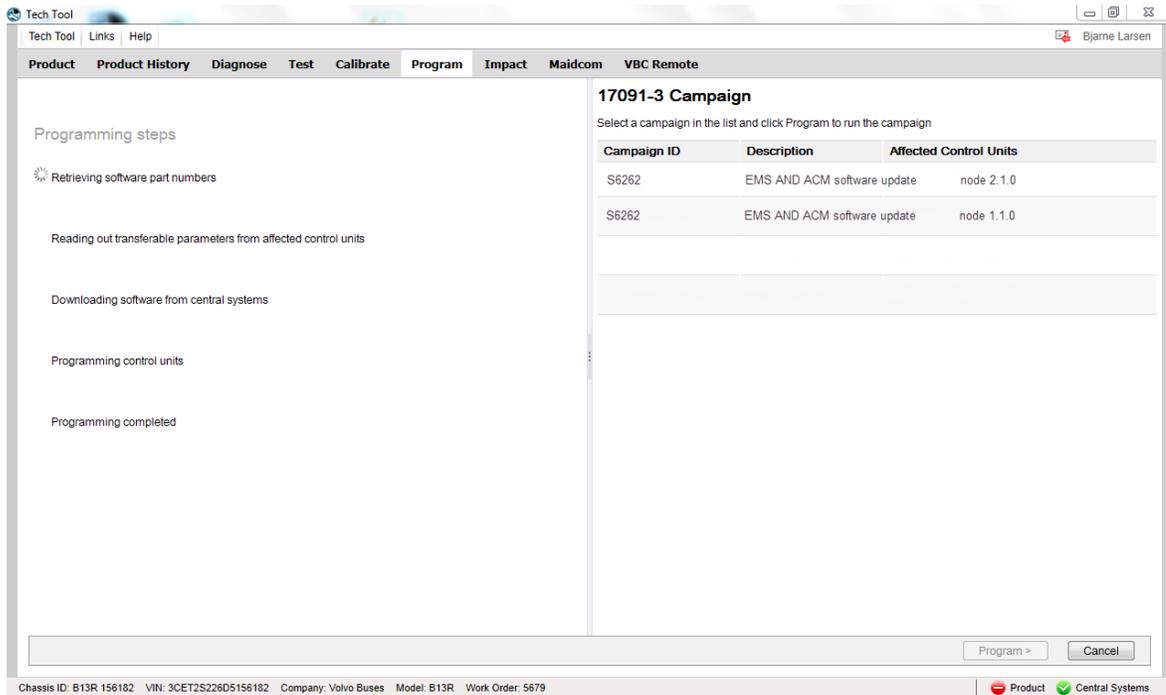
7. Select **Campaign** from the list. For this campaign, update the engine control module (EMS) and aftertreatment control module (ACM).

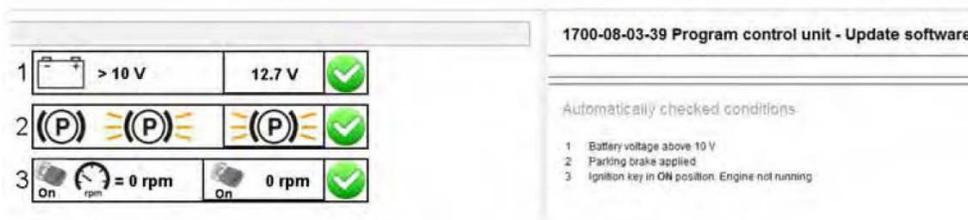
9. Certain conditions must be met to continue with programming: battery voltage above 10v, parking brake applied, and ignition key in ON position with engine not running. When all conditions have been met, click Continue to proceed with programming.

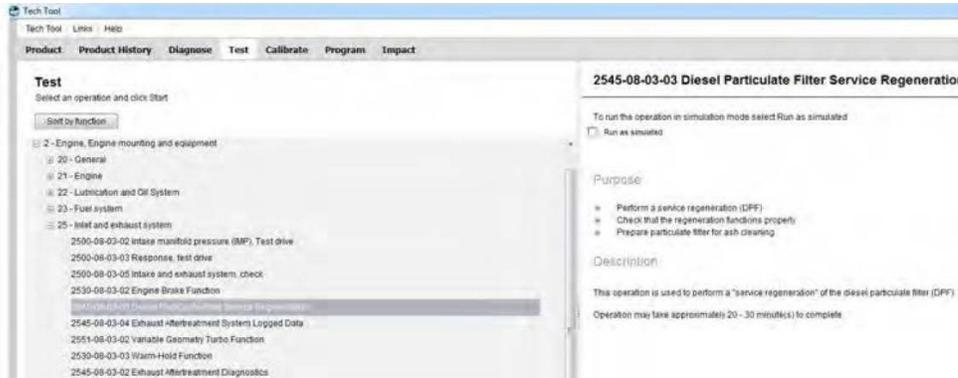
Note: Engine hours will be lost once modules have been programmed.

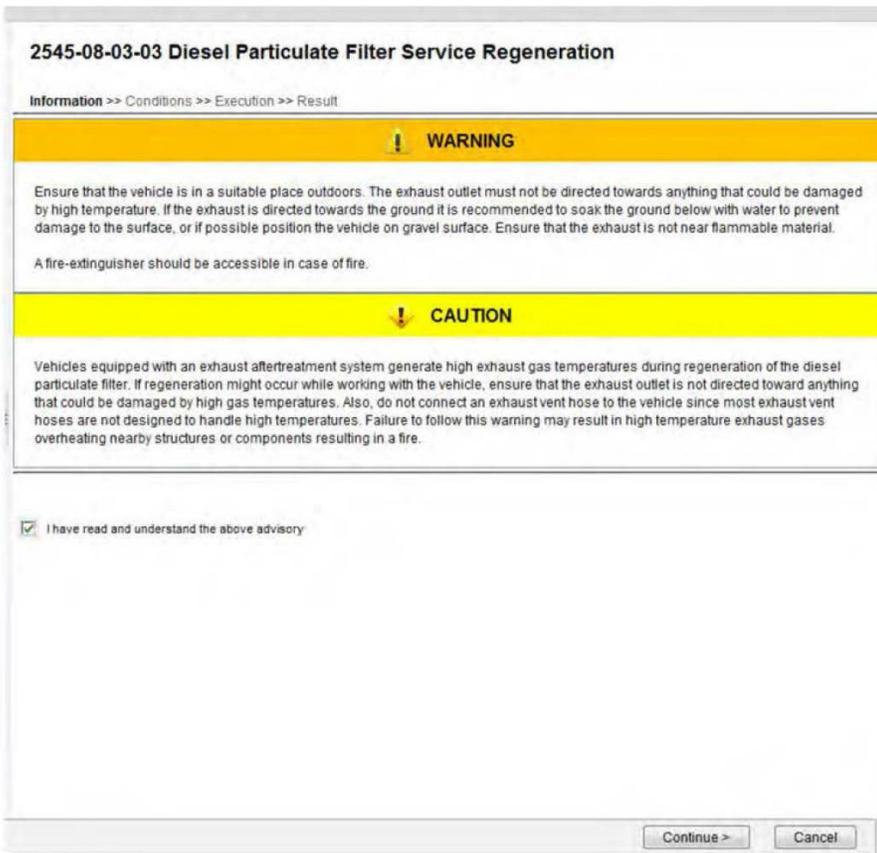
13. Review the advisories, check the box and click on Continue.

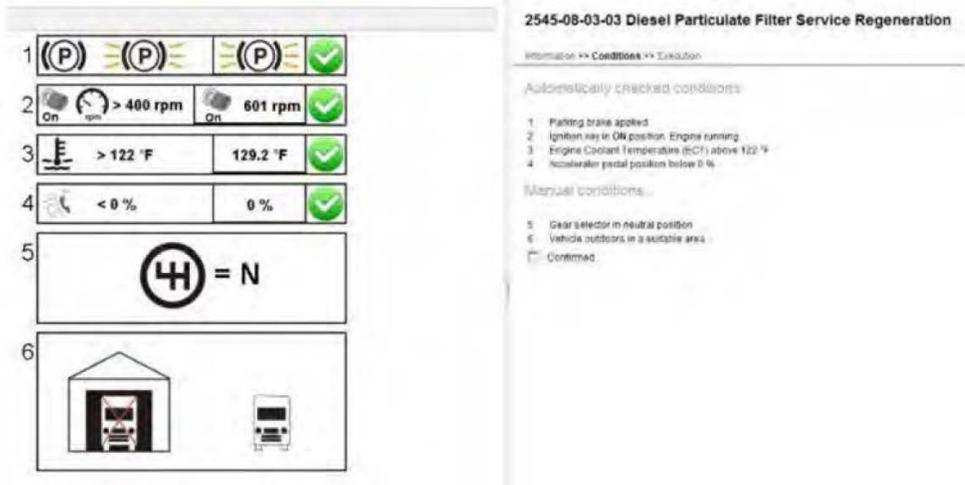
14. When all conditions are met, check the confirmed box and click on Continue.

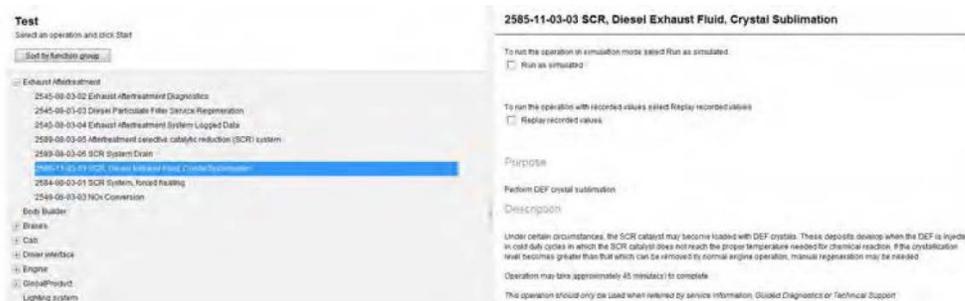
16. When the HEST light goes off, select Test from the Main Menu. Select 2585-11-03-03 SCR, Diesel Exhaust Fluid, Crystal Sublimation and click on Start.

Note: Start the Crystal Sublimation process within 2 minutes of engine coming back to idle.
