VOLVO 9700 PTO REPLACEMENT 9700 (B13R)

On the vehicles affected by this bulletin, the engine power take off (PTO) must be replaced by a new improved design unit.

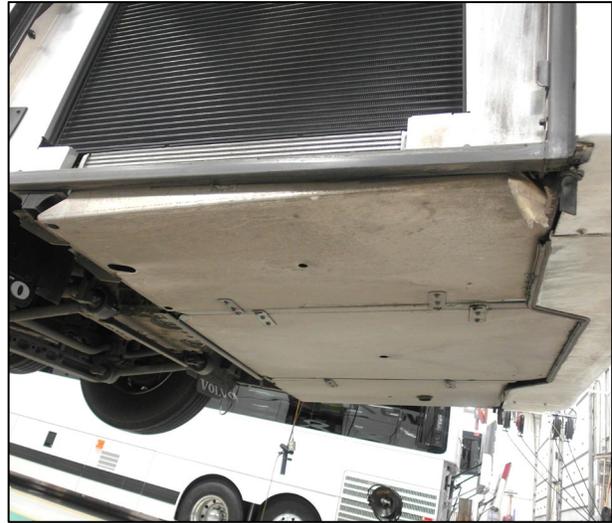
1. Lift the vehicle & remove the underside engine protective plates.

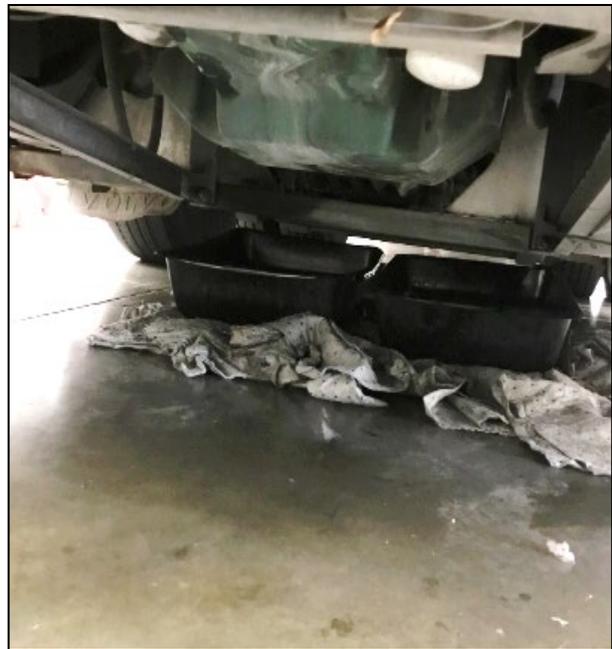
2. Put a large drain pan under the vehicle at the engine/transmission junction.

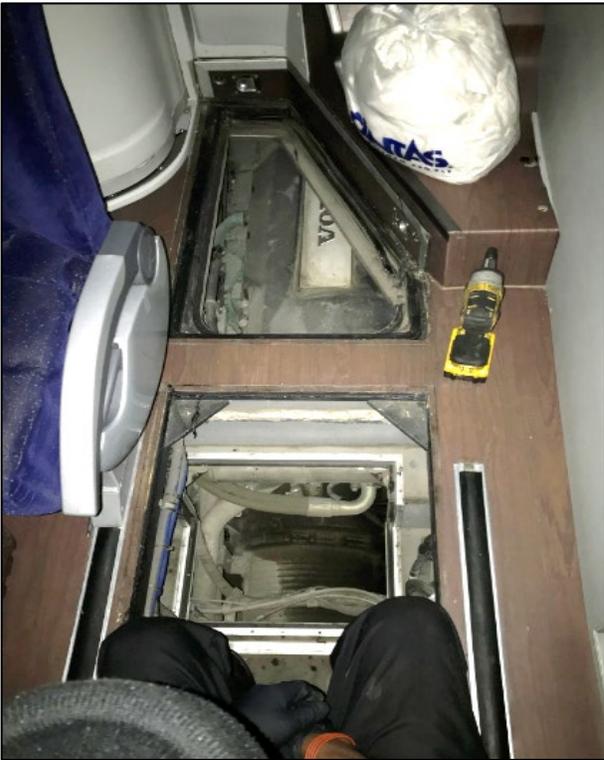
3. Open the floor hatches inside the vehicle.

NOTE
<i>Optional: It is possible to gain some working space by removing the fresh water tank.</i>

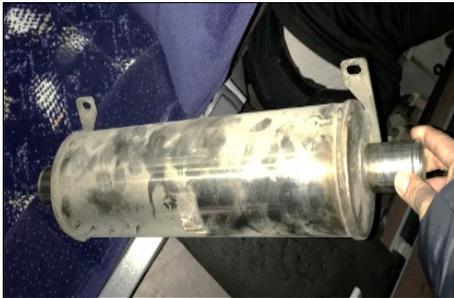
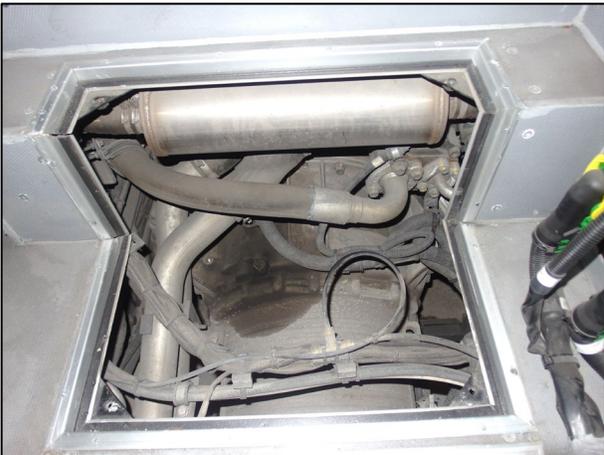
4. Remove the compressor air silencer.

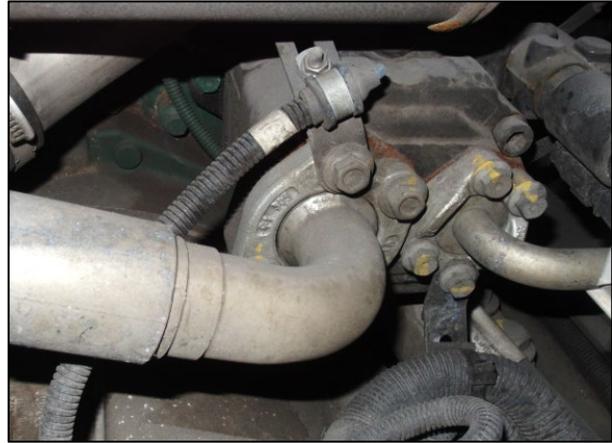
5. Disconnect both hydraulic hoses at the back of the hydraulic pump.

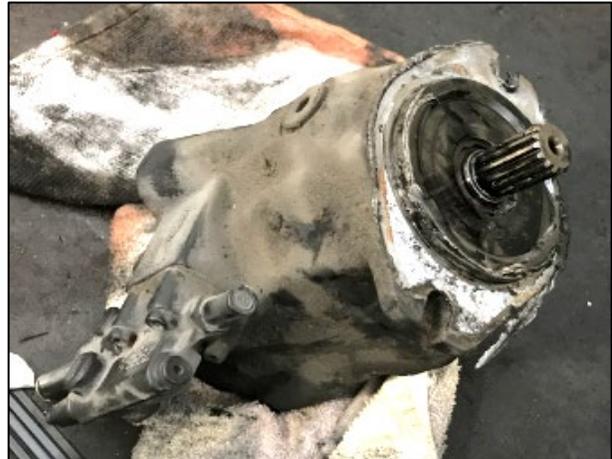
6. Remove the pump from the vehicle (discard pump O-ring).

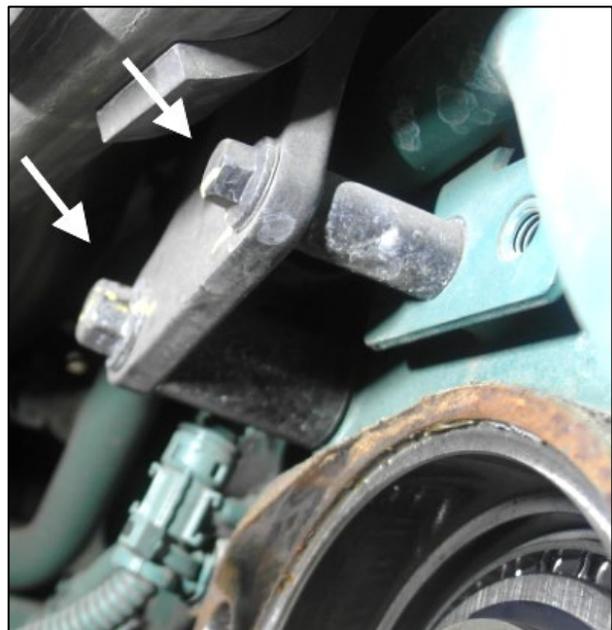
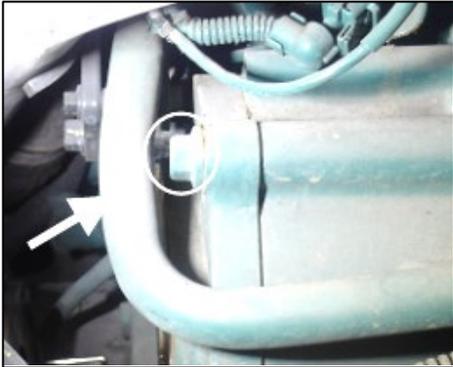
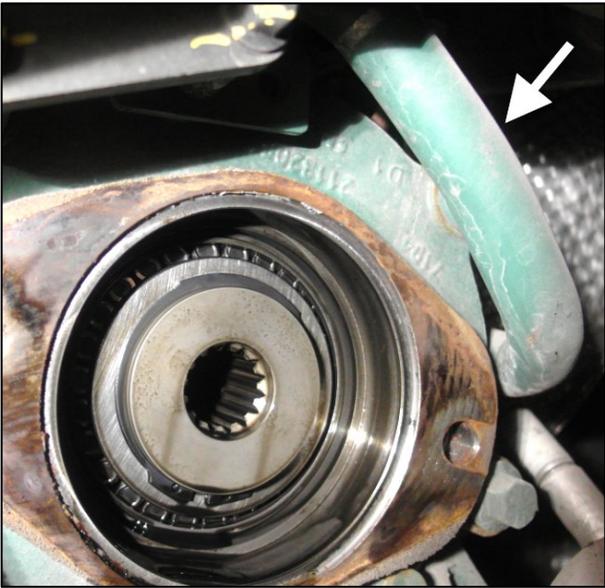
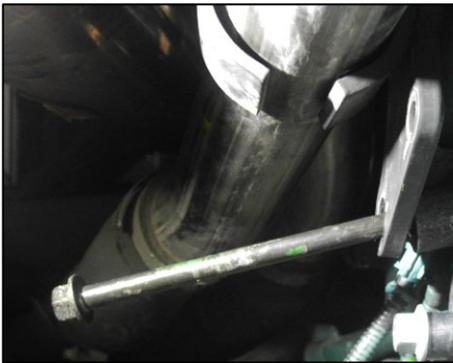
7. Remove the PTO from the vehicle.

- Remove the pipes bracket (one of the bracket screws is also the PTO cover upper left screw).
- Gently pry up the steel coolant hose on the upper right corner to allow PTO removal.
- Unscrew the remaining PTO cover screws.

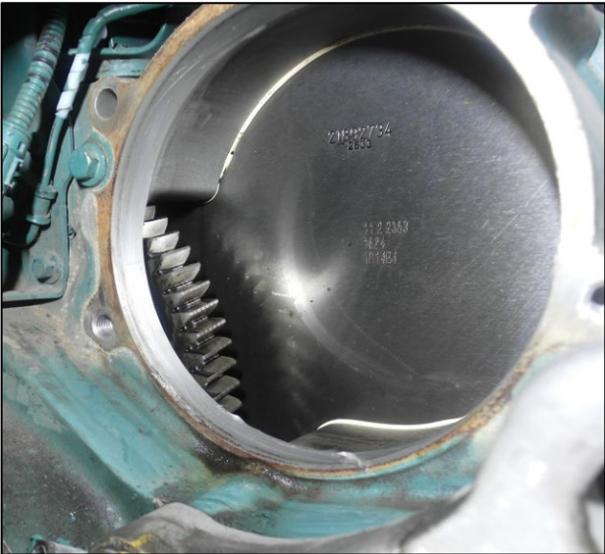
8. Clean the PTO mounting surfaces (make sure debris are not falling inside the engine).

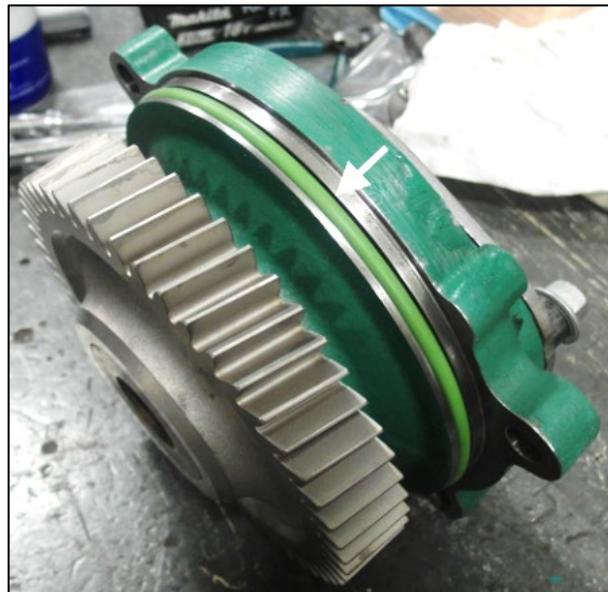
9. Install the supplied # **976068** O-ring on the new PTO # **23385737** (slightly lube the O-ring with engine oil).

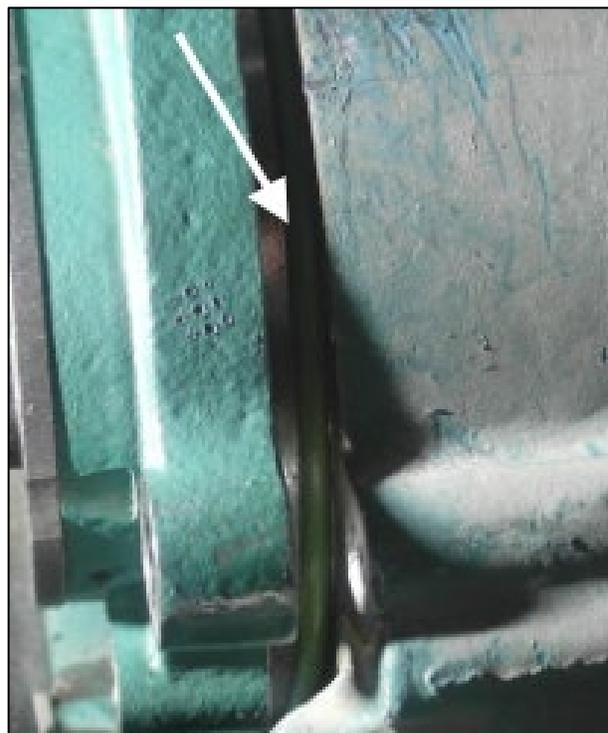
10. Slide the new PTO in place (pry coolant hose as required). Make sure the O-ring is engaging smoothly.

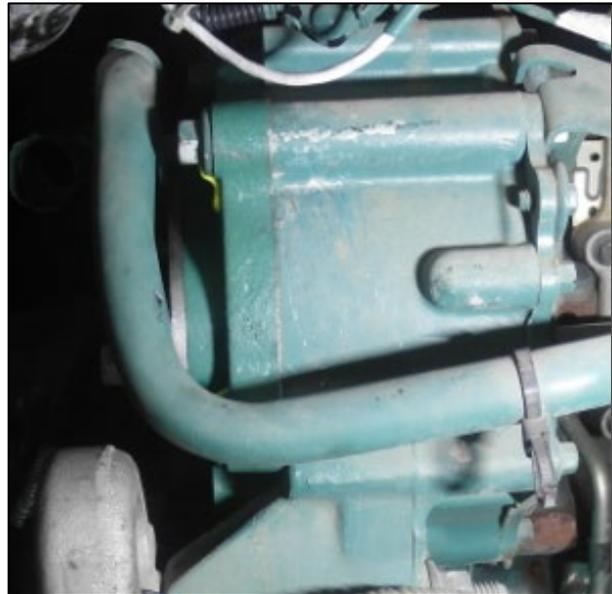
11. Secure the PTO to the engine (reinstall the pipes bracket)

TORQUE: 52 +/-5 Nm (38 +/- 4 lb-ft)

- *Apply torque seal to the bolt heads.*

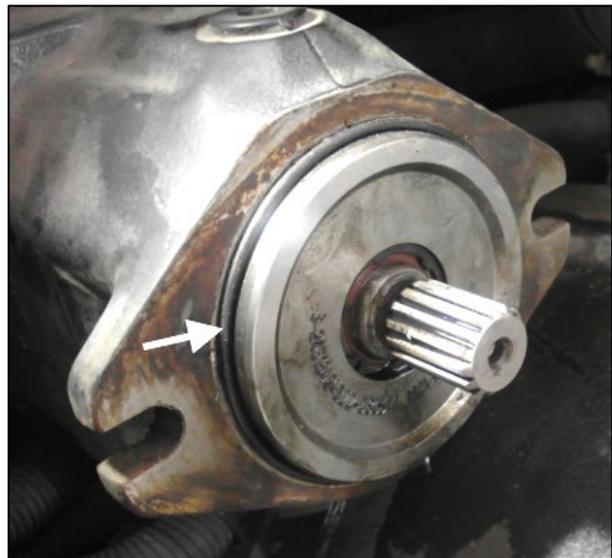
12. Clean the hydraulic pump mounting surface & install the new supplied # **925259** hydraulic pump O-Ring (slightly oil the O-ring).

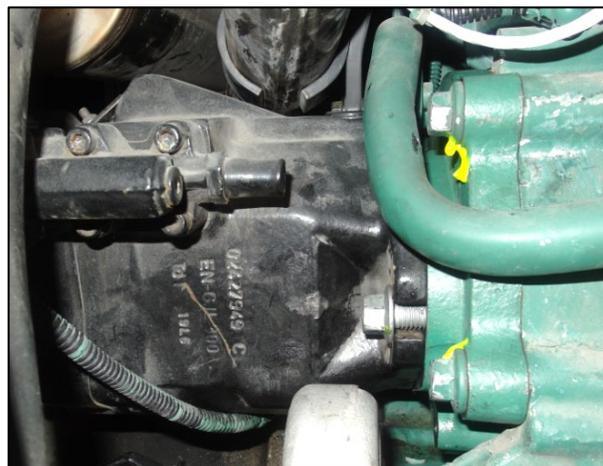
13. Remove PTO protective cover & reinstall the hydraulic pump.

TORQUE: 52 +/-5 Nm (38 +/- 4 lb-ft)

- Apply torque seal to the bolt heads.

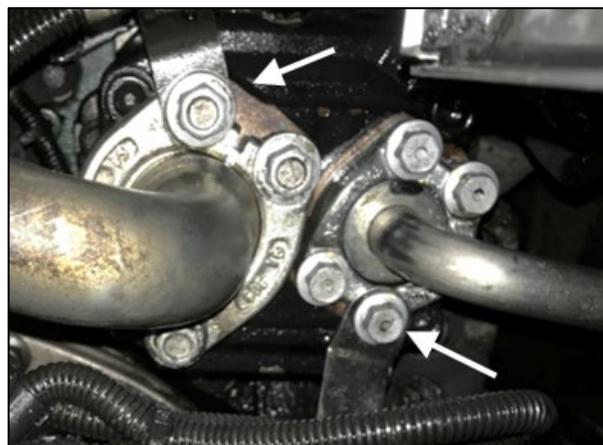
14. Reinstall hydraulic hoses at the back of the pump (also reinstall brackets).

TORQUE: 52 +/-5 Nm (38 +/- 4 lb-ft) in a cross pattern.

- Apply torque seal to the bolt heads.

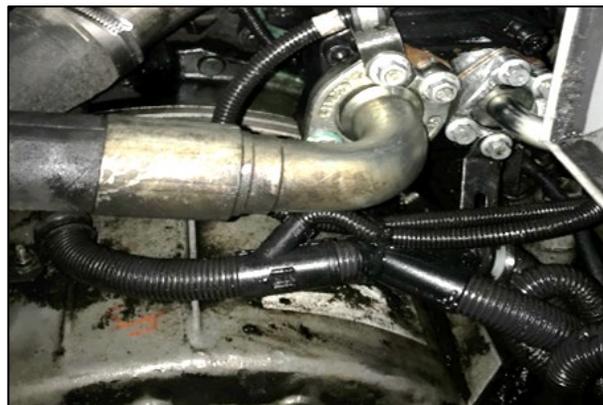
15. Clean the area (oil spillage).

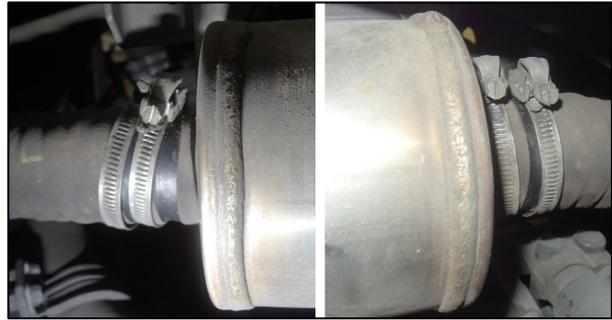
16. Reinstall air compressor silencer (bracket & clamps).

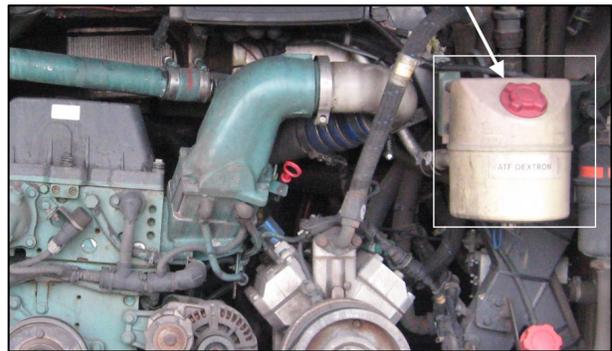
17. Refill the hydraulic system with ATF Dextron oil.

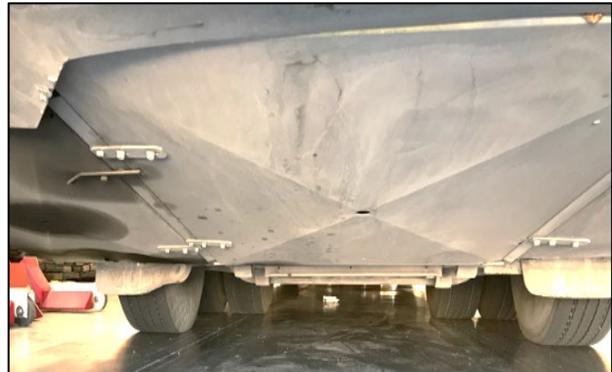
18. Lower and start the vehicle to check for leaks (correct as necessary). If no leaks are found, reinstall protective plates under the vehicles and close the floor hatches.
