## Conditions for fault code P2002:

- PM Filter Efficiency Monitor

- Update required for diagnostic function monitoring the DPF efficiency.

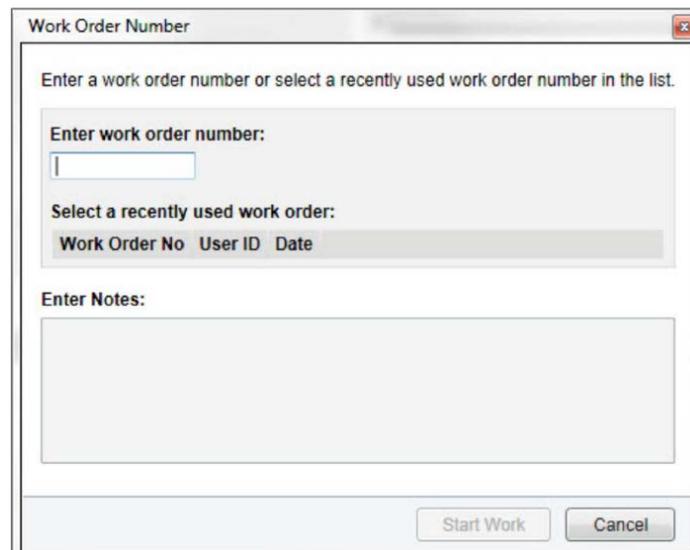
1. Connect Premium Tech Tool (PTT) to the vehicle diagnostics connector using the 16 pin OBD cable 88890304 and Communication Interface 88890300. Connect the PC to a functional LAN or modem connection and a 120 Volt AC source.
2. Turn the ignition switch "ON".
3. Log in to PTT and Identify Vehicle is displayed.
4. Once the vehicle has been identified, enter the Work Order Number information. Then click *Start Work*.

A screenshot of a software dialog box titled "Work Order Number". The dialog box has a title bar with a close button (X). The main content area contains the following elements:

- A text prompt: "Enter a work order number or select a recently used work order number in the list."
- A section labeled "Enter work order number:" with a text input field below it.
- A section labeled "Select a recently used work order:" with a table below it. The table has three columns: "Work Order No", "User ID", and "Date".
- A section labeled "Enter Notes:" with a large text area below it.
- At the bottom right, there are two buttons: "Start Work" and "Cancel".

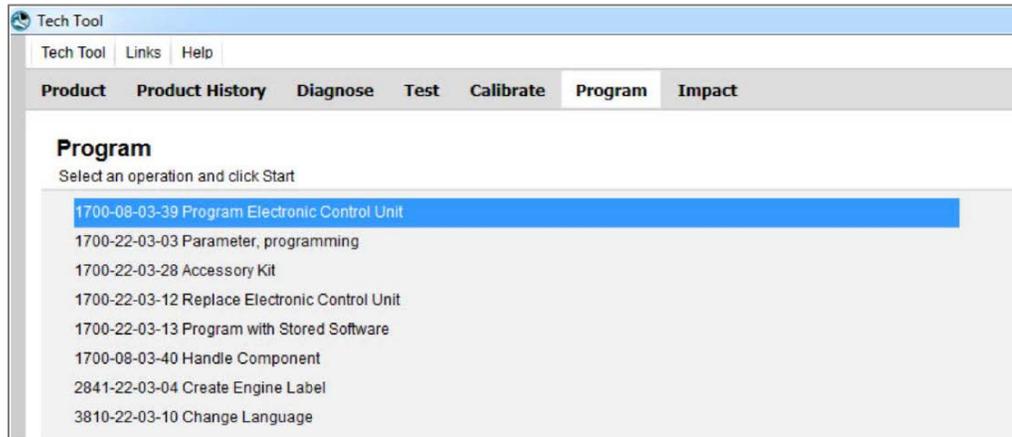
5. From the Main Menu select *Program* and then *Program Electronic Control Unit 1700-08-03-39*. Then click *Start*.

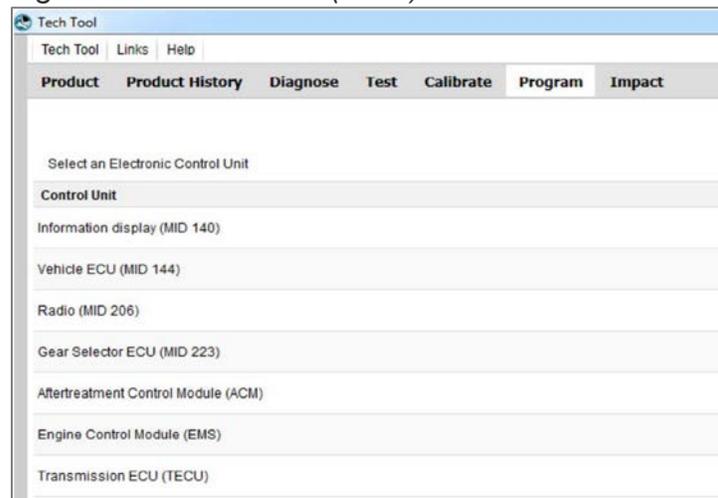
6. Select the *Engine Control Module (EMS)* from the list.

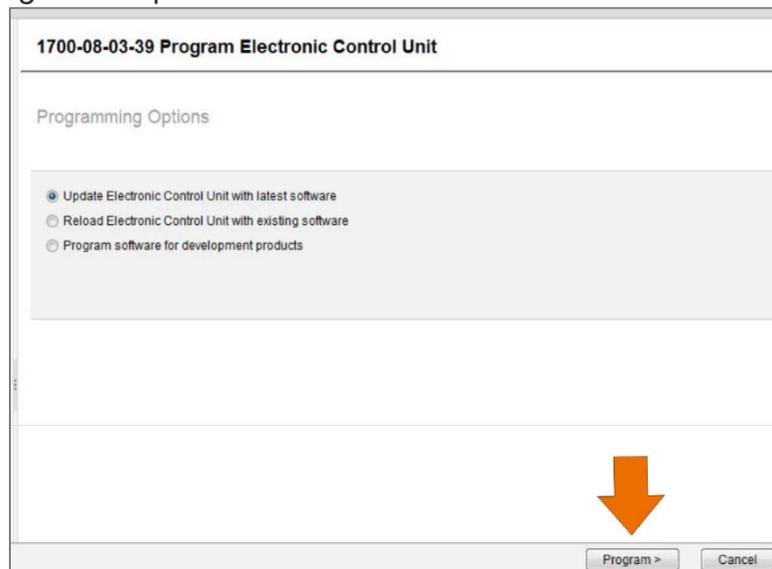
7. Select *Program* to update the electronic control unit with the latest software.

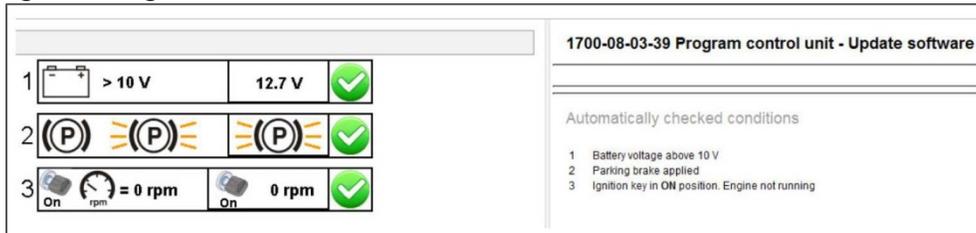
- Certain conditions must be met to continue with programming: battery voltage above 10v, parking brake applied, and ignition key in ON position with engine not running. When all conditions have been met, click *Continue* to proceed with programming.

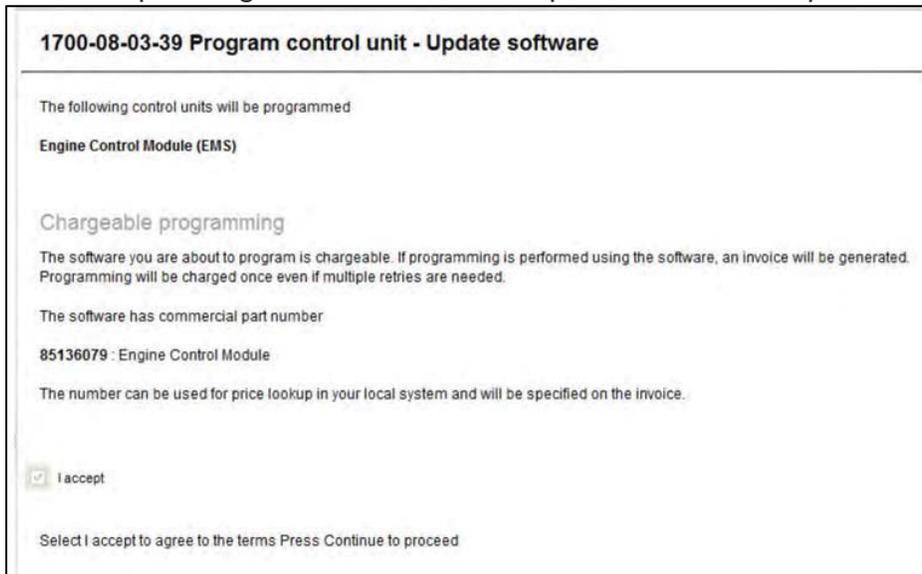
- Select "I accept" to agree to the terms and press Continue to proceed.

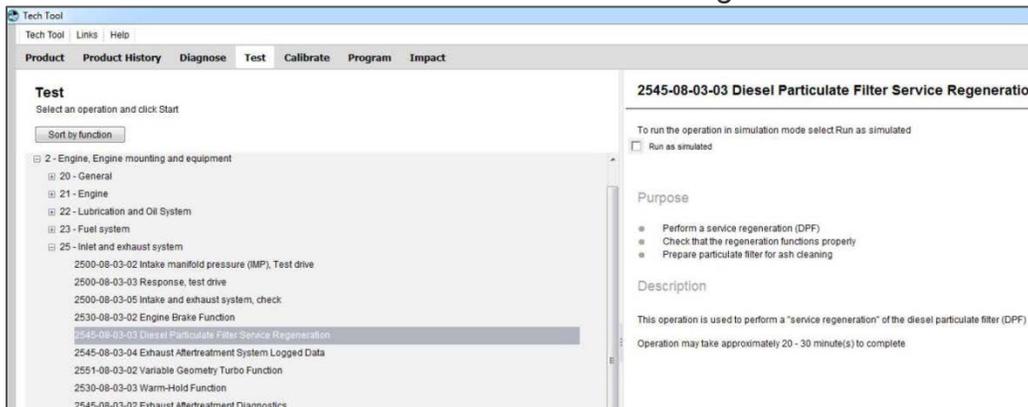
- When ACM programming is complete, select *Test* from the Main Menu. Select *2545-08-03- 03 Diesel Particulate Filter Service Regeneration* and click on *Start*.
