## WARRANTY BULLETIN

Wb10-36A

SUBJECT : REPROGRAMMING OF I/O-A & I/O-B MODULES FOR IMPLEMENTATION OF THE ESSENTIAL FUNCTIONS TO OPERATE THE VEHICLE (BASIC LIMP-HOME FUNCTIONS)

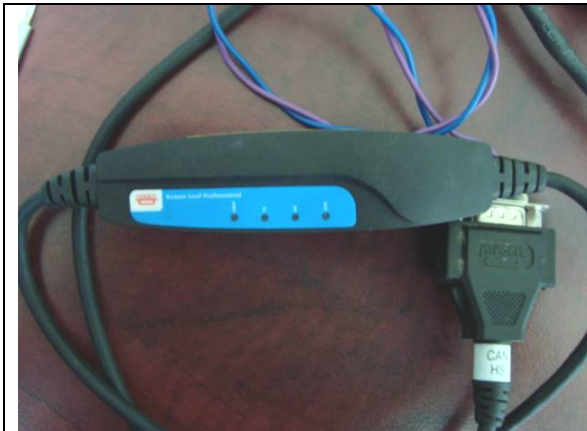
KVASER COMMUNICATION INTERFACE

The Kvaser communication interface (Prevost #685535) is necessary. One unit is available in your service center.

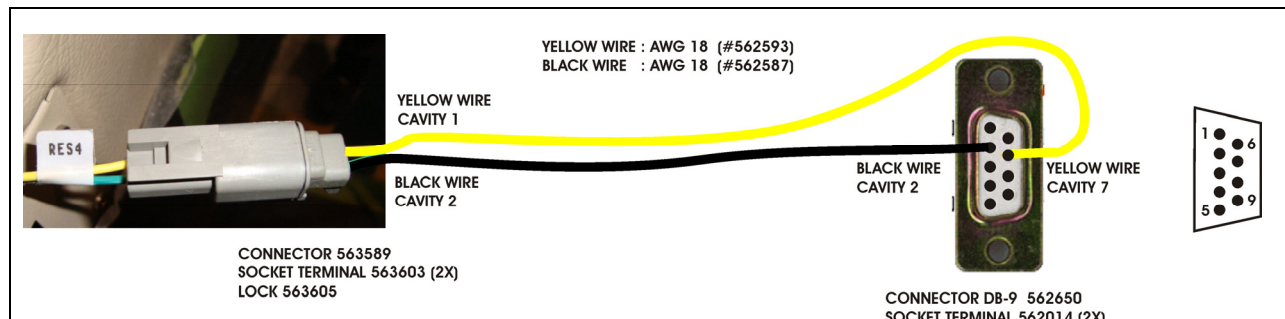
An interface harness must be made (see image below) and used to connect the Kvaser communication interface to RES4 connector located next to the dashboard multiplex modules (**RES3 in the rear electrical compartment may be used if more accessible**). Stow this harness with the Kvaser communication interface. It will be required for the reprogramming of other vehicles.

Connector RES3 may be used instead of RES4 if more accessible.

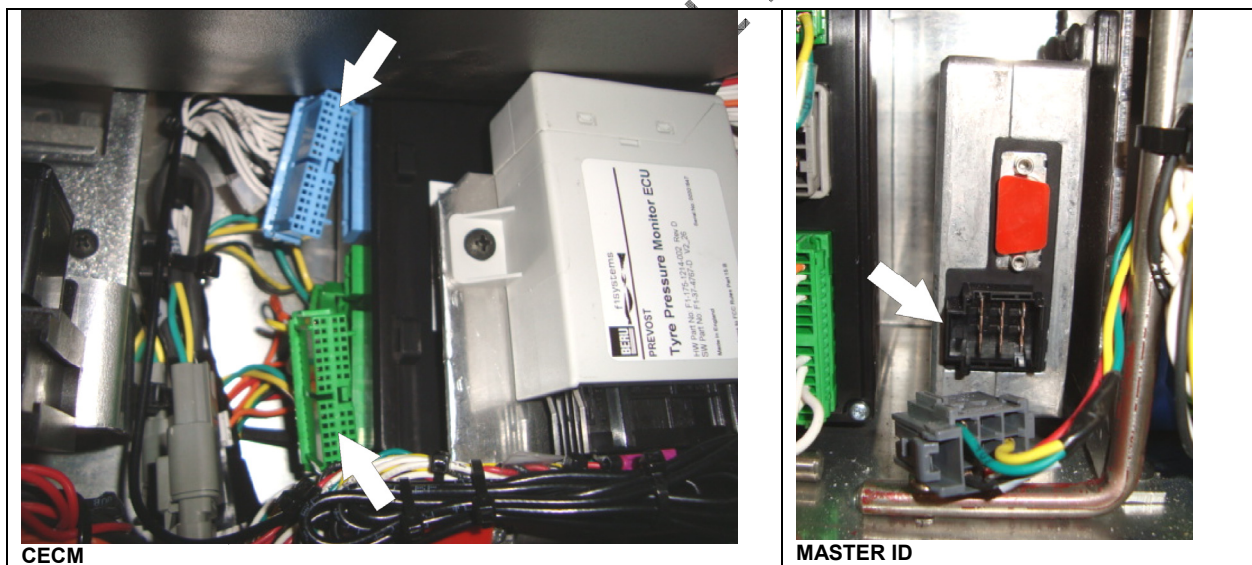
- Plug the Kvaser communication interface USB connector to your computer.
- Place the ignition switch to the OFF position.
- Inside front electrical compartment, unplug all connectors from CECM module and Master ID.

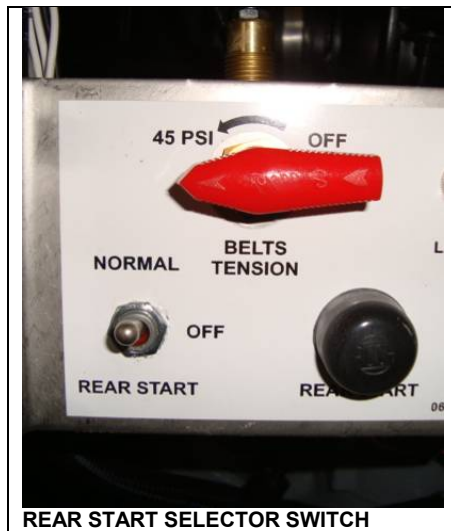
- Inside engine compartment, set the rear start selector switch to NORMAL.
