PREVOST

**SAFETY
RECALL**

SR23-20

DATE :	August 2023	SECTION :	06 ELECTRICAL
SUBJECT:	CORRECTIVE MEASURE ON THE DAYTIME RUNNING LIGHTS OPERATING LOGIC

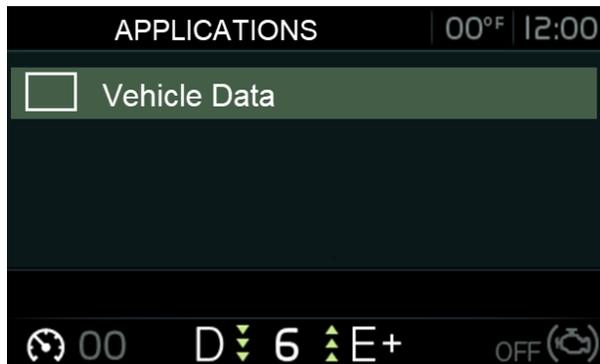
Figure 1

1. Check the vehicle multiplex software revision number with the instrument panel Driver Information Display (DID).
2. Press the *Application Tray/Back* key, select VEHICLE DATA and then press the *Enter/Select* key.

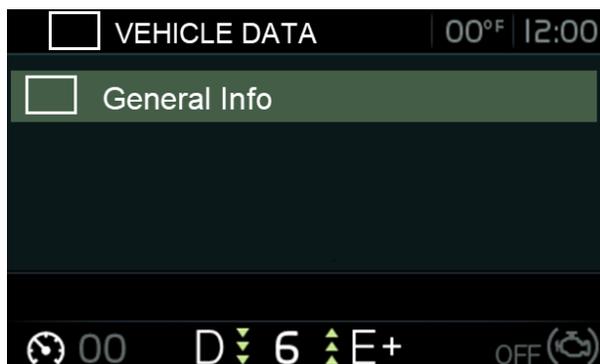
Figure 2

3. Scroll down, select GENERAL INFO and then press the *Enter/Select* key.

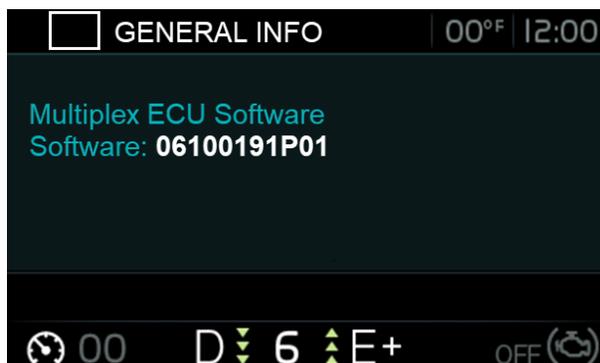
Figure 3

4. Scroll down up to Multiplex ECU software. The DID shows the multiplex software number and the actual revision number just after the letter "P".

5. Take note of the vehicle multiplex software revision number (PXX).
6. Compare the vehicle multiplex software revision number (PXX) shown in the DID with the required revision of [Table 1](#).

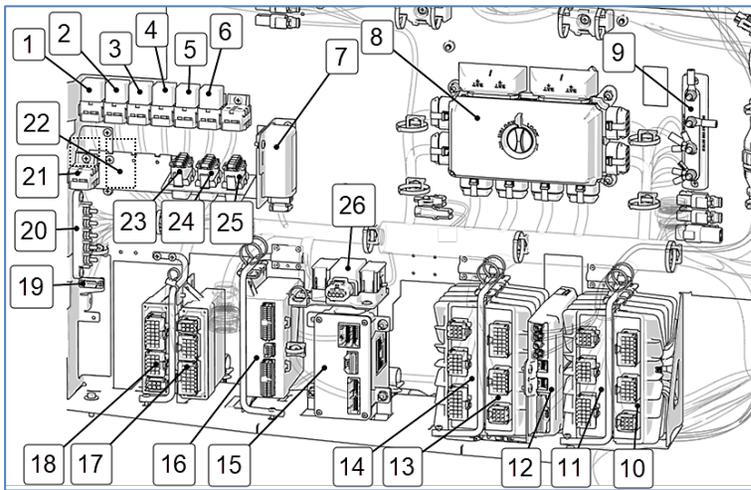
Figure 4

4. Turn the ignition to "ON" position.
5. Activate the Hazard flashers to prevent sleep mode.
6. Locate the RS232 serial port into the front service compartment (item 19, Figure 4).

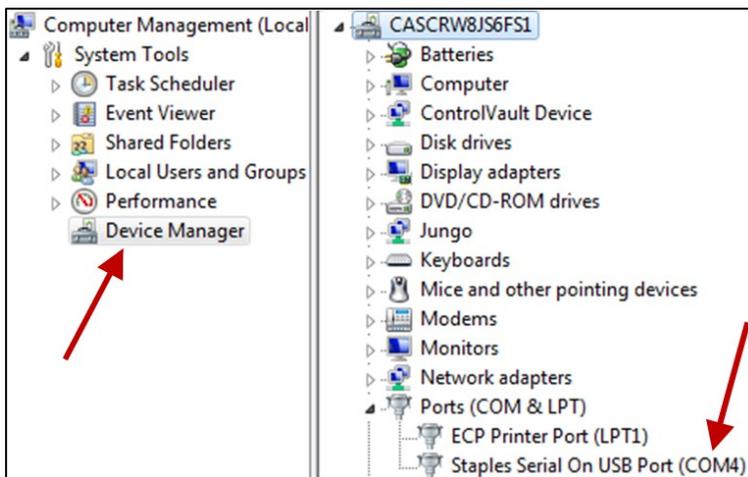
Figure 5

7. Click on "Device manager".
8. Expand the ports list.
9. Check the COM port number and note the number.

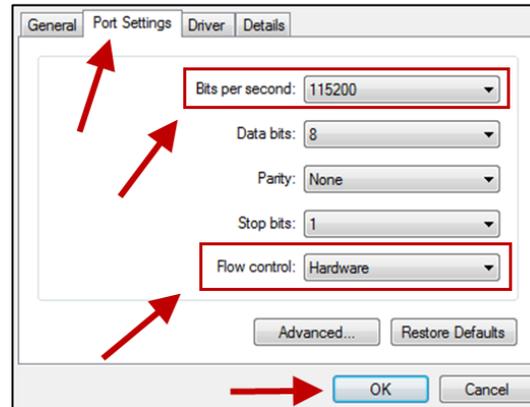
Figure 6

10. Double click on "COM" element to open the properties dialog box.
 11. Click on "Port Settings" tab.
 12. Select 115200 for the Bits per second.
 13. Select Hardware for the Row control.
- Click "OK".

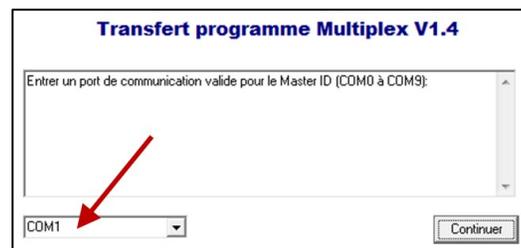
Figure 8

16. Launch the vehicle multiplex software (double click on the file name or right click on the file name and select Open).
17. Select the port number noted before.
18. Click "Continue" button.

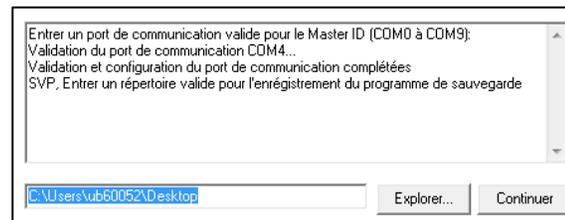
Figure 9

19. Select the destination of the backup file that will be generated with the update processing.
20. Click on "Continue" button.

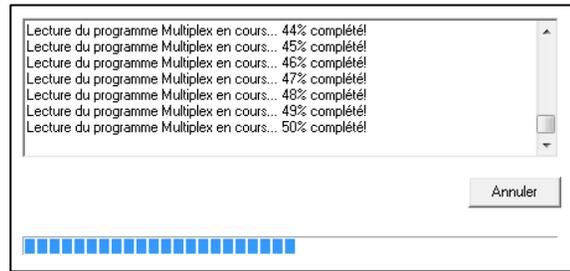
Figure 10

21. Update processes.

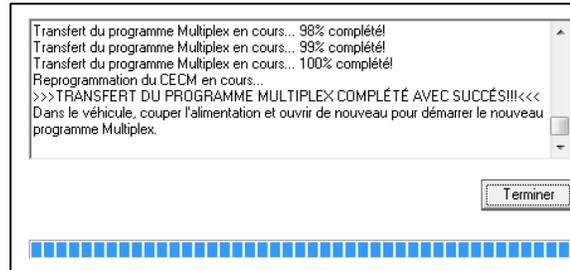
Figure 11

22. Wait until you get the message "TRANSFER COMPLETED".

23. Click "Finish" button.
