**PREVOST**

**MAINTENANCE Mi11-06D  
 INFORMATION**

<b>DATE :</b>	<b>FEBRUARY 2011</b>	<b>SECTION :</b>	<b>23 - Accessories</b>
<b>SUBJECT :</b>	<b>PREVOST AWARE ADAPTIVE CRUISE BRAKING (ACB) • FLR10 RADAR SENSOR ALIGNMENT</b>

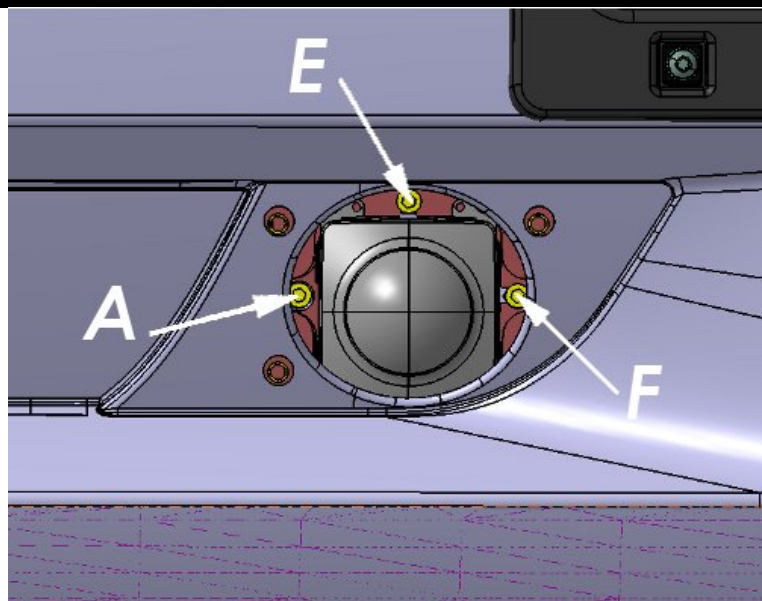
1. Adjust the radar sensor position in reference to the bumper opening to respect the required radar conical beam clearance.
2. Loosen screw **A**.
3. Open the reclining bumper.

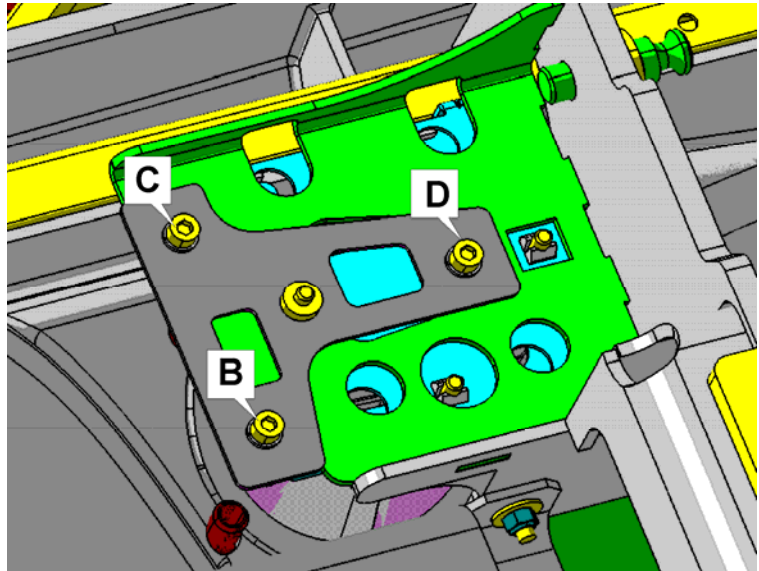
- Loosen screw **B**, **C** and **D**. The radar can be moved at this time.
- Close reclining bumper.

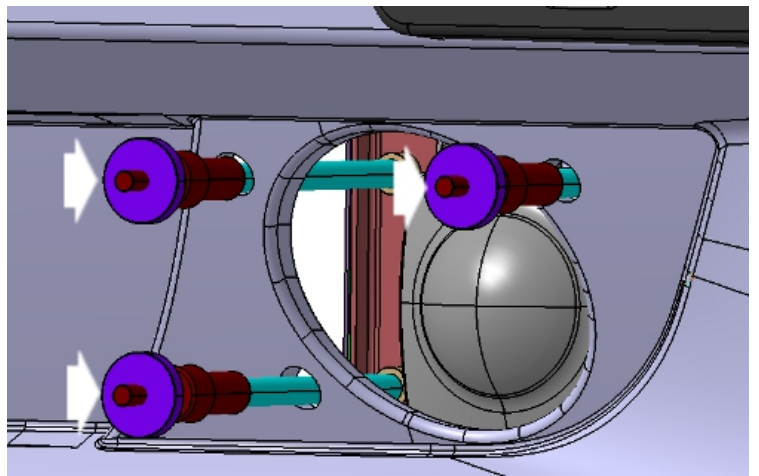
- Screw the 3 extensions included with the alignment tool firmly onto the radar sensor base plate as shown on figure at right.

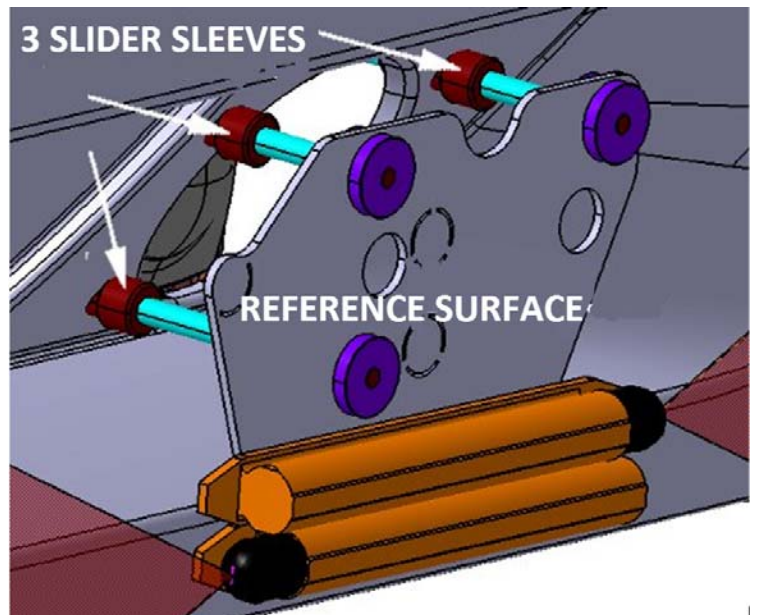
- Fix the alignment tool reference surface to the 3 extensions.
- Move the slider sleeves into the 1/2" diameter bumper skin holes to position the radar sensor assembly.

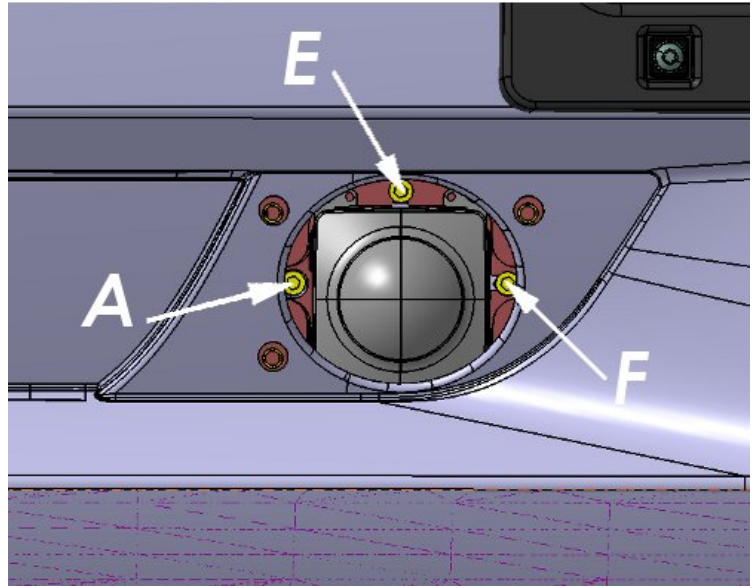
9. Tighten screw **A**.

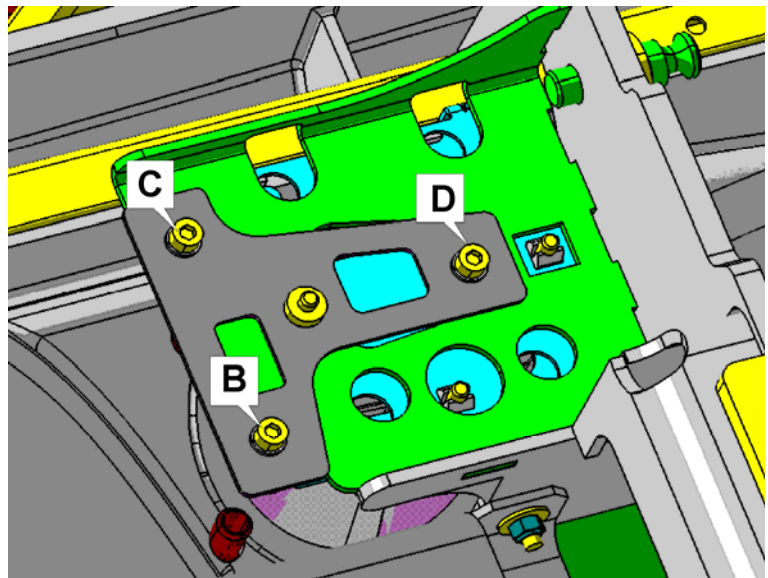
10. Lower reclining bumper and tighten screw **B**, **C** and **D**.

11. Close reclining bumper.

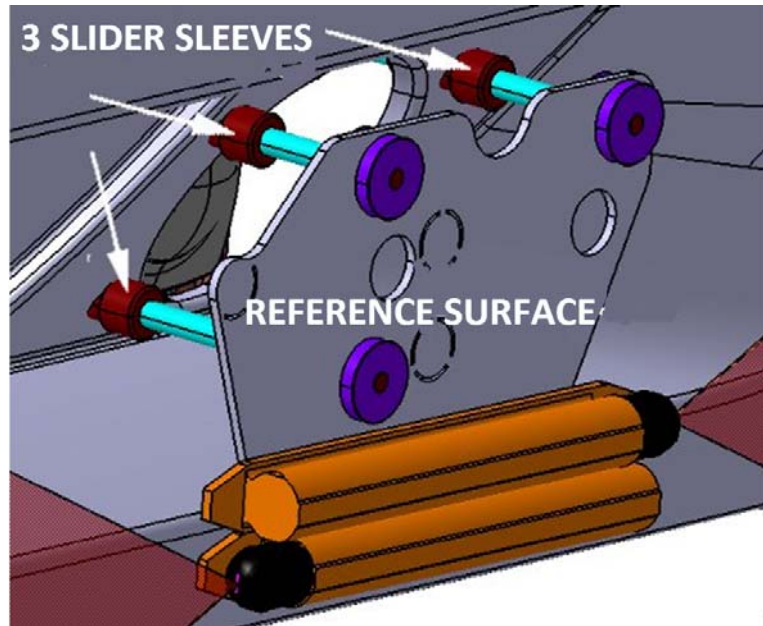
12. Slide the 3 slider sleeves out of the bumper skin holes.

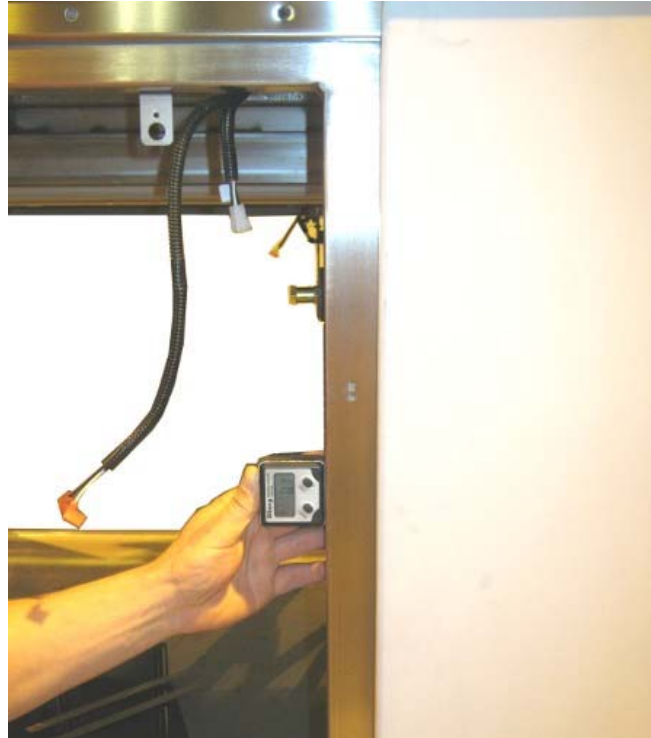
14. Set the digital angle gauge flat on a vertical chassis member. Check for proper verticality of the vertical member using a bubble level.

15. Press the ZERO button to set the gauge to 0.0°. LCD display will show 0.0°.

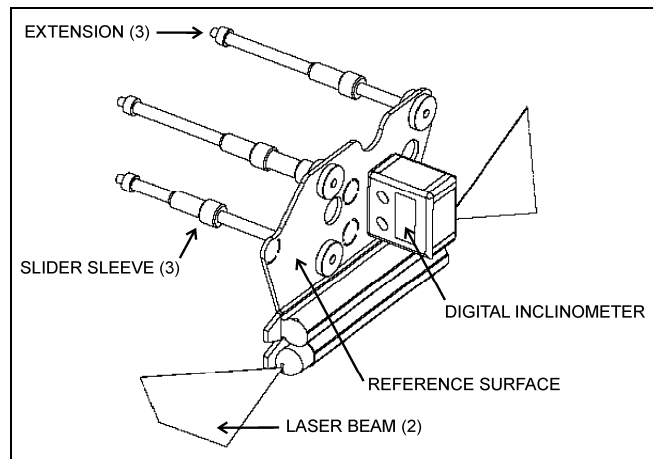
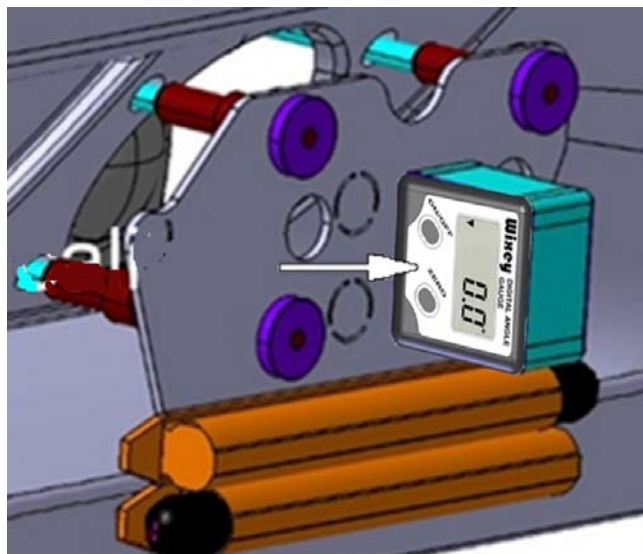
16. Place the digital angle gauge on the alignment tool reference surface as shown on figure 3.

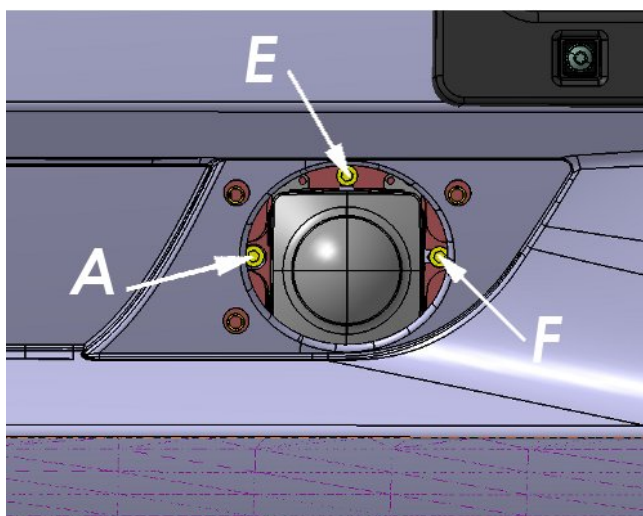
17. Screw **E** serves as tilt (vertical plane) adjustment. Turn screw **E** clockwise or counterclockwise depending on direction needed until digital angle gauge reads 0.0°.
18. If it's not possible to obtain 0.0° reading, assure that the 3 extensions are not leaning against the bumper skin at the 3 holes.
19. If the extensions are leaning against the bumper skin, repeat steps 1 thru 17.

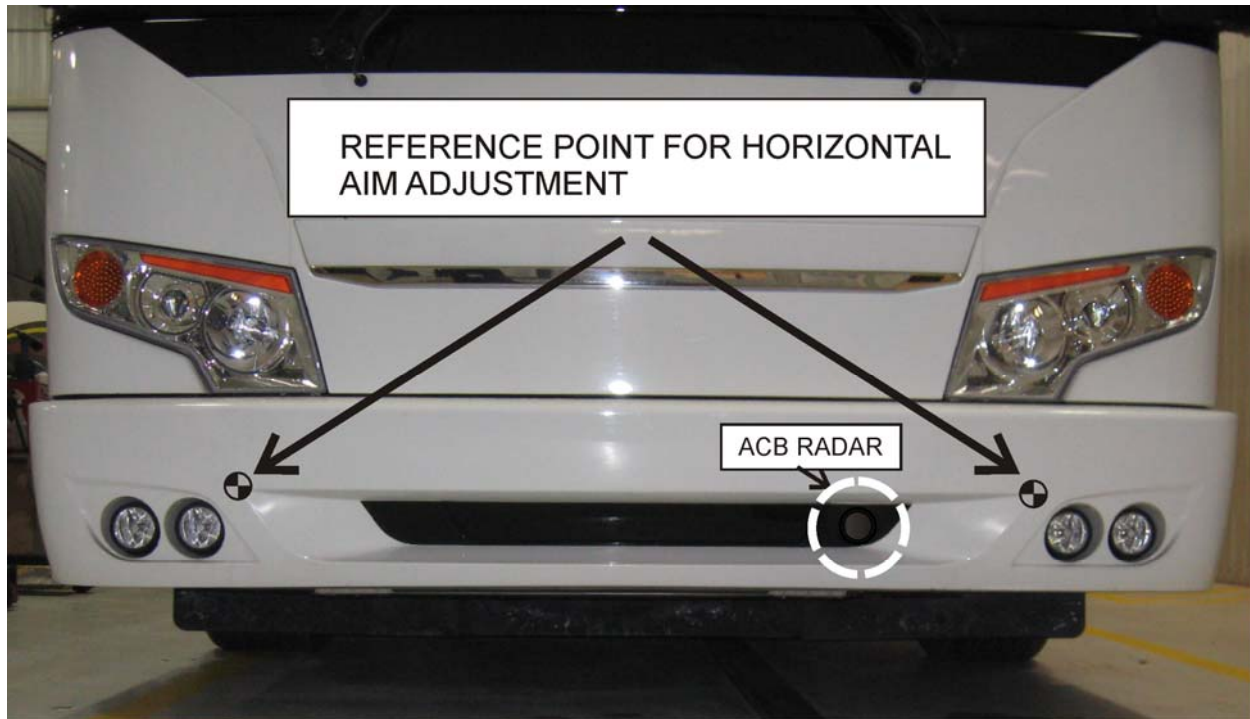
20. Define two symmetrically located reference points on the bumper. Later in this procedure, the distance between the bumper surface at these reference points and the laser beam will be measured and then adjusted to be equal on both sides.

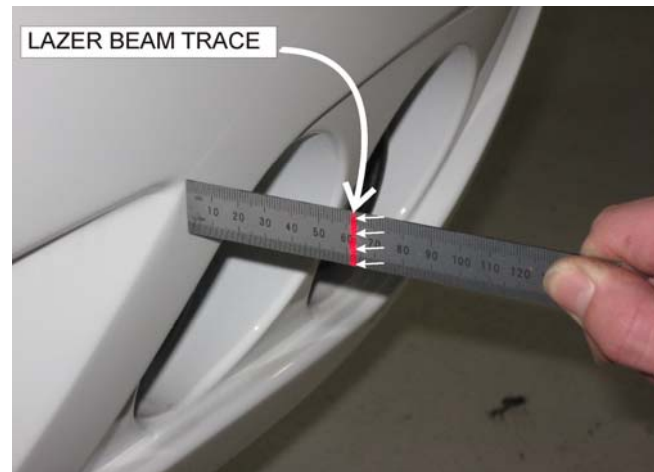
21. Turn on each laser and select the flat beam type
22. Using a measuring tape, measure distance between the bumper at the reference point and the laser beam. This measure must be equal on both sides.
23. Screw **F** serves as horizontal aim adjustment. Turn screw **F** clockwise or counterclockwise depending on direction needed in order to have the same measurement on both sides.

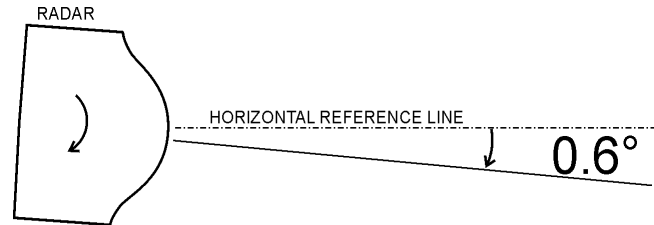
25. Once the radar sensor tilt and horizontal aim adjustment is complete, use the digital angle gauge to adjust a tilt of  $0.6^\circ$  downwards using screw E.

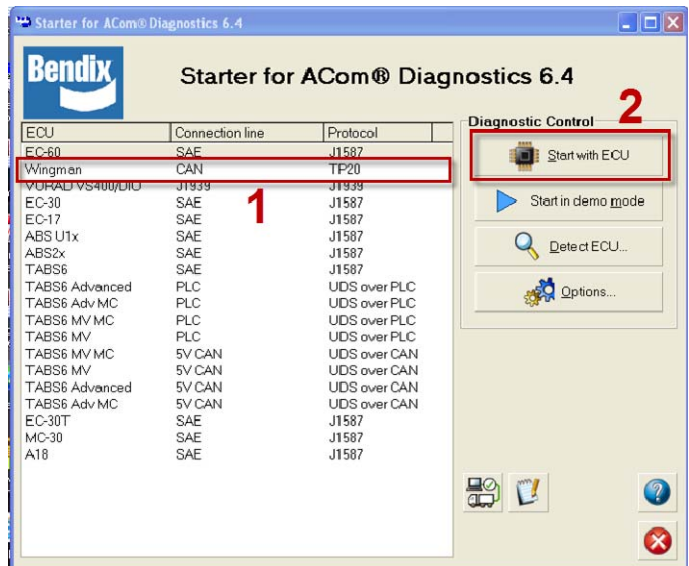
26. On Google, search for « bendix acom diagnostics software ».
27. Download the latest version of *Bendix ACom Diagnostics*® software on your laptop.
28. Launch *Bendix ACom Diagnostics*®.
29. Select *Wingman CAN TP20* and then click on *Start with ECU*.

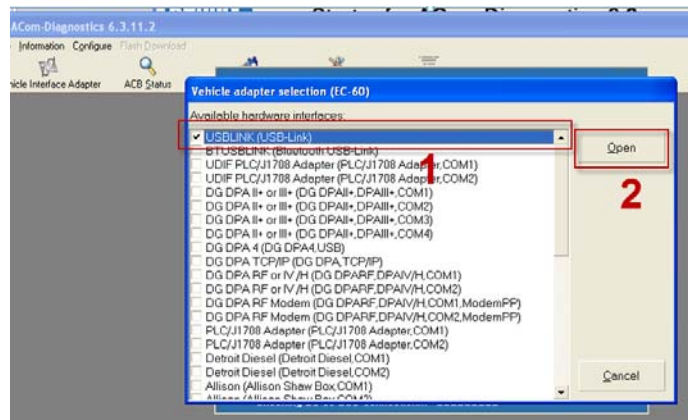
30. Select your type of connection (USB-Link) and then click on *Open*.

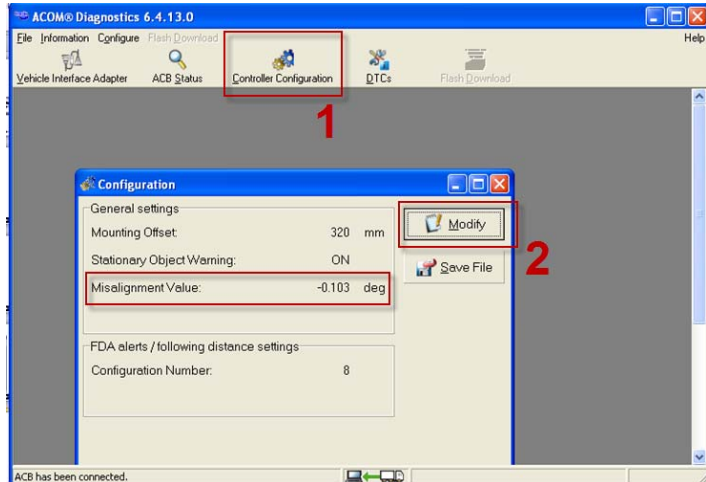
- To reset the Misalignment Value, select *Controller Configuration* and then click on *Modify*.

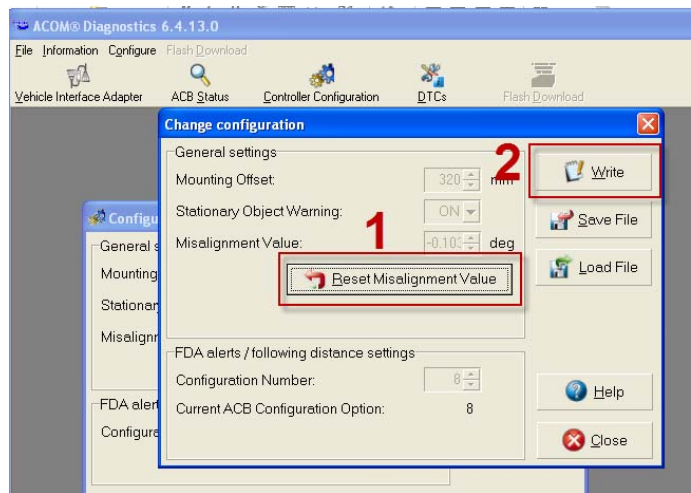
- Click on *Reset Misalignment Value* and then click on *Write*.

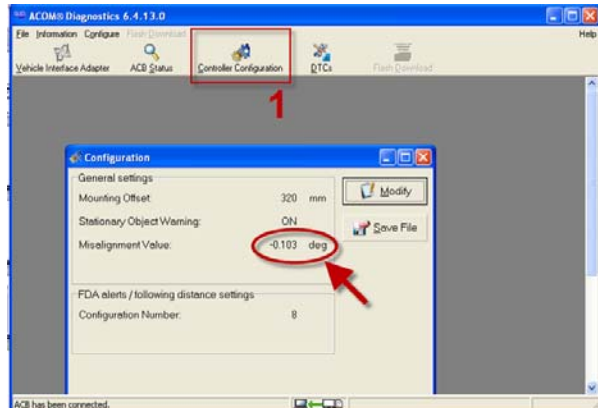
- After the road test, use *Bendix ACom Diagnostics®* software to check the Misalignment Value (refer to Part 5 for the procedure).
- If the absolute value of the misalignment (numerical value without regard to sign + or -) is greater than 0.7deg, it is necessary to perform the complete alignment of the radar once again, starting from Part 1 up to Part 7.
