PREVOST

WARRANTY BULLETIN

WB13-65D

DATE :	NOVEMBER 2013	SECTION :	01 - Engine
EXPIRATION:	NOVEMBER 2015		
SUBJECT :	ACM AND EMS UPDATE

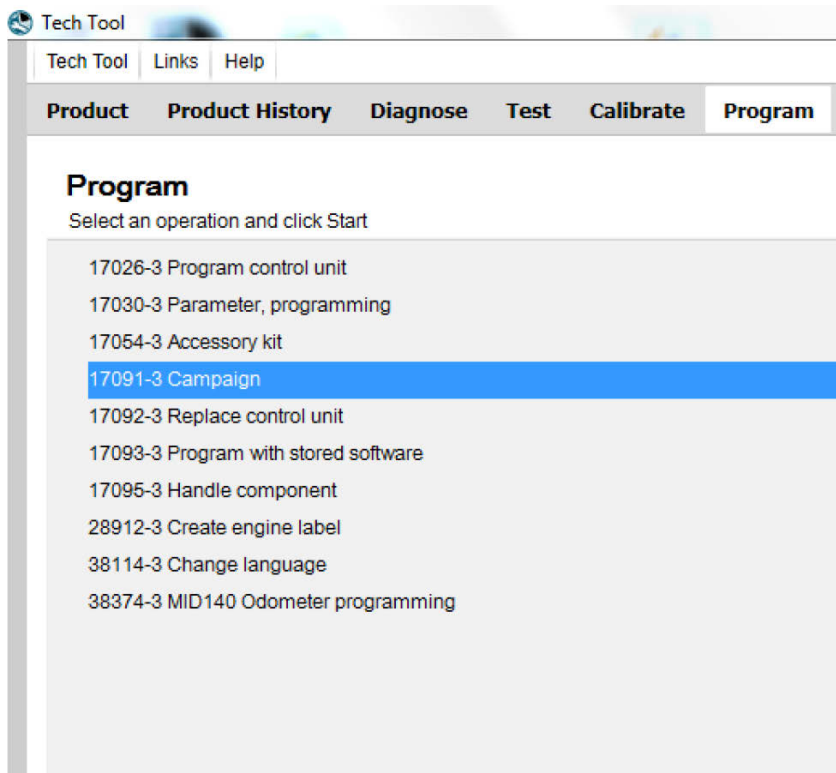
7. From the Main Menu select Program and then Campaign 17091-3. Then click Start.

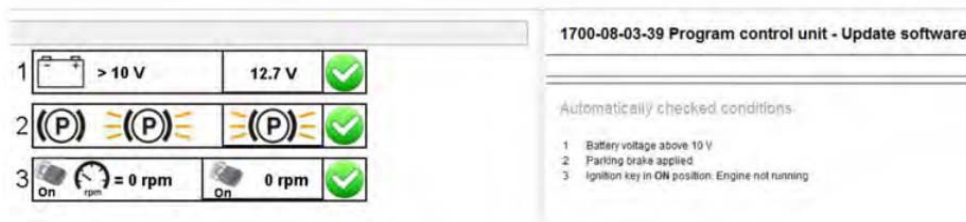
- Certain conditions must be met to continue with programming: battery voltage above 10v, parking brake applied, and ignition key in ON position with engine not running. When all conditions have been met, click Continue to proceed with programming.

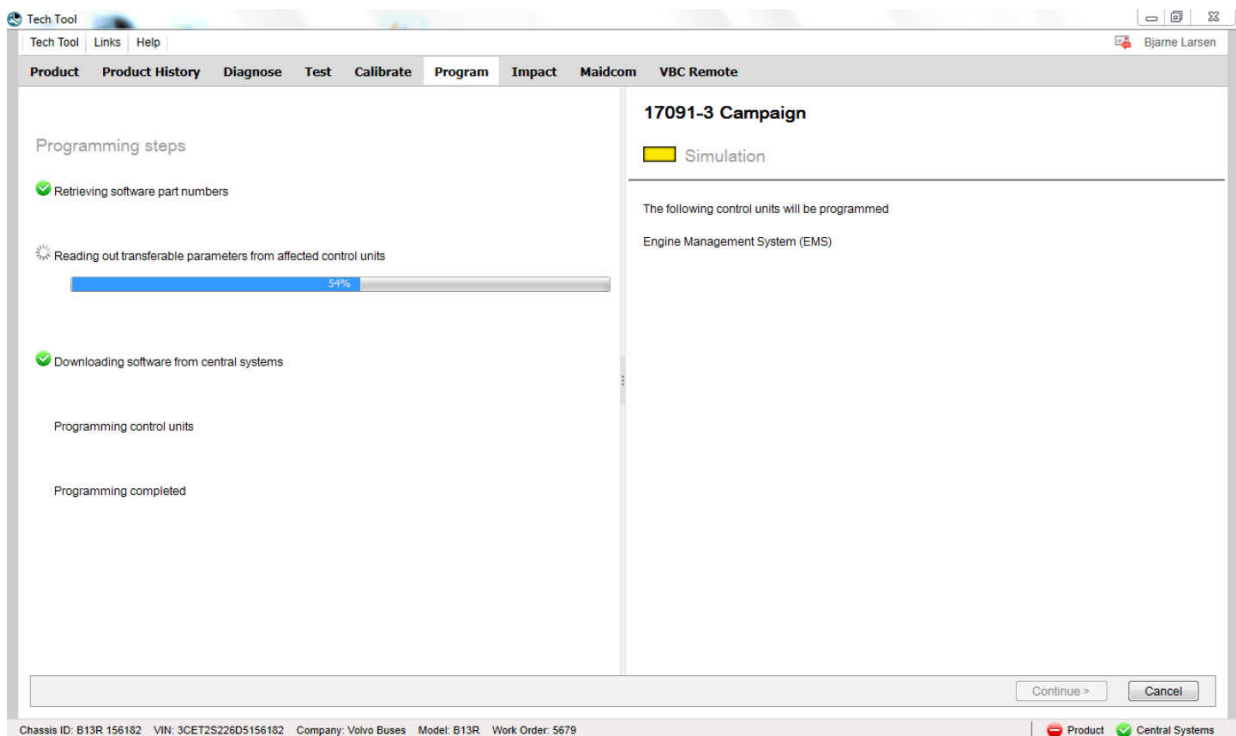
- Program is now ongoing
