DIAGNOSTIC TROUBLE CODES (DTC)

DTC P0658 Actuator Supply Voltage 1 (HSD1) Low

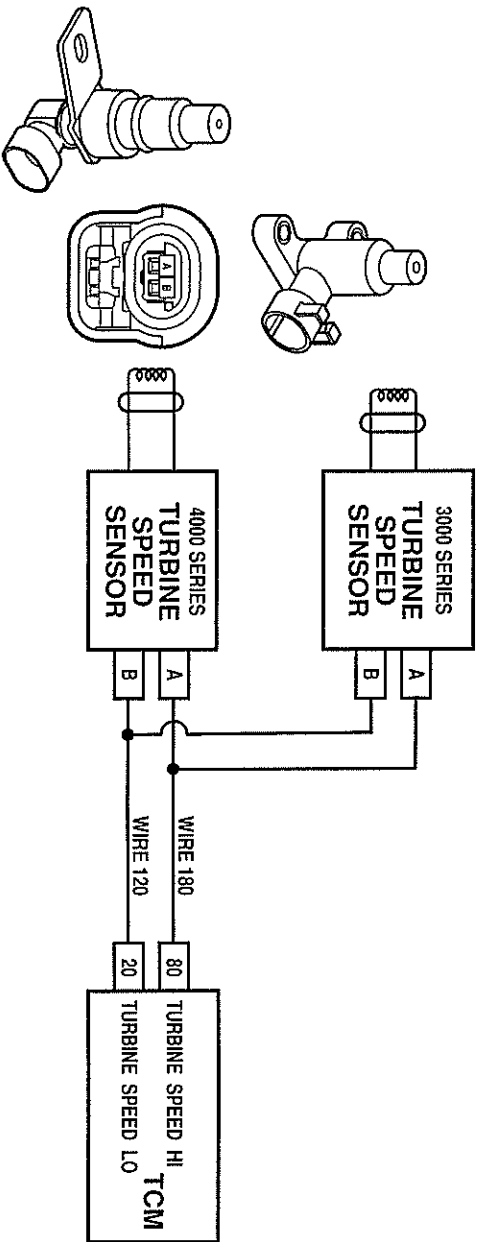
DTC P0716 Turbine Speed Sensor Circuit Performance

SPEED SENSOR CIRCUITS
Use twisted pairs of wires

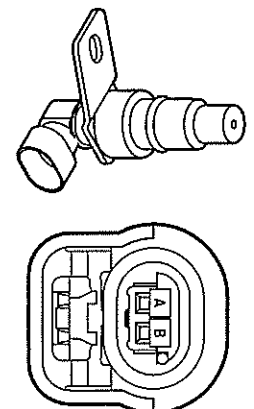
SPEED SENSOR CIRCUITS

Use twisted pairs of wires

Current Resistance (Ohms) January, 2006	Former Resistance (Ohms) Before January, 2006	TEMP (°F)	TEMP (°C)
250	200	-40	-40
340	300	68	20
450	400	230	110
