**MAINTENANCE
INFORMATION**

mi97-19

DATE: 26-08-97	SECTION: 18
SUBJECT: Stiffer spring for roof ventilation hatch

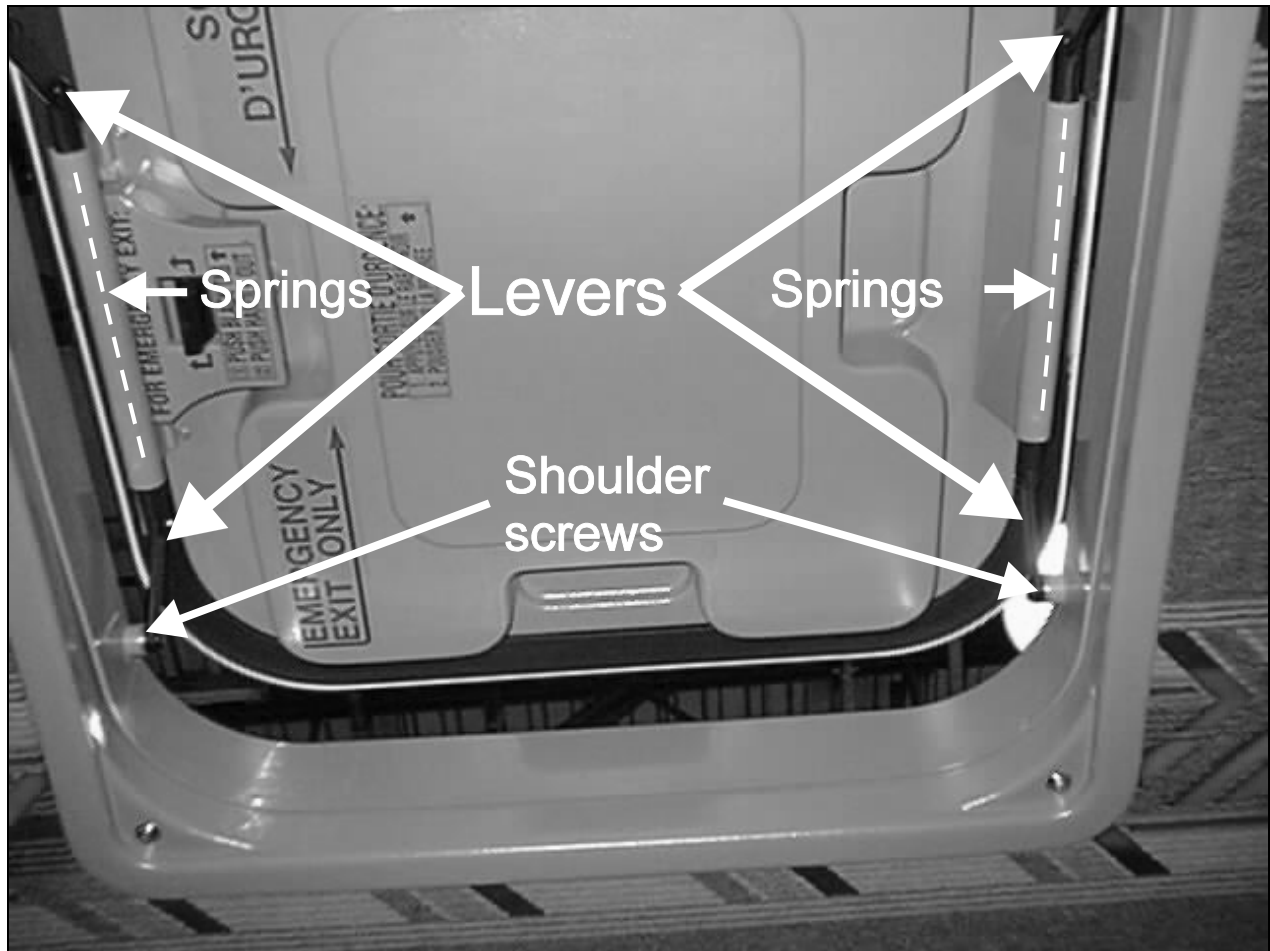
FIGURE 1: H3-45 ROOF VENTILATION HATCH

Certain road conditions may cause the roof ventilation hatch to open by itself. In order to avoid this inconvenience, a stiffer spring can be installed according to the next procedure.

1. Unscrew the shoulder screws of roof ventilation hatch.
2. Remove the ventilation hatch and the 4 springs located inside the hatch(Fig. 1).

Note: In order to remove inside springs, pull on the two levers on each side.

3. Install new springs (2 on each side).
4. Reinstall levers of roof emergency door as previously.
