**SAFETY
RECALL**

SR13-53

| SUBJECT : | TAIL LAMP PHOTOMETRICS |

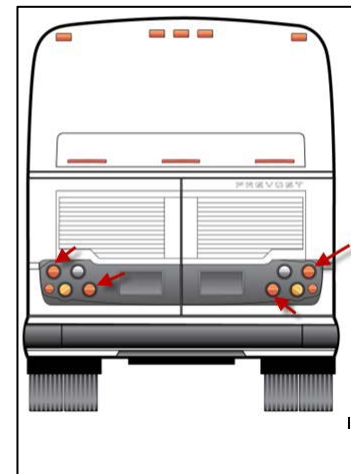
On vehicles affected by this recall, the photometric intensity of the tail lamps exceeds the requirements outlined in Federal Motor Vehicle Safety Standard (FMVSS) No 108 'Lamps, reflective devices, and associated equipment'.

The tail lamp may appear to be brighter at certain points confusing following drivers about whether the vehicle is braking, increasing the risk of a crash.

Performing a multiplex software update in a Prevest Service Center will correct light intensity.

1. Update the multiplex software with Vehicle Program Generator (VPG) to the following complist and revision.
