PREVOST

WARRANTY BULLETIN

DATE: September 1998 SECTION: 12

SUBJECT: INSTALLATION OF A PARKING BRAKE BUTTON PROTECTIVE COVER

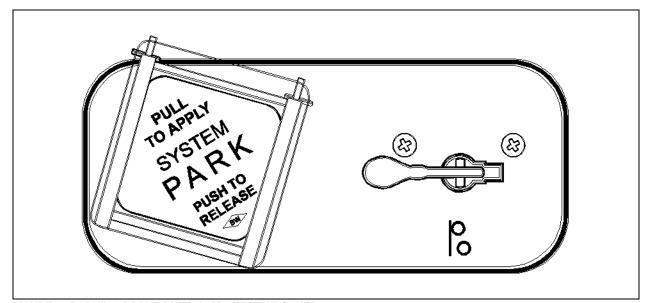
FIGURE 2: PARKING BRAKE BUTTON PROTECTIVE COVER

Install parking brake button inside protective cover (Prévost part #391727), indexing them so that roll pin can be installed. Secure button by installing the roll pin. See figure 2.

Note: The operation of the parking brake will be modified by the addition of the protective cover. To apply parking brake, lift protective cover c/w button; to release parking brake, open protective cover and push yellow button.
