**WARRANTY
BULLETIN**

Wb99-28

DATE : OCTOBER 1999	SECTION : 23 - Accessories
EXPIRATION: OCTOBER 2000	
SUBJECT : REPLACEMENT OF LAVATORY NIGHT LAMP LIGHT BULB

Model	VIN
H3-41 & H3-41 Coaches Model Year : 1998 – 2000	From 2PCH3349XW <u>1012285</u> up to 2PCH33496Y <u>1013355</u> incl.

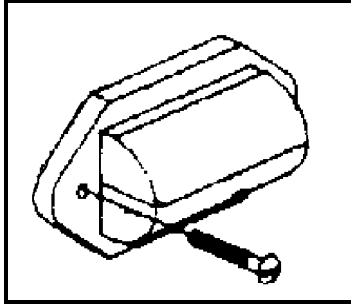
FIGURE 1 : NIGHT LAMP

1. Locate the night lamp. The night lamp is the lamp that remains constantly lit when the engine is running. It is located near the lavatory door frame.
2. Unscrew the lamp and remove the light bulb by pulling it from the socket (figure 1).
3. Insert the new light bulb in the socket.
4. Reinstall the night lamp.

For the above-mentioned vehicles, replacing the lavatory night lamp light bulb with a long lasting light bulb increases the light bulb lifetime expectancy to 15000 hours.

Part No.	Description	Qty
562276	Light bulb 657, 28 volts	1
