SAFETY RECALL

SR19-03P-B

DATE :	April 2019	SECTION :	23 ACCESSORIES
SUBJECT:	EXTINGUISHER CONTROL HEAD INSPECTION

REVISION: B This revision replaces all previous versions

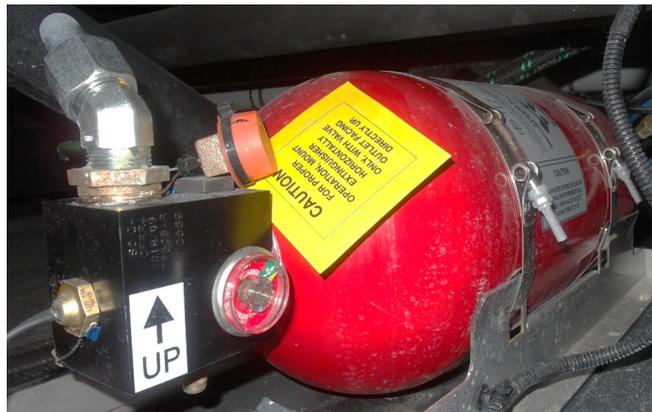
Extinguisher with a black box control head is not impacted. Do not replace this control head.

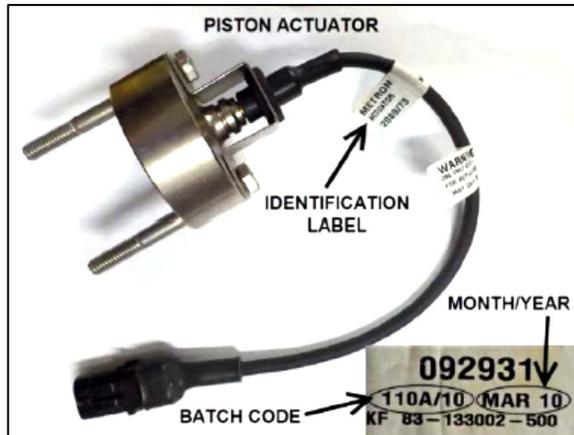
Figure 2

2. Locate the piston actuator identification label.
3. Record the batch code from the label on the certification sheet at the end of this document.

Both tags on this particular extinguisher are the same. Typically only one information label and one warning label will be found on the piston actuator.

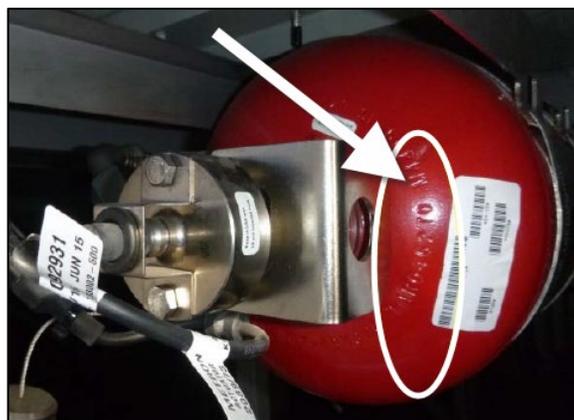
Figure 3

The piston batch code is located beside the Month/Year information on the label (see Figure 3).

The batch code is located beside the Month/Year information on the label shown in Figure 3.

5. If the batch code DOES NOT match any of the recall batch codes shown in the table below, place a GREEN dot decal or a small piece of GREEN tape on the control head. The piston actuator is functional.

BATCH CODES IMPACTED
042A/15
467A/17
639A/17

6. Close up the extinguisher compartment.
7. If the batch code matches any of the recall batch codes shown in the table ABOVE, place a RED dot decal or a small piece of RED tape on the control head. The piston actuator has to be replaced.
8. If the labels are missing on the extinguisher control head, replace the piston actuator.
9. Call a Prevest Service Center and make an appointment to replace the control head.

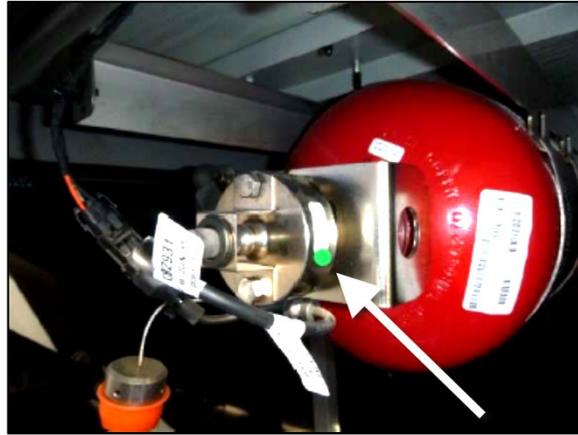
Figure 4

The extinguisher serial number is located on the neck of the extinguisher tank and starts with the letters “**TAR**” followed by 6 digits (see Figure 4).

Extinguisher serial number is located on the neck of the extinguisher tank and starts with the letters "TAR" followed by 6 numbers.

4. Record the extinguisher serial number on the certification sheet at the end of this document.
