**PREVOST**

**WARRANTY  
BULLETIN**

Wb07-03

<b>DATE:</b> MAY 2007	<b>SECTION:</b> 23 - Accessories
<b>EXPIRATION:</b> MAY 2009	
<b>SUBJECT:</b> INSTALLING DECAL WARNING AGAINST PERFORMING ANY WELDING WORK

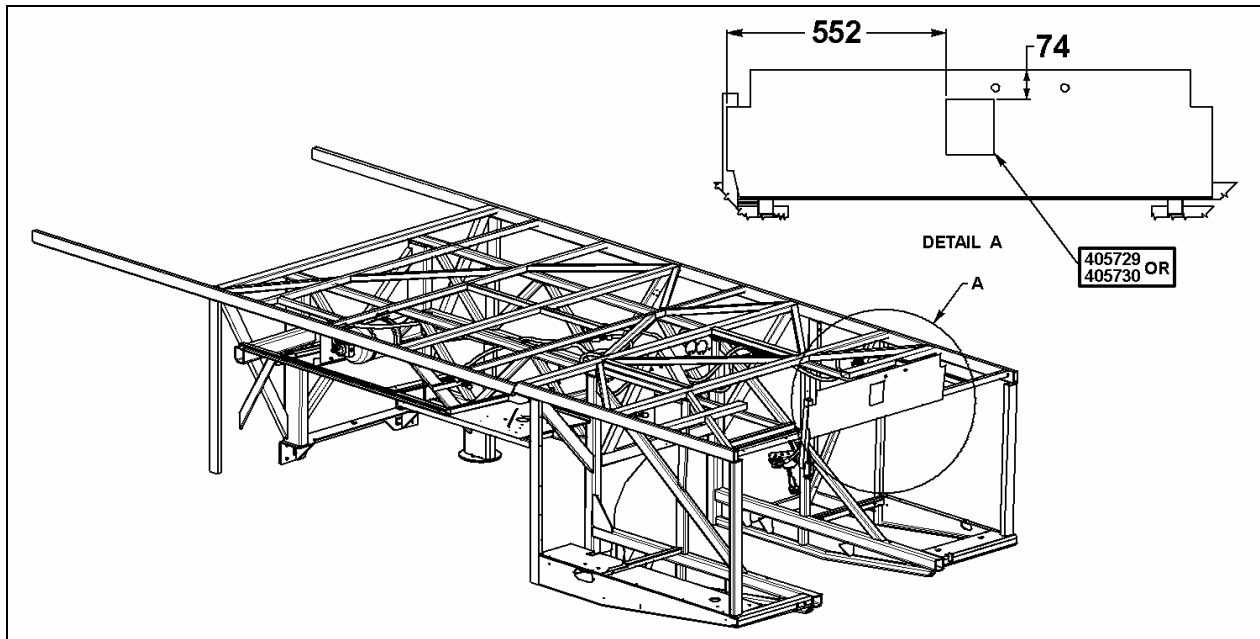
FIGURE 1

On the above-mentioned vehicles, there is a possibility that the decal warning against performing any welding work when the vehicle is equipped with an Automatic Fire Detection and Suppression System (AFSS), was not installed in the engine compartment.

The system might activate by mistake if arc or gas welding is performed.

1. Open engine compartment door then check if decal was installed, if not install as per figure 1.

Choose the proper decal according to the requirements.
