PREVOST

WARRANTY BULLETIN

WB13-62B

DATE :	SEPTEMBER 2013	SECTION :	10 - Front axle
EXPIRATION:	SEPTEMBER 2015		
SUBJECT :	TORQUE INSPECTION ON FRONT AXLE SUPPORT BOLT

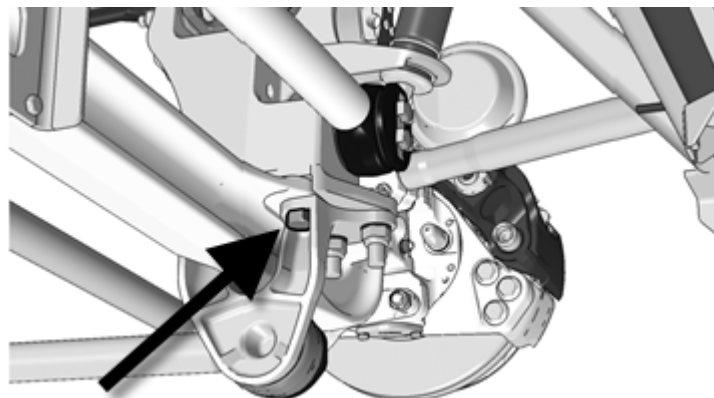
On the vehicles affected by this bulletin, torque must be verified on one of the axle support mounting bolts. An interference of a production tool with the casting on the nut side of the fastener may have resulted in lower effective torque.

1. On the front axle, left side (driver's side). Locate this bolt (arrow).

2. Verify the torque on this bolt.

Value should be

255 +/- 25 lbf-ft. (**230 - 280** lbf-ft).

If value is within range, clean and apply torque seal mark.
