# PREVOST

## WARRANTY BULLETIN

**WB15-14**

DATE :	MAY 2015	SECTION :	04 - Exhaust
EXPIRATION:	MAY 2017		
SUBJECT :	EXHAUST DIFFUSER DRAIN TUBE

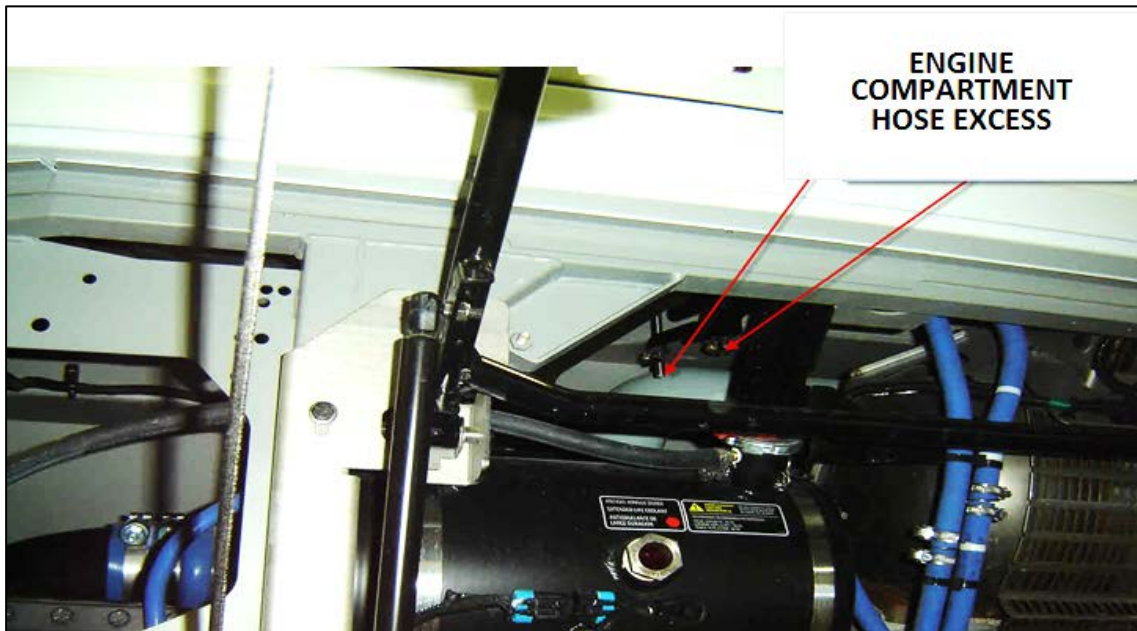
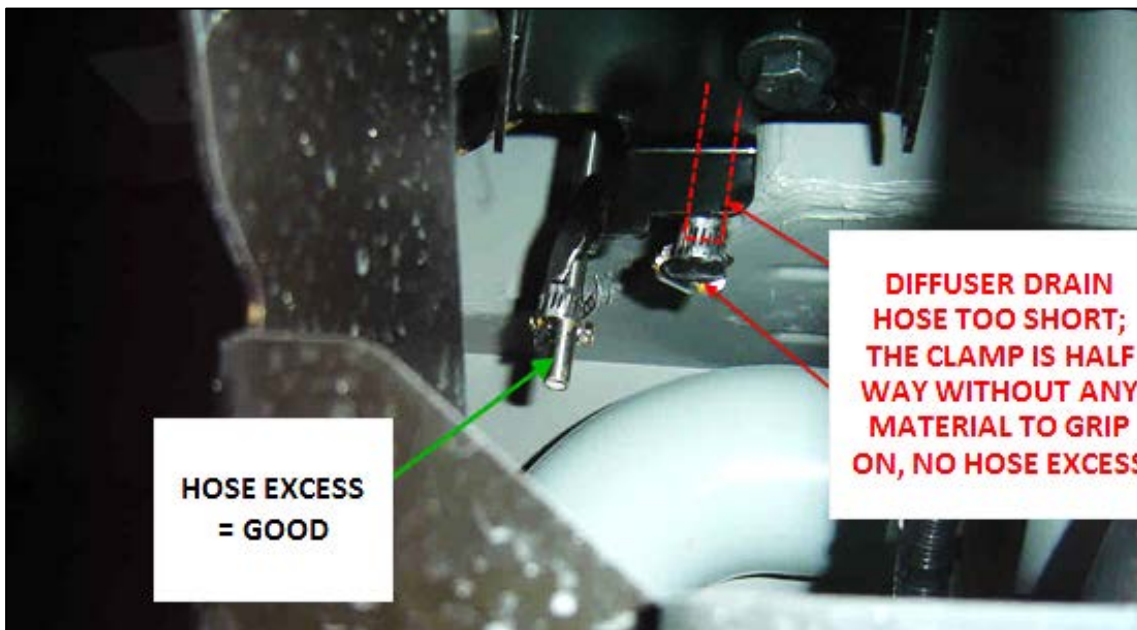
1. In the engine compartment, inspect the lower part of the diffuser drain tube and make sure there is an excess length allowing proper seating of the clamp.
2. If it is not the case, unscrew the clamp to free the tube.

3. Add adapter #5011119 to the upper connexion.
4. Re-tighten lower clamp.
