AS-Tronic Rear Housing Change

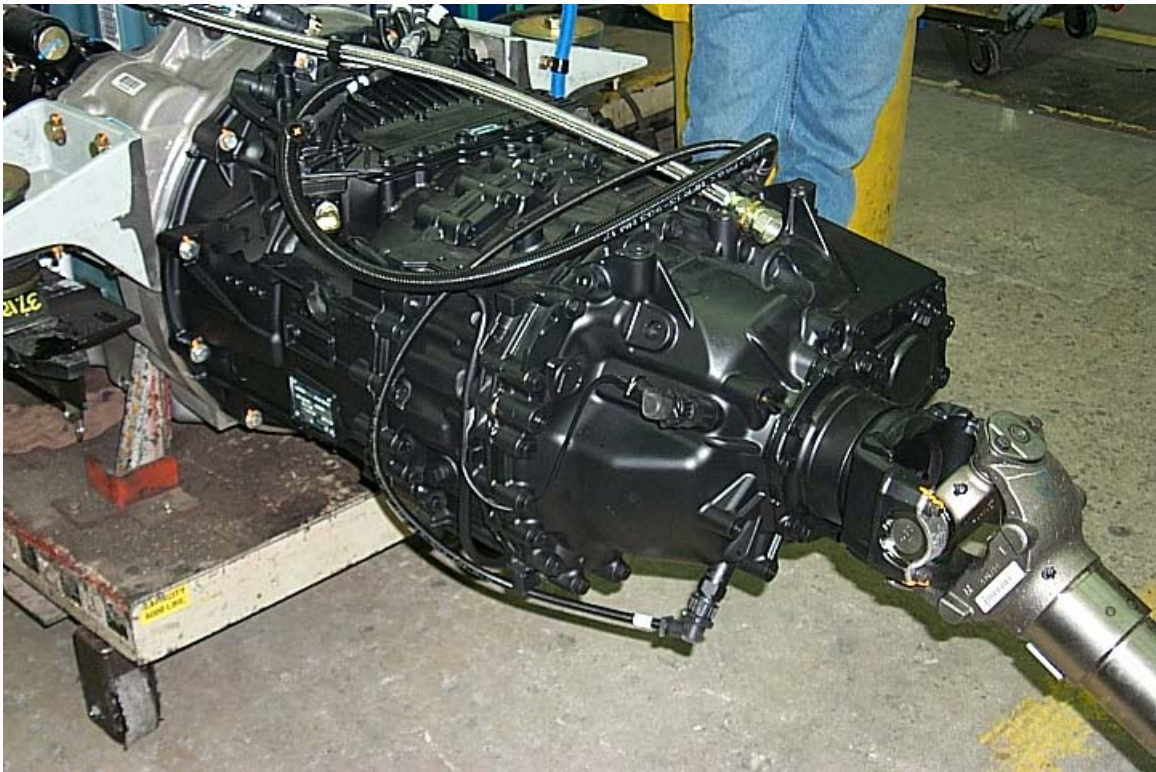
Photo No. 4: “New” Housing

This Threaded Insert Missing
On New Housing
