1. PROPELLER SHAFT

1.1 DESCRIPTION

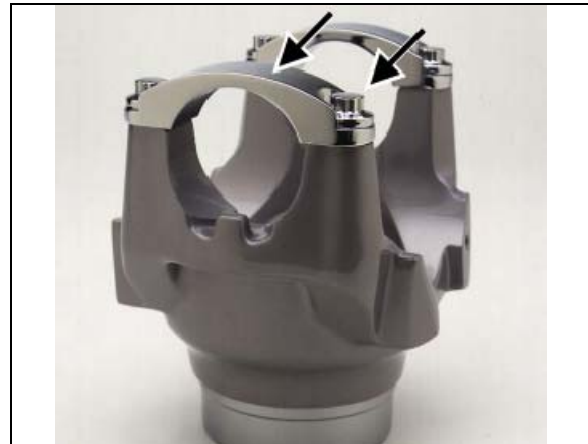
**FIGURE 3: COLD FORMED BEARING RETAINER AND BOLTS AS USED ON PREVOST VEHICLES**

**DO NOT** reuse cold formed bearing retainers and bolts. Reuse of bearing retainer and bolts can cause driveline failure, which can result in separation of the driveline from the vehicle.
