2. PROPELLER SHAFT

2.1 DESCRIPTION

## SECTION 09: PROPELLER SHAFT

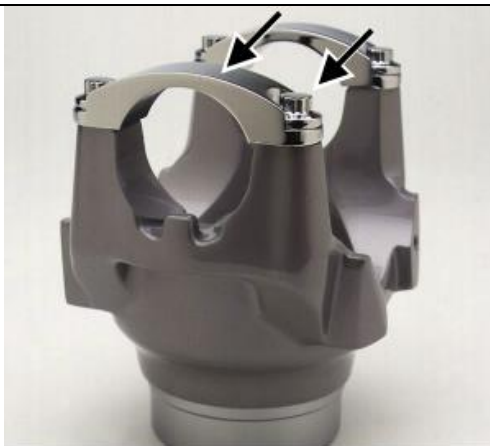
FIGURE 2: COLD FORMED BEARING RETAINER AND BOLTS AS USED ON PREVOST VEHICLES

DO NOT reuse **cold formed bearing retainers** and **bolts**. Reuse of bearing retainer and bolts can cause driveline failure, which can result in separation of the driveline from the vehicle.

- **All universal joints securing hardware (bearing retainers and bearing retainers bolts, spring tabs and bolts) must be removed and replaced** using new OEM specified replacement parts (FIGURE 1 & Figure 2).

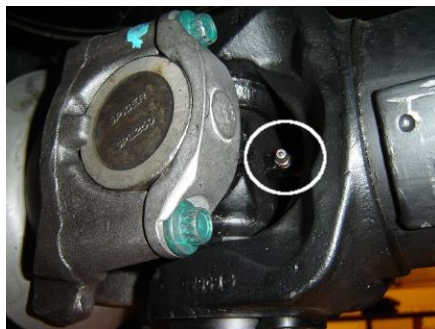
FIGURE 5: BEARING LUBRICATION ZIRK

1. Use recommended lubricant to purge **all** four seals of each universal joint. This flushes abrasive contaminants from each bearing assembly and assures proper filling of **all** four bearings.

Maximum grease gun pressure should not exceed 60 psi. Excessive grease gun pressures may cause seal damage.

2. Make sure fresh grease is evident at all u-joint bearing seals.

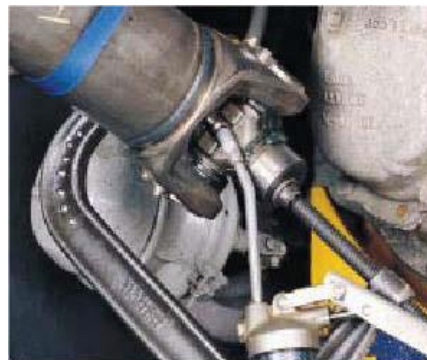
FIGURE 7: C-CLAMP

3. If any of the seals fail to purge, try to move the propeller shaft from side-to-side while applying grease gun pressure.
  - a) If all four bearing positions still do not purge, releasing seal tension may be necessary.
  - b) Remove the bearing retainer bolts and bearing retainers and discard. Do NOT reuse.
  - c) Once the bearing cups are free, allow the propeller shaft to rest on the support strap.
  - d) Apply a c-clamp around the inboard bearings.

- e) Apply grease gun pressure. Completely purge both bearings.
- f) If bearings still do not purge, complete the removal of the u-joint and inspect for blockage.
- g) If the u-joint still do not purge at all four positions after following the steps in this procedure, replace the u-joint.

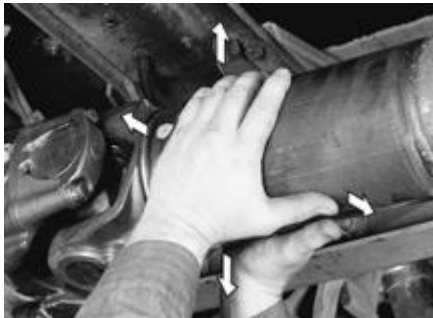
FIGURE 8: CHECK FOR LOOSENESS

- Visually inspect for damaged bearing retainers, loose bearing retainer bolts, loose companion flange, bolts and nuts, loose or missing spring tabs or spring tab bolts, damaged tangs on end fittings, damaged or missing rotating bearing cups. If any of these situations are evident, replacement of the component is necessary.
- Check all input and output end fittings for looseness. Take hold of the end fitting with both hands. Try to move it vertically and horizontally to feel any looseness.

- There should be less than **.006"** movement in the u-joint relative to the end yoke. If looseness is greater than **.006"**, the u-joint should be replaced.
- Check for the presence of all grease zerk fittings. Damaged zerks should be replaced. Loose zerks should be tightened.

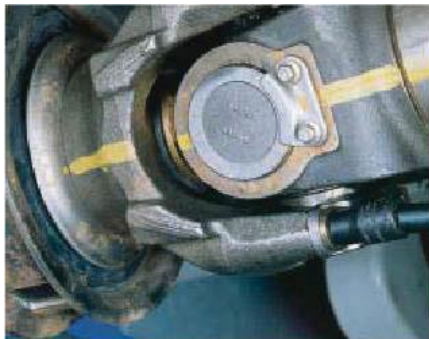
FIGURE 9: PHASING MARKS

- Mark all mating propeller shaft components with a paint marker to assure proper phasing during reassembly.
- Reassembly of a propeller shaft that is out of phase can cause vibration and failure to propeller shaft components.

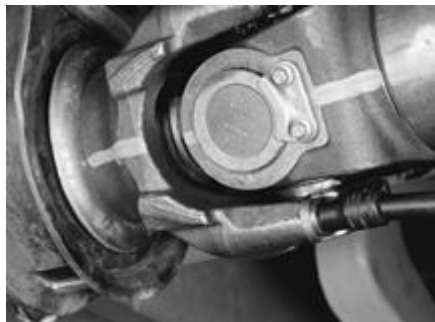
1. Mark propeller shaft (phasing marks). It is imperative to mark all the mating components of a propeller shaft, as illustrated below. Mark the propeller shaft with a marking stick, paint marker or other legible marking device. In addition, be sure to mark all bearing positions, spline positions and shaft locations. This assures proper reassembly of the propeller shaft into the vehicle, in its original position.

FIGURE 10: PHASING MARKS

FIGURE 11: PHASING MARKS

FIGURE 12: PHASING MARKS

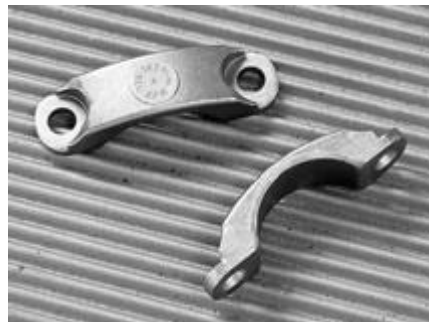
FIGURE 14: COLD FORMED BEARING RETAINERS

2. Be sure to ALWAYS use support straps to prevent the propeller shaft from falling out of the vehicle.
3. Remove the bearing retainers and bolts at rear end. Discard bolts, and bearing retainers.

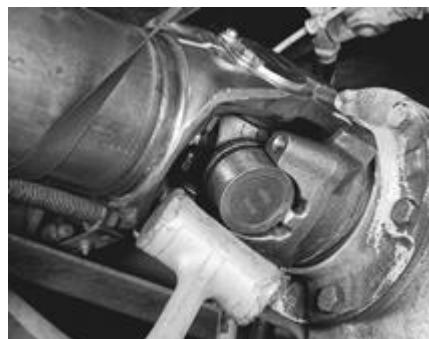
FIGURE 15: UNSEATING BEARING CUP ASSEMBLIES

4. It may be necessary to unseat bearing cup assemblies by tapping on yoke or bearing cup with a soft-faced hammer. Once the bearing cup assemblies are free, collapse the propeller shaft until both bearing assemblies clear the open end yoke cross holes. Allow the propeller shaft to rest on support strap.

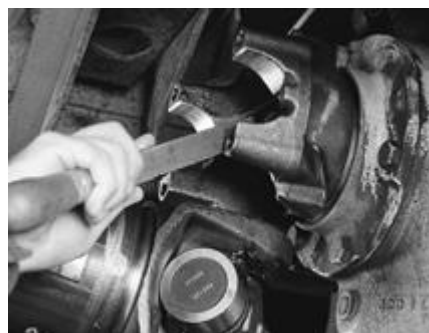
FIGURE 16: RAISED METAL OR FRETTING ON OPEN YOKE CROSS HOLES

5. Remove bearing retainers and bolts at the front end.
6. Inspect all end yoke cross hole surfaces and bolt hole threads for damage. If the bolt hole threads are damaged, the yoke must be replaced.
7. Inspect for raised metal or fretting on open yoke cross holes can be removed with a fine-toothed file and/or emery cloth.

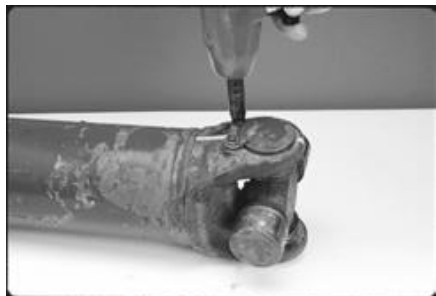
FIGURE 17: SPRING TAB BOLTS REMOVAL

1. **For Quick Disconnect Style:** Remove spring tab bolts and discard, and remove outboard bearing cap assemblies.

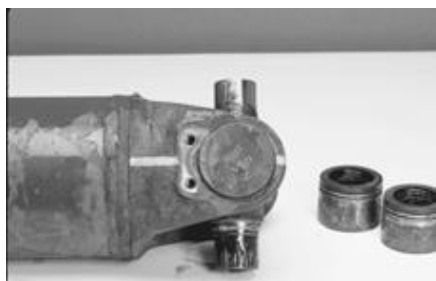
FIGURE 18: CORRECT POSITIONING

2. Make sure universal joints cross assembly is not tilted in the yoke. Place bearing cup spacer onto the base of the arbor press and under the yoke. If the arbor press is larger than the bearing cup diameter, a smaller diameter push rod will be needed to avoid damaging the yoke or bearing.

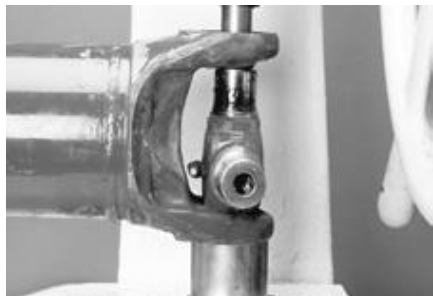
FIGURE 21

4. The bearing cup is not designed to drop out of the yoke. Move the partially pressed-out bearing cup from side to side, to "walk" the bearing cup out of the yoke ear. Remove the bearing cup from the trunnion.
5. Place the yoke in the press, with the remaining bearing cup face down. Using a push rod, press on the end of the journal cross trunnion. Continue to press down on the journal cross trunnion until the shoulder of the journal cross makes contact with the inside of the yoke ear.

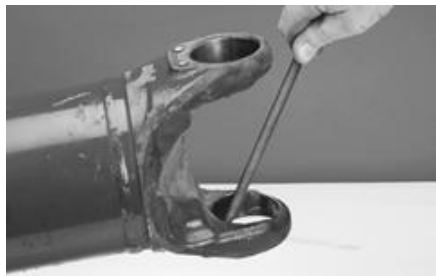
FIGURE 22: RAISED METAL OR FRETTING CAN BE REMOVED FROM YOKE CROSS HOLES WITH A FINE-TOOTHED FILE

1. Inspect the tube yoke and flange yoke (if applicable) cross hole surfaces for damage or raised metal. Raised metal or fretting can be removed from yoke cross holes with a fine-toothed file and/or emery cloth.

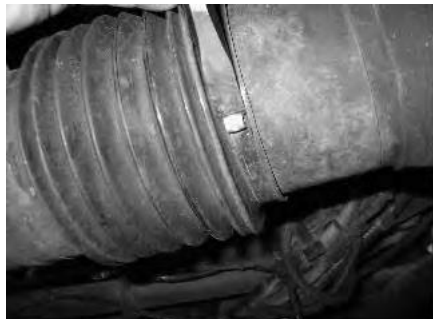
FIGURE 23: BOOT CLAMP

1. It is imperative to mark all mating components of the propeller shaft. Mark the propeller shaft with a marking stick, paint marker or other legible marking device.
2. Remove and discard both boot clamps. Clamps may be separated using a chisel to disengage locking hooks. DO NOT reuse clamps.

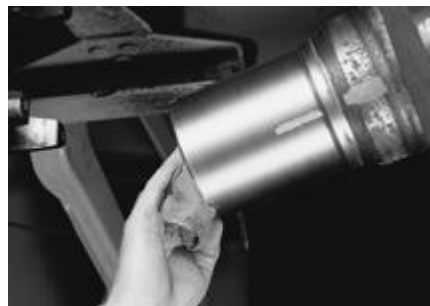
FIGURE 24: CLEAN GREASE FROM SPLINE SLEEVE

1. Clean ALL grease from yoke shaft and spline sleeve. Make sure grease-cutting solvent does not intrude into the tube through the vent hole in the spline sleeve plug. Be sure the phasing marks made during disassembly are not removed.

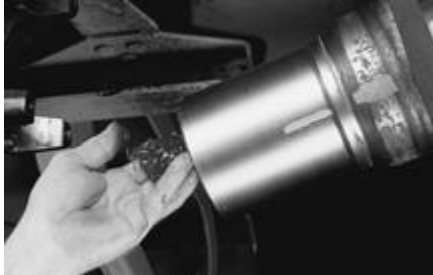
FIGURE 25: APPLY GREASE

- After all traces of grease and cutting solvent have been removed from the yoke shaft and spline sleeve, apply half of the grease provided to the yoke shaft splines and the other half to the spline sleeve, cover the entire splined surface.

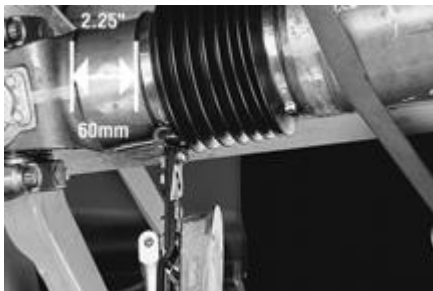
FIGURE 26: POSITION THE END OF THE BOOT AT THE 2.25 INCHES (55-60MM) MARK MADE ON THE YOKE SHAFT SHOULDER

- Measure and place a mark 2.25 inches (55-60mm) from yoke shaft shoulder with a marking stick, paint marker or other legible marking device.

- Position a clamp on each end of the new boot. Slide the boot onto the grease-free yoke shaft shoulder.
- Collapse the boot and insert the yoke shaft into the splined sleeve, making sure phasing marks are in line. Position the end of the boot at the 2.25 inches (55-60mm) mark made on the yoke shaft shoulder and tighten boot clamps to the specified torque. Yoke shaft shoulder must be clean, dry and grease free.

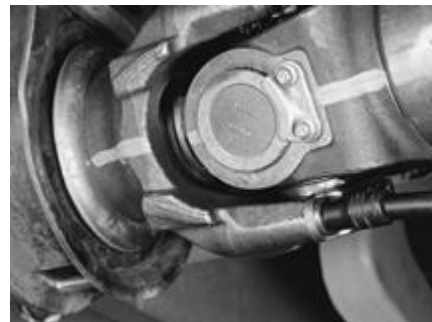
FIGURE 27: ALIGN THE PHASING MARKS BETWEEN THE YOKE AND PROPELLER SHAFT

- Before installing the propeller shaft, inspect the yoke surface for burrs and damage. Mating surfaces should be clear of rust, contamination and grease.
- With safety straps in place, align the phasing marks between the yoke and propeller shaft.

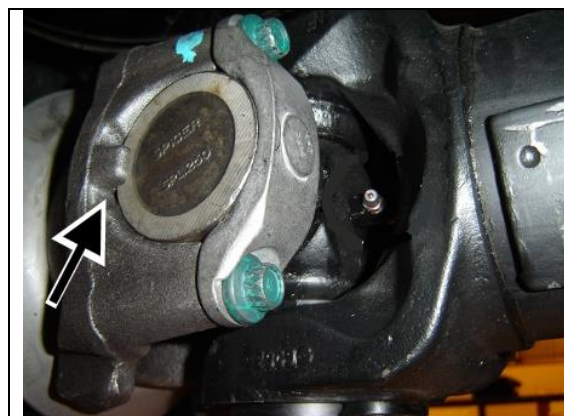
FIGURE 28: YOKE TAB (EAR)

- Align the bearing cups with the yoke ears making sure that the cups are evenly spaced between the tabs (ears) of the yoke. A soft faced hammer can be used to fully seat the bearing cups into the yoke.

**Note: Bearing cups must be fully seated between the yoke tabs (ears). Failure to seat the cups properly will result in a premature failure.**

- The universal joint caps must be seated properly between the yoke tabs (ears) (FIGURE 28).
- All universal joint bearing retainers must have been replaced using new hardware and fasteners.
- All fasteners have been torqued properly and are torque-marked.
- Locking tabs, if used, must be bent over the bolts.
- There must be no mixing of new and old parts on a universal joint.
- The driveshaft must be phased properly.
- Driveshaft guard (hoop) must be in place.
- Driveshaft universal joints must be greased after reinstallation of driveshaft in vehicle (fresh grease showing at all u-joint end caps).

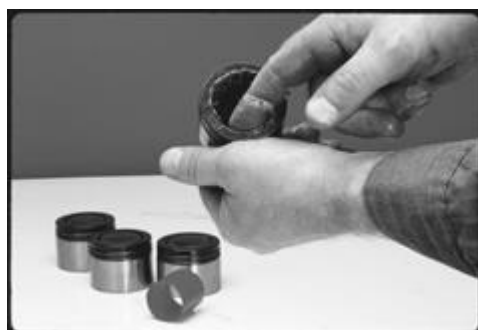
FIGURE 29: GREASING BEARING CUP

1. Remove needle retaining plugs from all bearing cup assemblies. Using a high quality National Lubricating Grease Institute E. P. Grade 2 lubricating grease, wipe each bearing cup assembly with grease. Fill all cavities between the needle rollers. Also apply a liberal coating of grease on the bottom of each bearing cup assembly and on the lip of the seal.

**Caution - Spicer DOES NOT recommend wiping the outside of bearing cup assemblies or yoke cross holes with grease, oil or silicone-based sprays. This could result in bearing cup assembly rotation in yokes.**

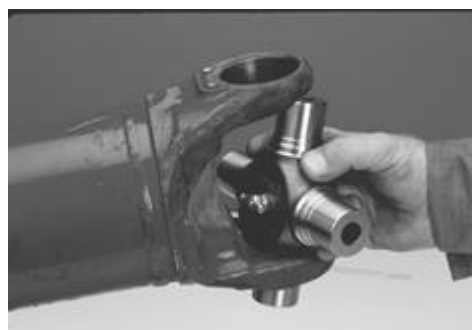
FIGURE 30: POSITION THE JOURNAL CROSS INTO THE YOKE CROSS HOLES WITH THE GREASE ZERK FITTING INWARD TOWARD TUBING

2. Position the journal cross into the yoke cross holes with the grease zerk fitting inward toward tubing. The double-headed, grease zerk (nipple) fitting should be perpendicular to the yoke cross holes.

**Note: Failure to properly position the universal joint will result in the inability to grease the universal joint.**

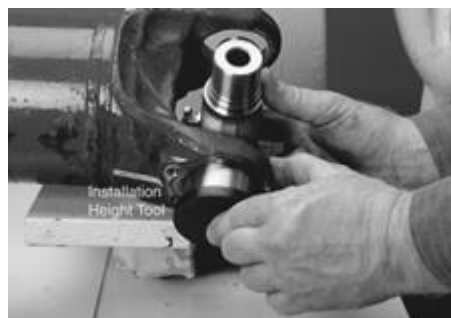
FIGURE 31

3. Move one end of the journal cross to cause a trunnion to project through the cross hole beyond the outer machined face of the yoke ear. Take one bearing cup assembly and position an installation height tool on the end of the bearing cup assembly. Place the bearing cup assembly over the protruding trunnion diameter and align it to the yoke cross.

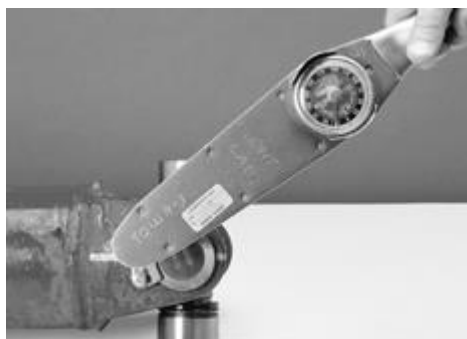
FIGURE 33

5. Flip yoke 180 degrees. Position the remaining installation height tool on the end of another bearing cup assembly. Place bearing cup assembly over trunnion diameter and align it to the yoke cross hole. Push the bearing cup assembly until both installation height tools are flush with the cross hole face.
6. Install new spring tabs and 8mm thread bolts. Make sure that no grease or foreign material is present between the contact areas of the spring tabs, bearing cups and yoke cross hole faces. Tighten bolts to the required torque.

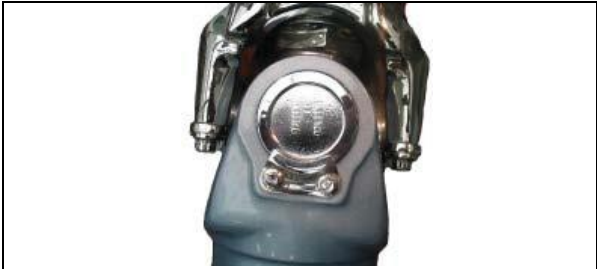
**SPRING TAB BOLT TORQUE**

Bolts are specially heat-treated. DO NOT substitute inferior grade bolts.

Series	Head size	Size	Bolt torque
SPL250	8mm	8mmx1.00	25-30lb-ft
	6 Points
