**WARRANTY
BULLETIN**

Wb00-10

DATE : MARCH 2000	SECTION :	06 - Electrical
EXPIRATION: MARCH 2001		
SUBJECT : WATER SEEPAGE IN FRONT ELECTRICAL COMPARTMENT

Model	VIN
H3-41 & H3-45 Coaches Model Year : 1998-2000	From 2PCH3349XW1012285 up to 2PCH33491Y1013750 incl.

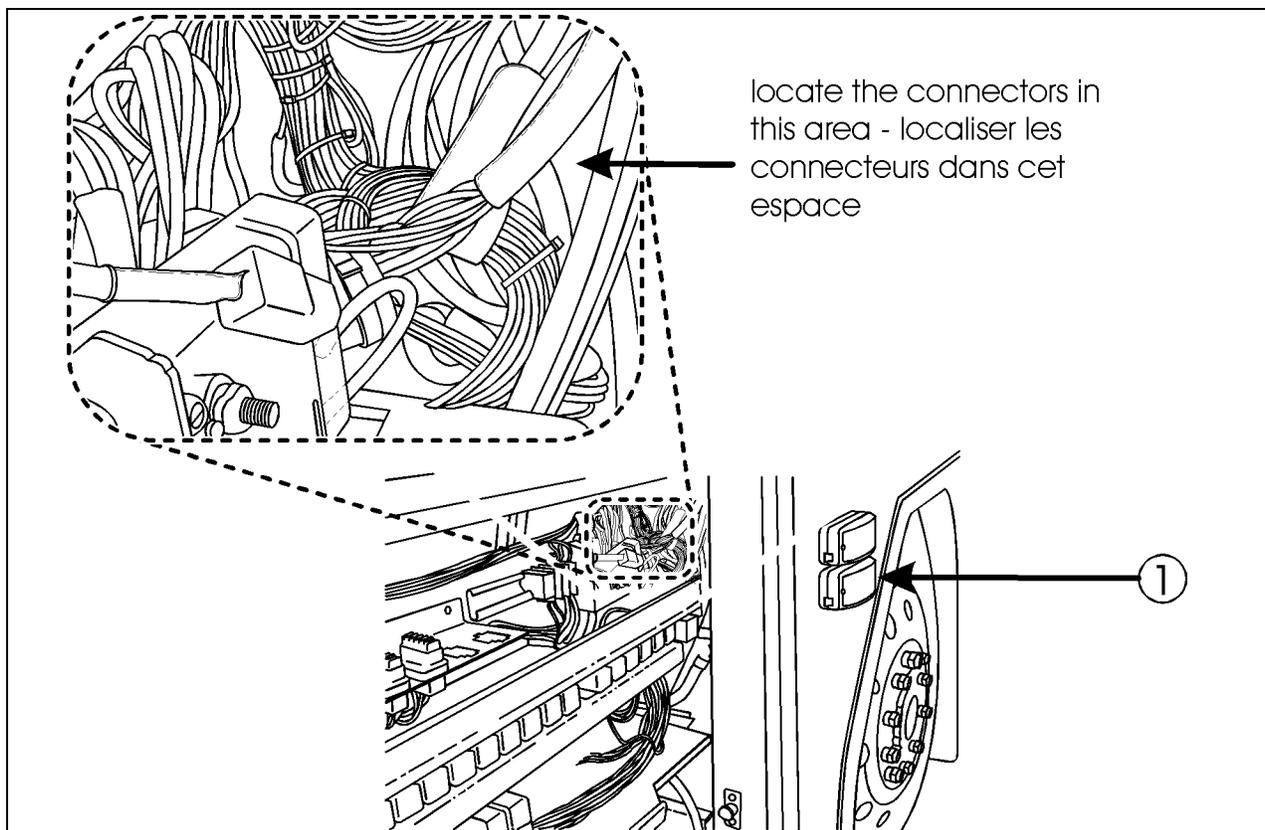
FIGURE 1 : MARKER LIGHT

On the above mentioned vehicles, it is necessary to protect some connectors in case of water seepage.

1. Locate the two marker lights beside the front electrical compartment. Dismount the lower one (item figure 1).
2. Check the water tightness of the cable grommet, apply Sikaflex or a silicone sealant.
3. Open the front electrical compartment door. Referring to figure 1, check if there is water in the area behind the marker lights.
4. In the same area, connectors (C45, C500, C506, etc.) must be fastened to a nearby wire harness to keep them off the floor and out of humidity (figure 1). Use cable ties.
