PREVOST

Warranty Bulletin

95-18

Date: **May 1995**
Section: **6**
Subject: **DIODE INSTALLATION IN BATTERY COMPARTMENT**
Application:

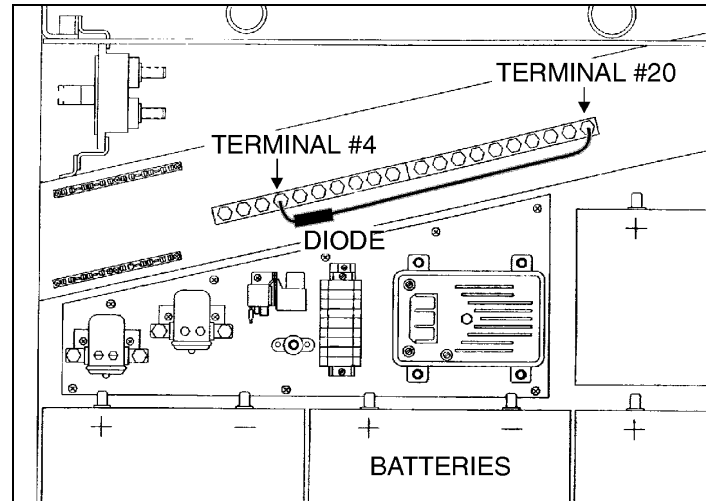
FIGURE 1

1. In last baggage compartment, open battery compartment.
2. Unscrew nuts from #4 and #20 terminals (Fig. 1), install diode assembly between these two terminals and reinstall nuts.

Caution: Wire extremity with diode should be installed on terminal #4.

In order to eliminate the possible interference in the P.A. system, occurring when central heating system's valve discharges itself, the Prévost Car engineering department have recently made a modification that you can perform on your own vehicle. Perform this modification according to the following procedure.
