**WARRANTY
BULLETIN**

Wb99-32

DATE : OCTOBER 1999	SECTION : 06 - Electrical
EXPIRATION: OCTOBER 2000	
SUBJECT : REPLACEMENT OF RELAY R68

Model	VIN
H3-41, H3-45 Coaches Model Year : 1998 - 1999	From 2PCH3349XW1012285 up to 2PCH33491X1013276 incl.

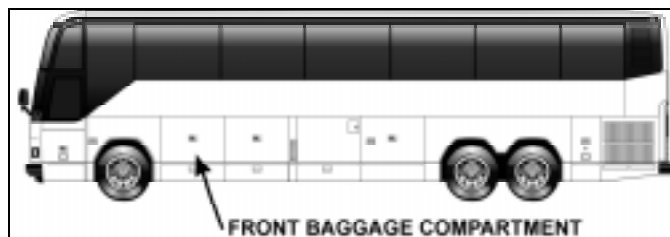
FIGURE 1: LOCATION OF FRONT BAGGAGE COMPARTMENT

1. Open front baggage compartment L.H. or R.H. side door (refer to figure 1).
2. Relay R68 is located in the upper middle front part of baggage compartment, on top of front wheelhousing.
3. Remove the three nuts and washers securing the plastic protective panel.

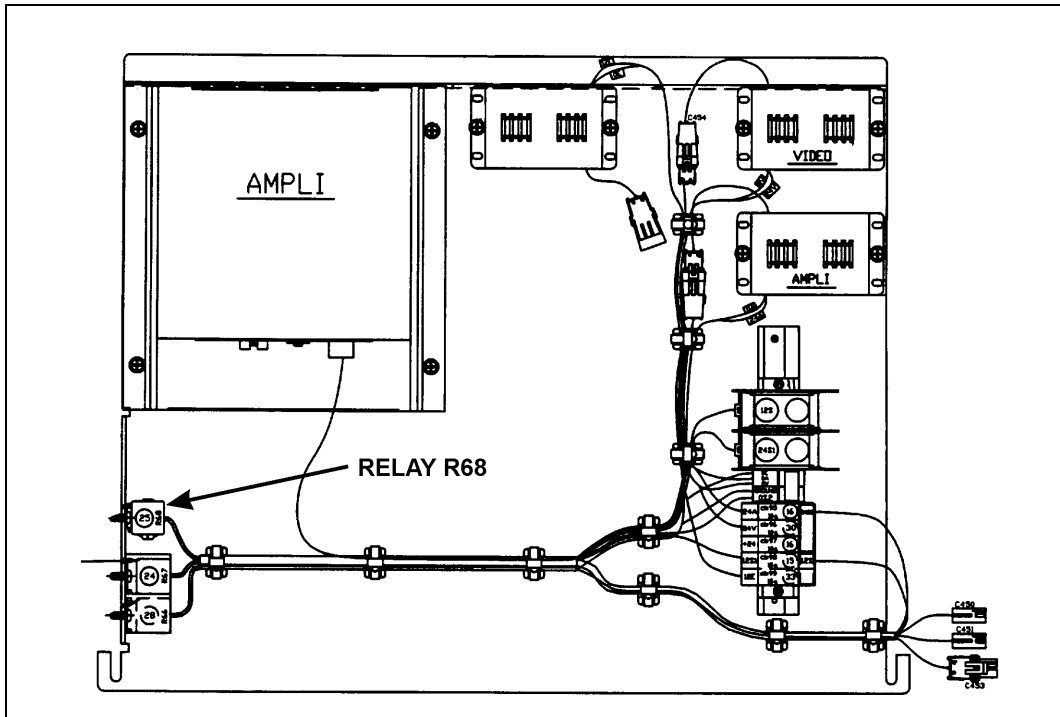
FIGURE 2: LOCATION OF RELAY R68

On the above-mentioned vehicles, changing relay R68 with a **built-in diode relay** will solve the problem which results from the occasional burning of the dashboard switches green LED. This relay is located along with the sound system components in the front baggage compartment

4. Locate relay R68 on the L.H. side (refer to figure 2). Disconnect wire and unfasten fixing screw. Remove former relay.
5. Secure new built-in diode relay (Prévost #561991) using fixing screw and reconnect wire.
6. Replace plastic protective panel.
