MAINTENANCE INFORMATION

MI24-83

DATE :	April 2024	SECTION :	18 BODY
SUBJECT :	PASSENGER STEP MOVING

Model
Volvo 9700 From Model Year : 2009 - XXXX

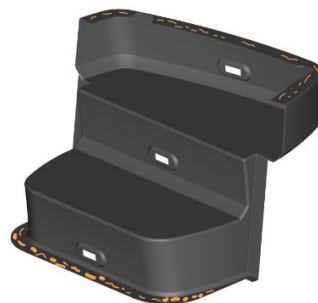
Figure 5

5. Remove the stairs and clean the sealant remains.

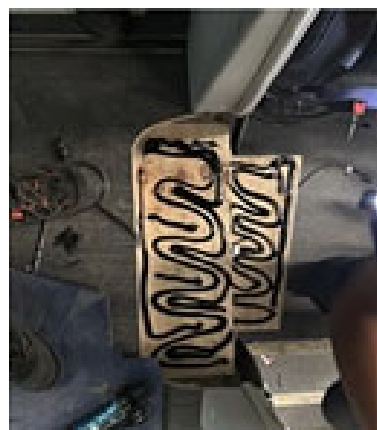
Figure 7

7. Apply adhesive 23184960 on the area where the stairs will be installed.

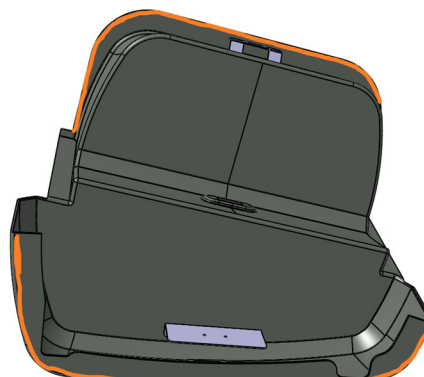
Figure 8

8. Apply sealant 682176 on the stairs edge.

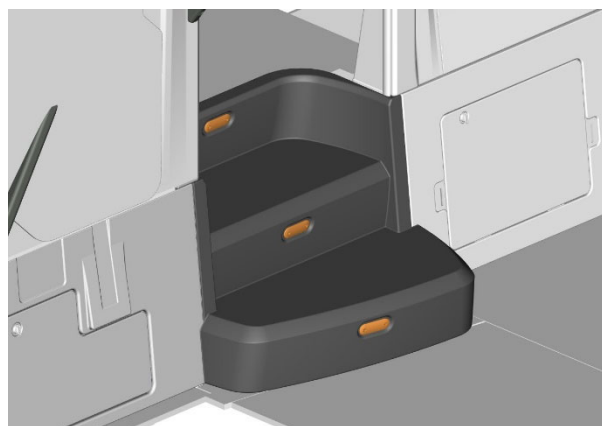
Figure 14

14. Reinstall the lamp steps.
